Concrete House Stands up to Katrina

Full Mitigation Best Practice Story

Harrison County, Mississippi

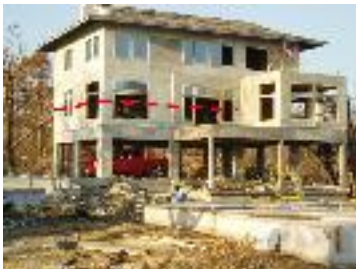
The water line was at 28 ft. as indicated by the red line in this photo.

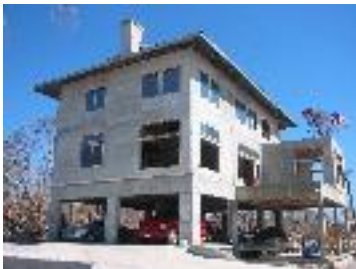
Stronger building materials and techniques proved effective during Hurricane Katrina.

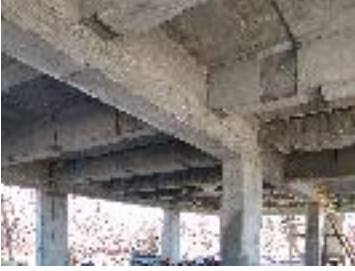
Concrete post and beam construction.

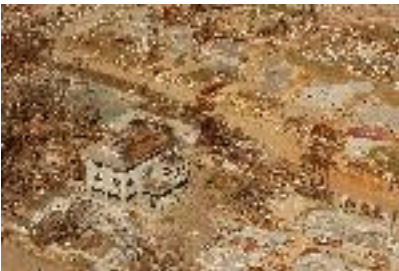
Aerial View of the Surrounding Destruction in Pass Christian, Mississippi.
