Ultrasonic Air Leak Survey

08/09~8/10/2011

National Energy Technologies LLC

report: 110800-1
staff: C. TURCICH
cert: UET2007245
equip: 9000MPH
serial: 928155

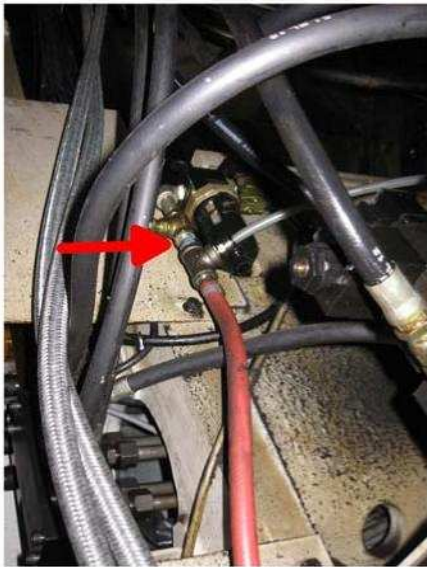
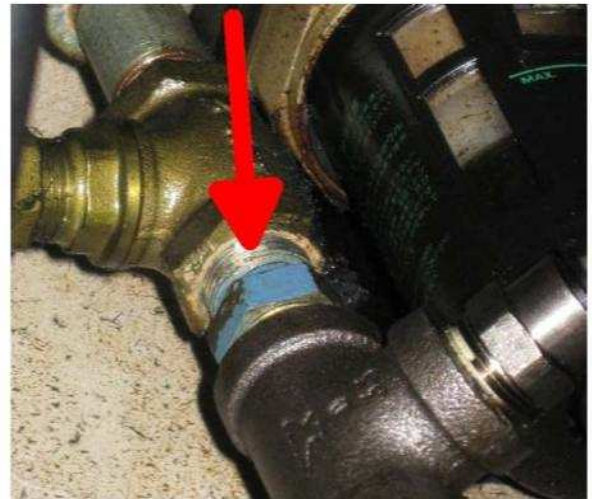
6	Long Shaft Cell Lathe #3
\$ 322	air feed to filter
8/9/2011	nipple upstream of valve
56 db	
100 psi	
3.4 cfm
