iiAssessment - Potholes

Project Name: Potholes _____

Date: 2/20/2014 _____

Field Inspector: Todd Rickenberg _____

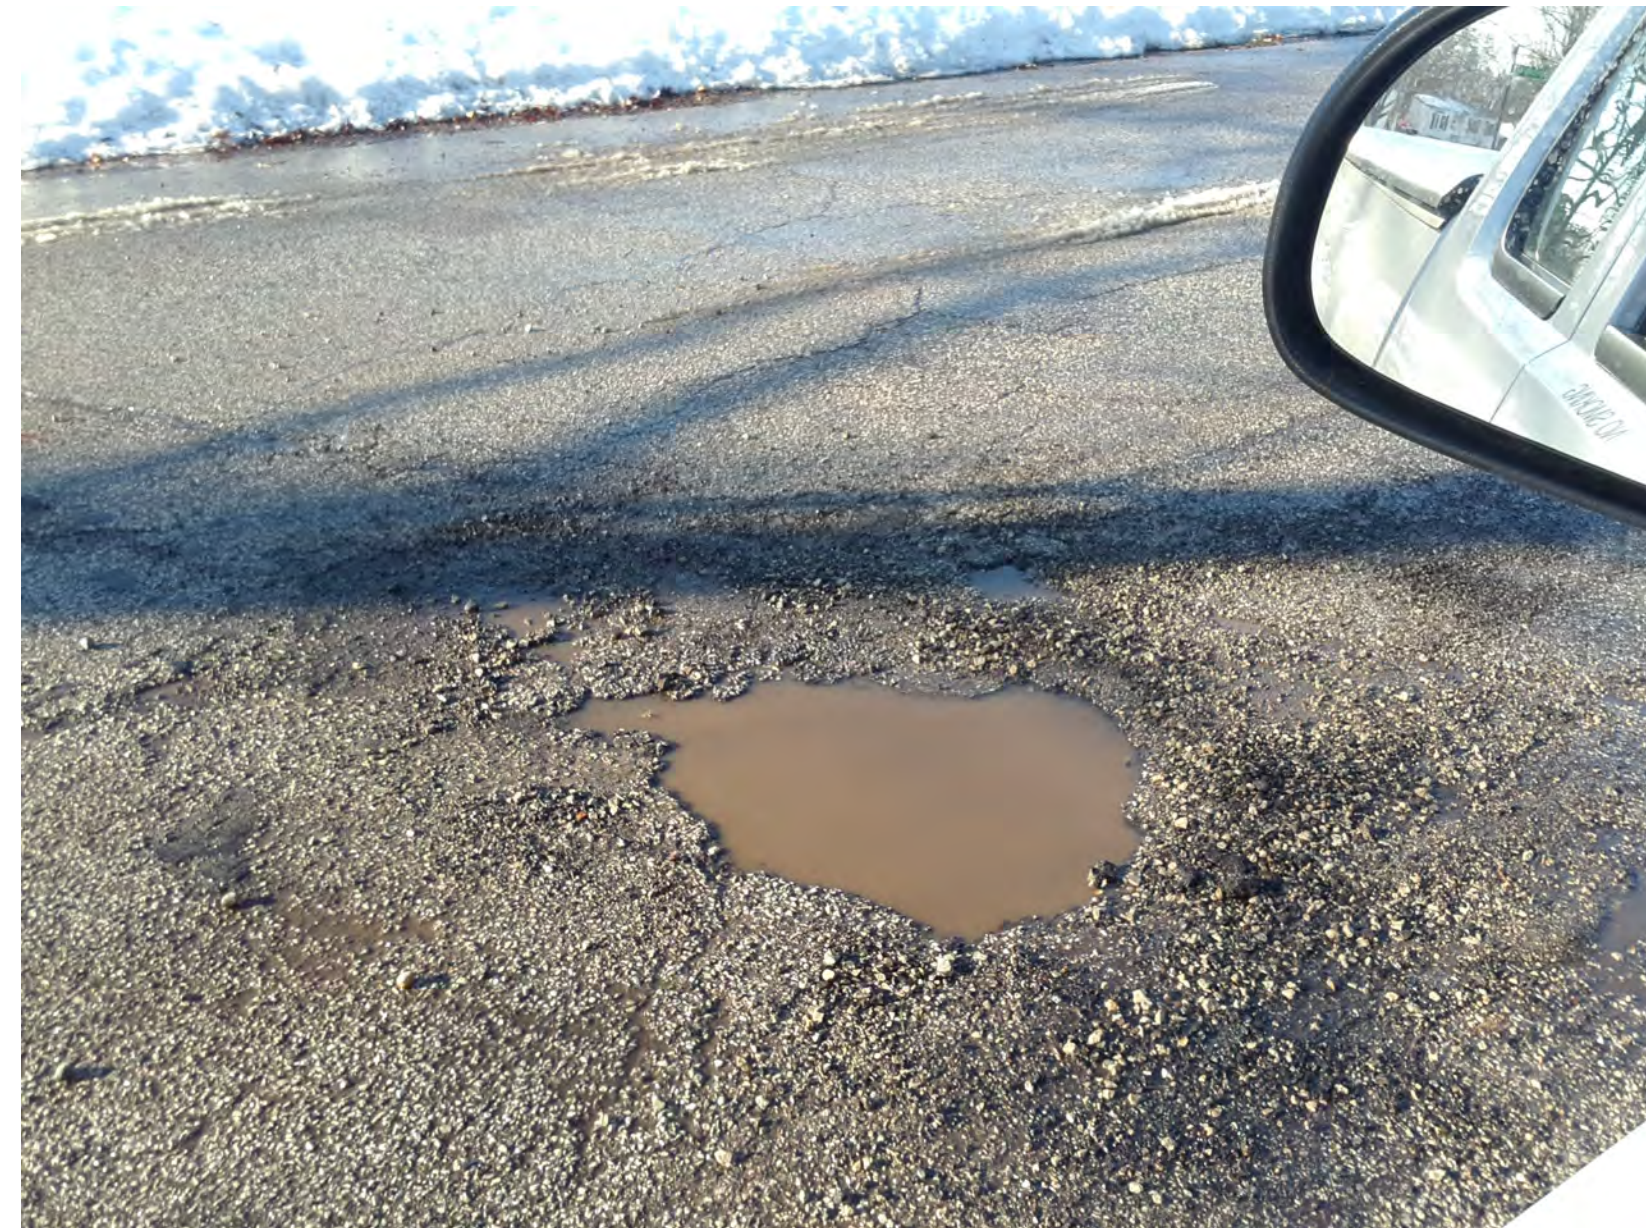
Asset ID: 1705944 _____

Deficiencies: 1 (Unacceptable), High Urgency _____

2'x2'x2" _____

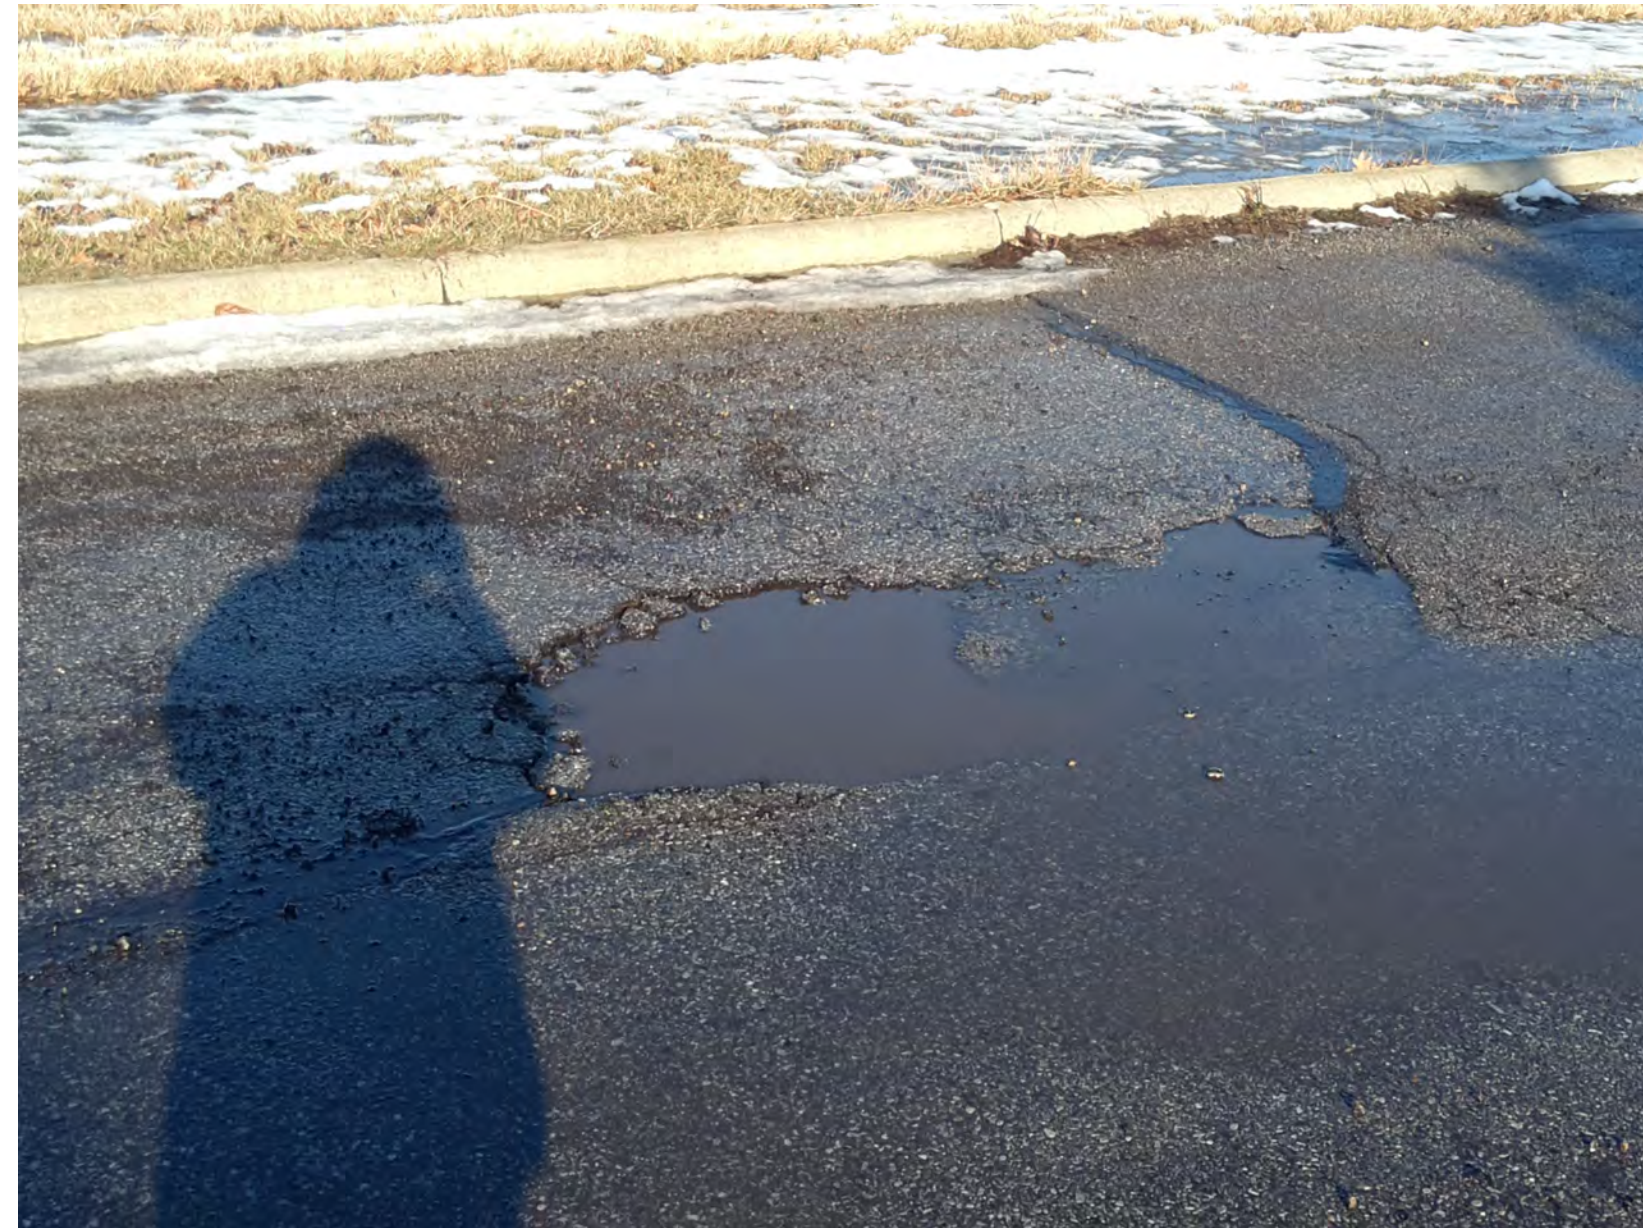
Asset ID: 1705945 _____

Deficiencies: 1 (Unacceptable), High Urgency _____

2'*3'*3" _____

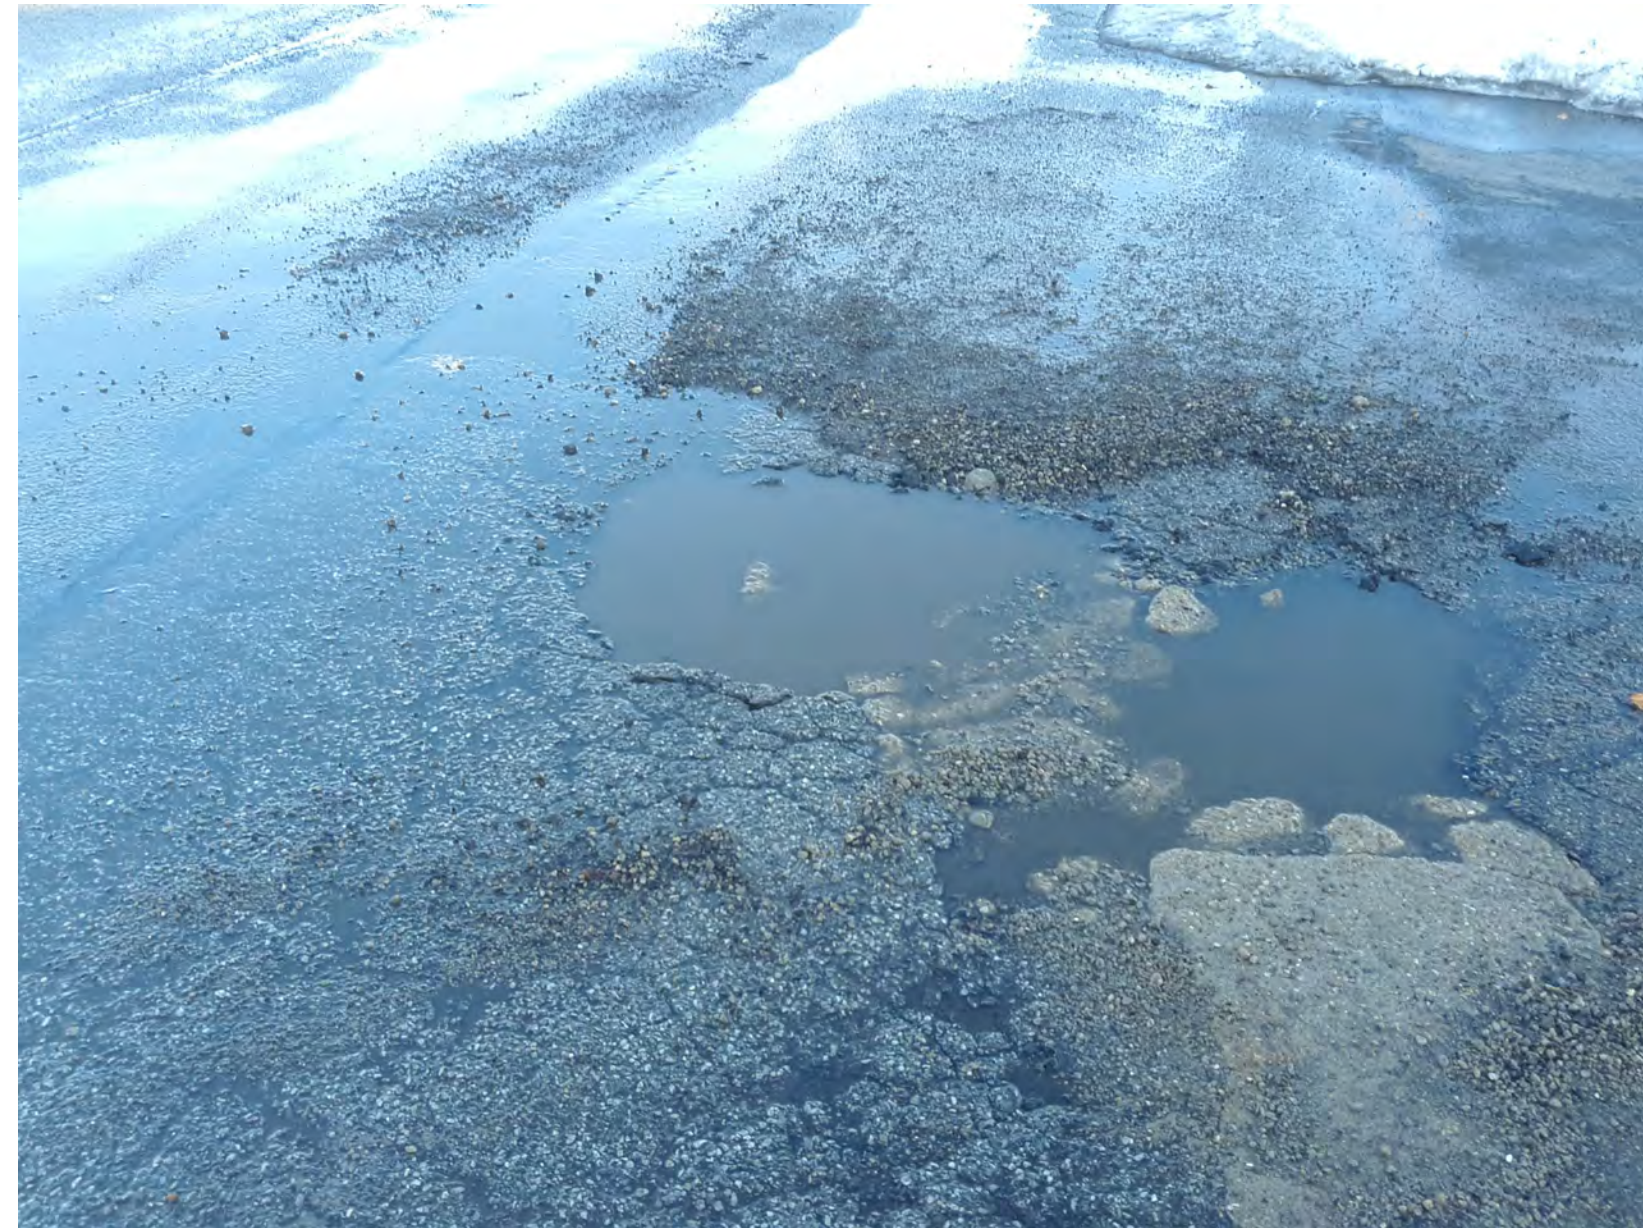
Asset ID: 1705946 _____

Deficiencies: 1 (Unacceptable), High Urgency _____

5'4" x 3" _____

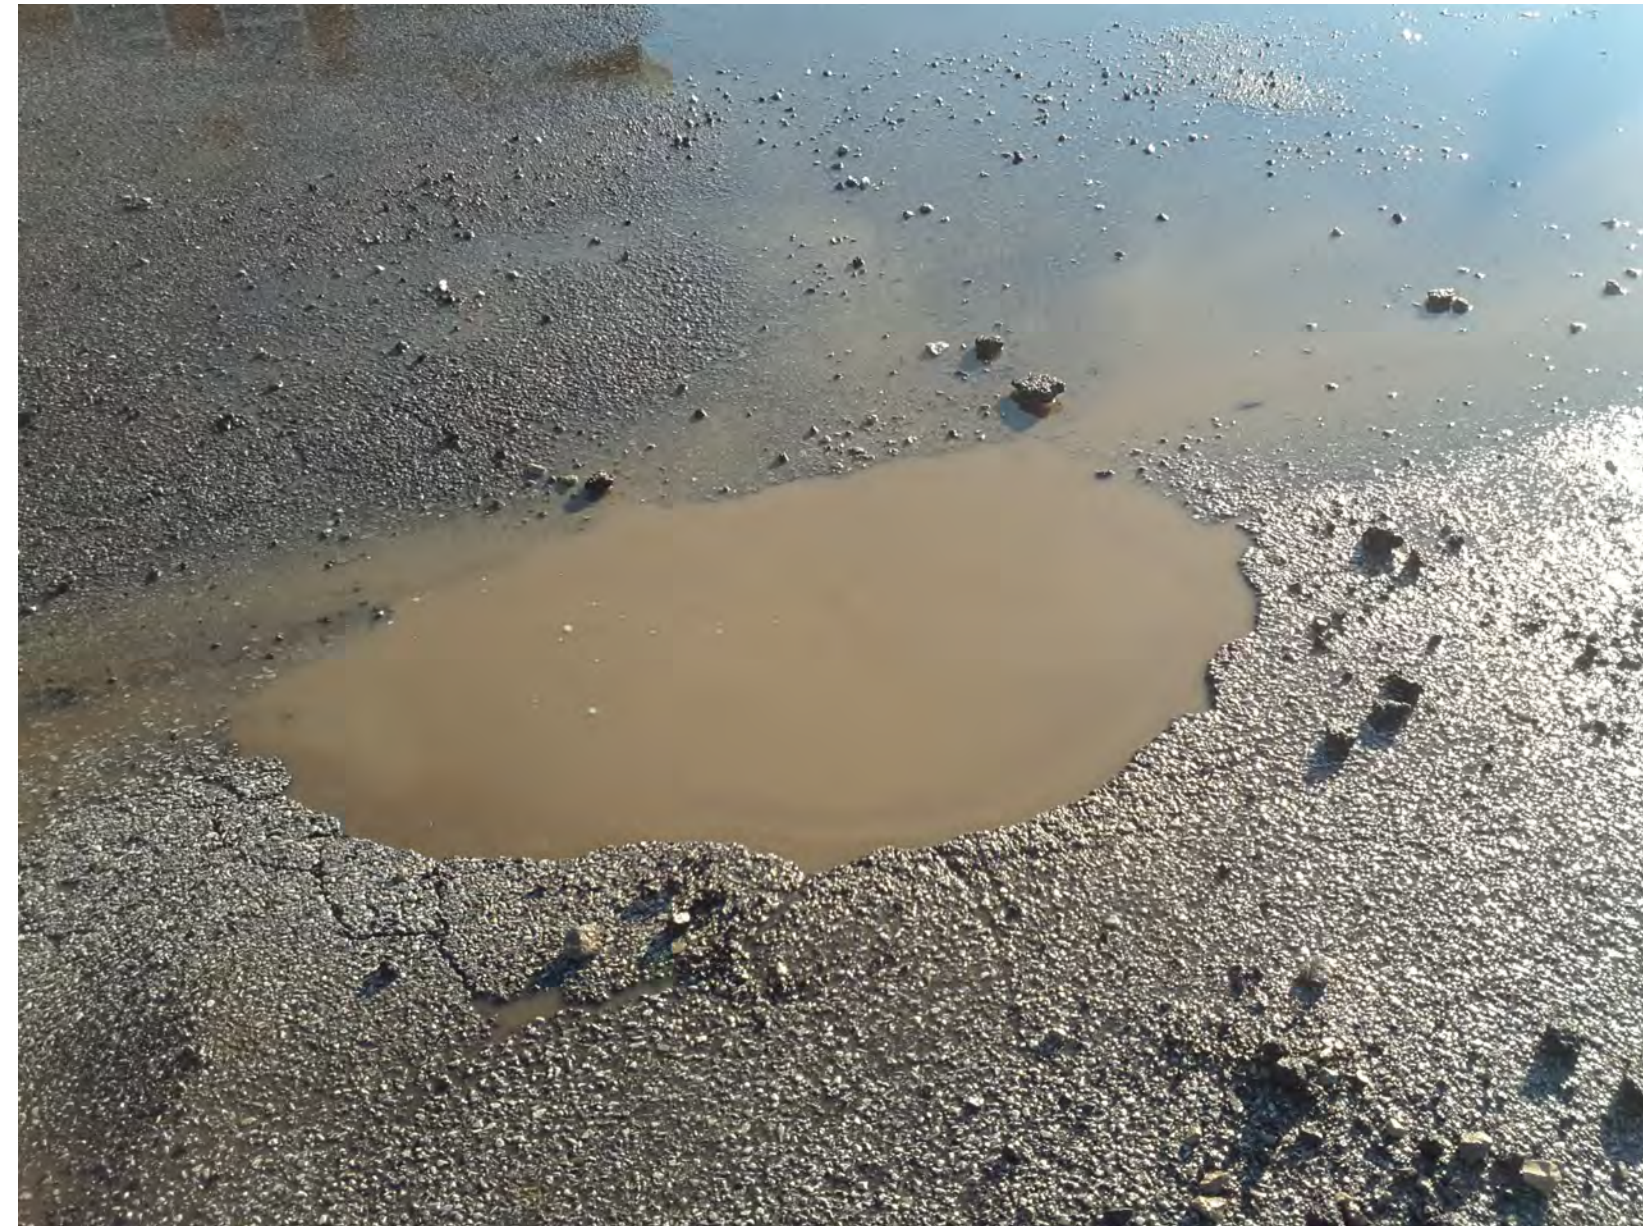
Asset ID: 1705947 _____

Deficiencies: 1 (Unacceptable), High Urgency _____

4'x2'x3" _____

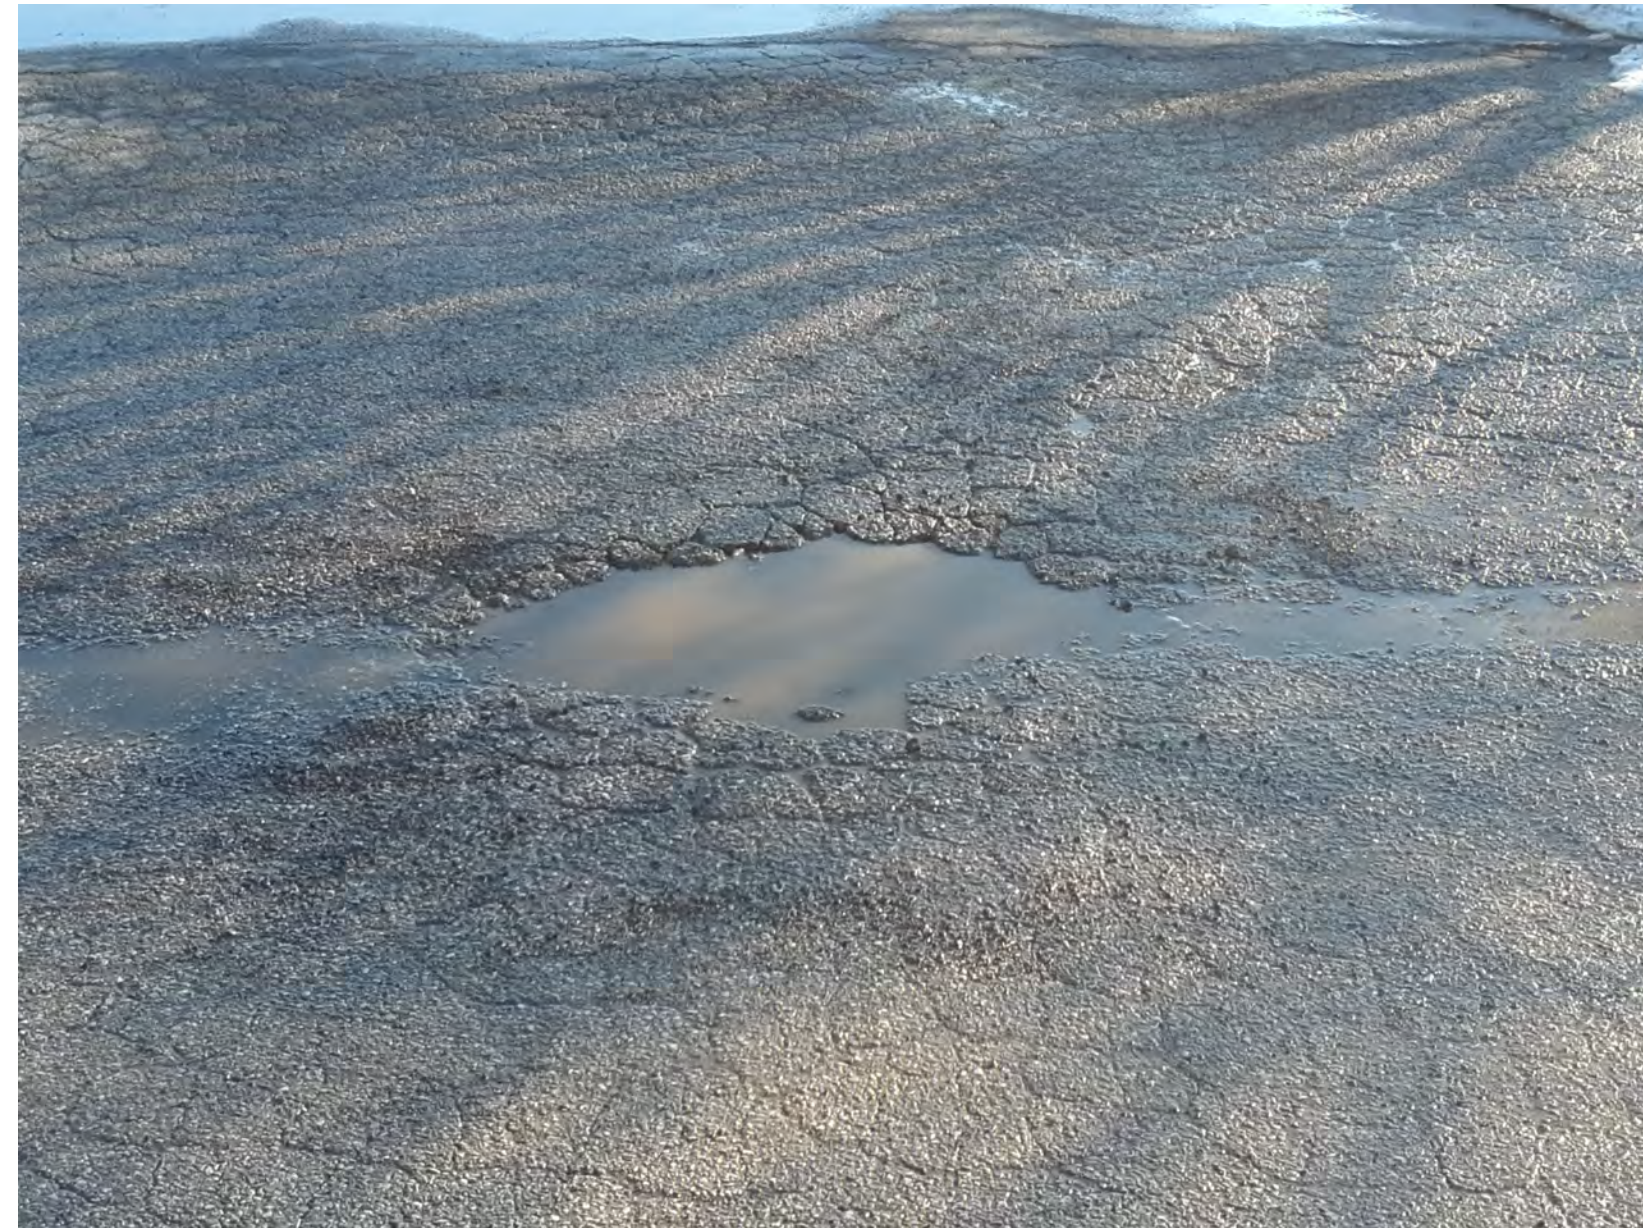
Asset ID: 1705948 _____

Deficiencies: 1 (Unacceptable), High Urgency _____

2'x2'x2" _____

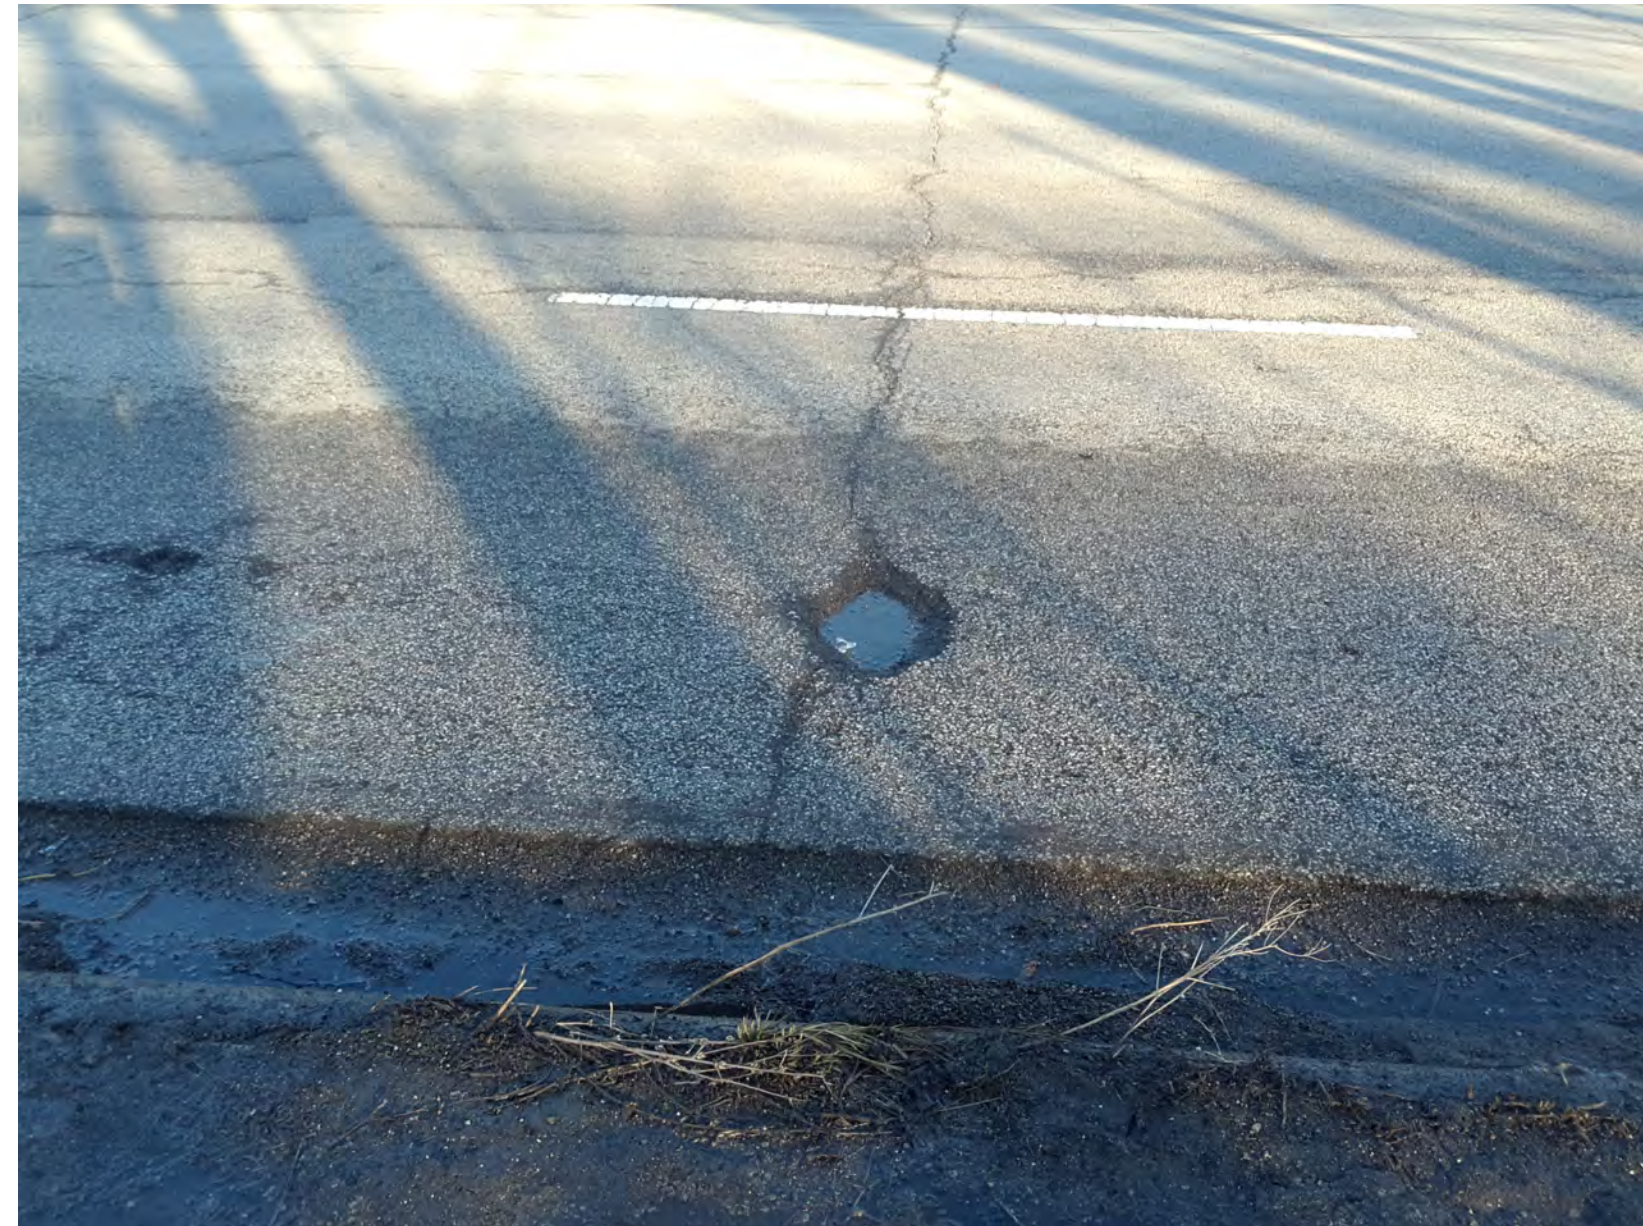
Asset ID: 1705949 _____

Deficiencies: 1 (Unacceptable), Medium Urgency _____

1'x1'x2" _____

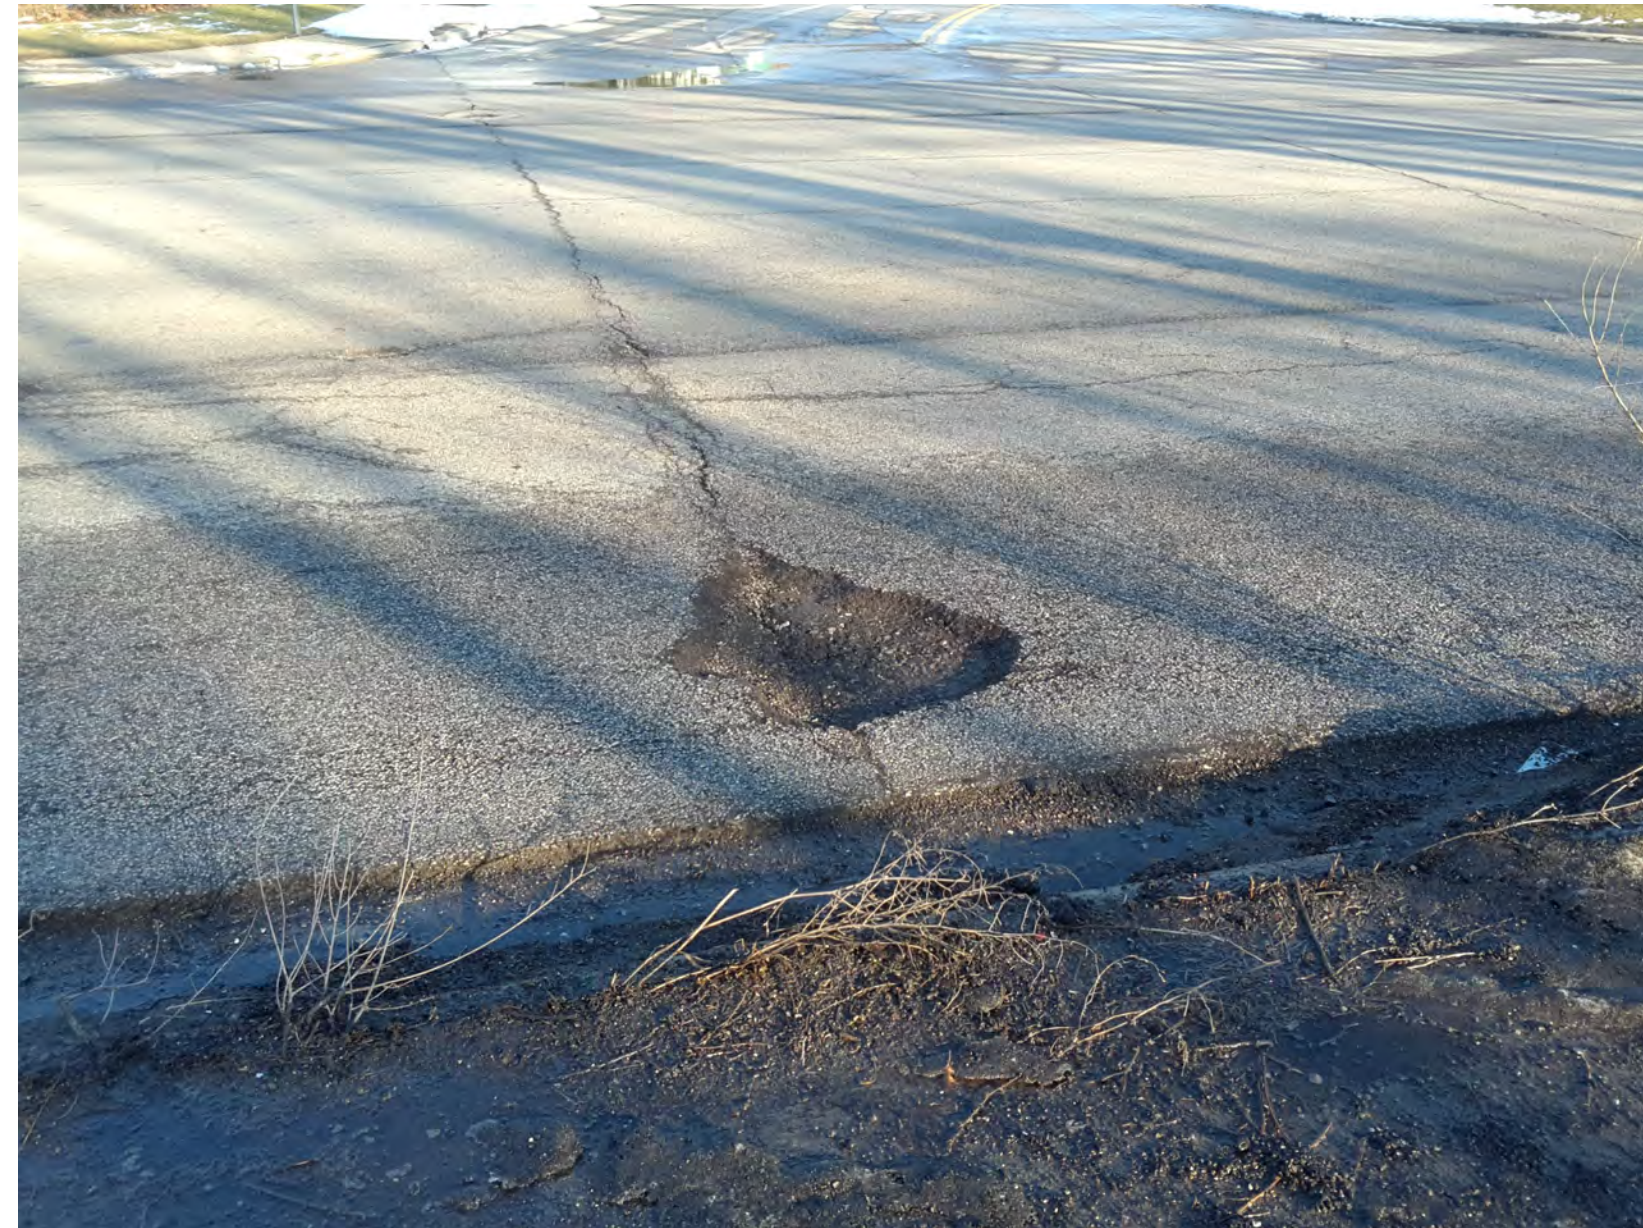
Asset ID: 1705950 _____
Address: 5077-5079 Cleveland Avenue, _____
Columbus, OH 43231, USA _____
Longitude: -82.95193 _____
Latitude: 40.07437 _____
Direction: N/A _____

Length: N/A _____
Width: N/A _____
Height: N/A _____
Type: N/A _____
Material: N/A _____
Deficiencies: 1 (Unacceptable), High Urgency _____

3'x4'x2" _____

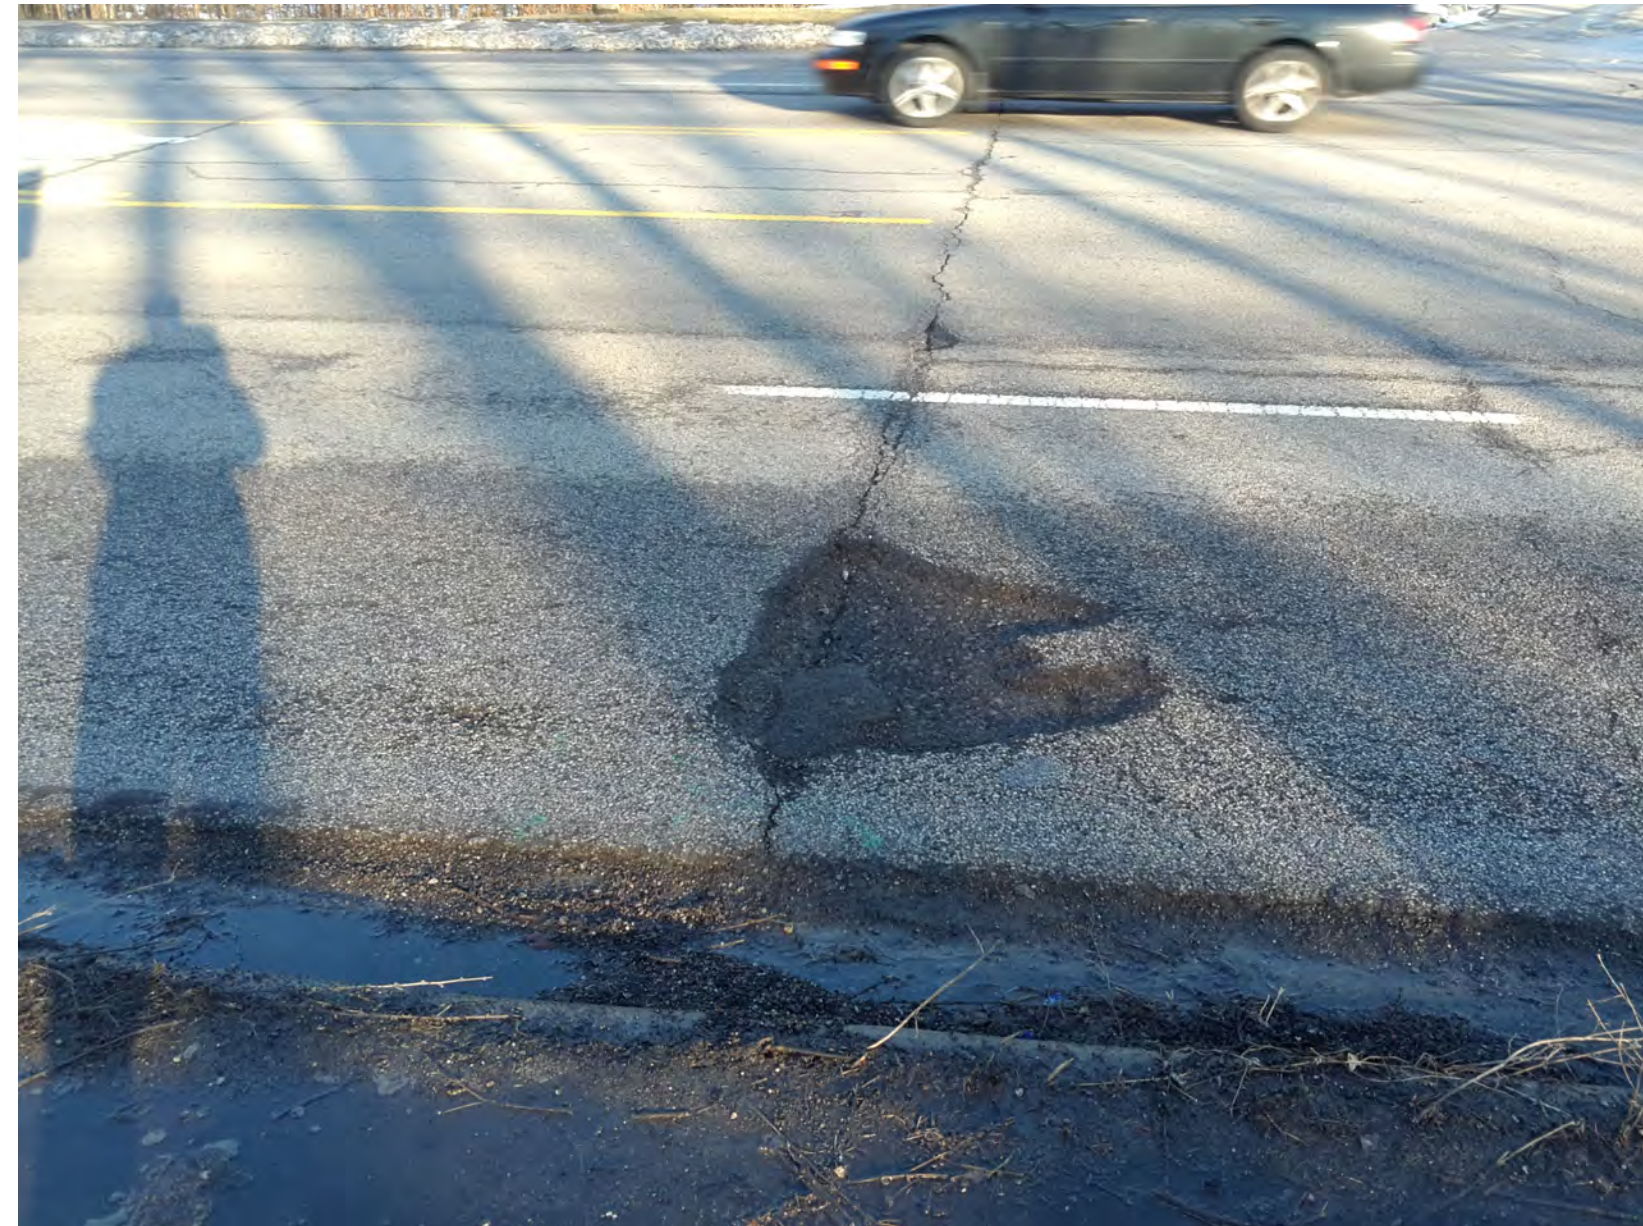
Asset ID: 1705951 _____

Deficiencies: 1 (Unacceptable), High Urgency _____

4'x4'x2' _____

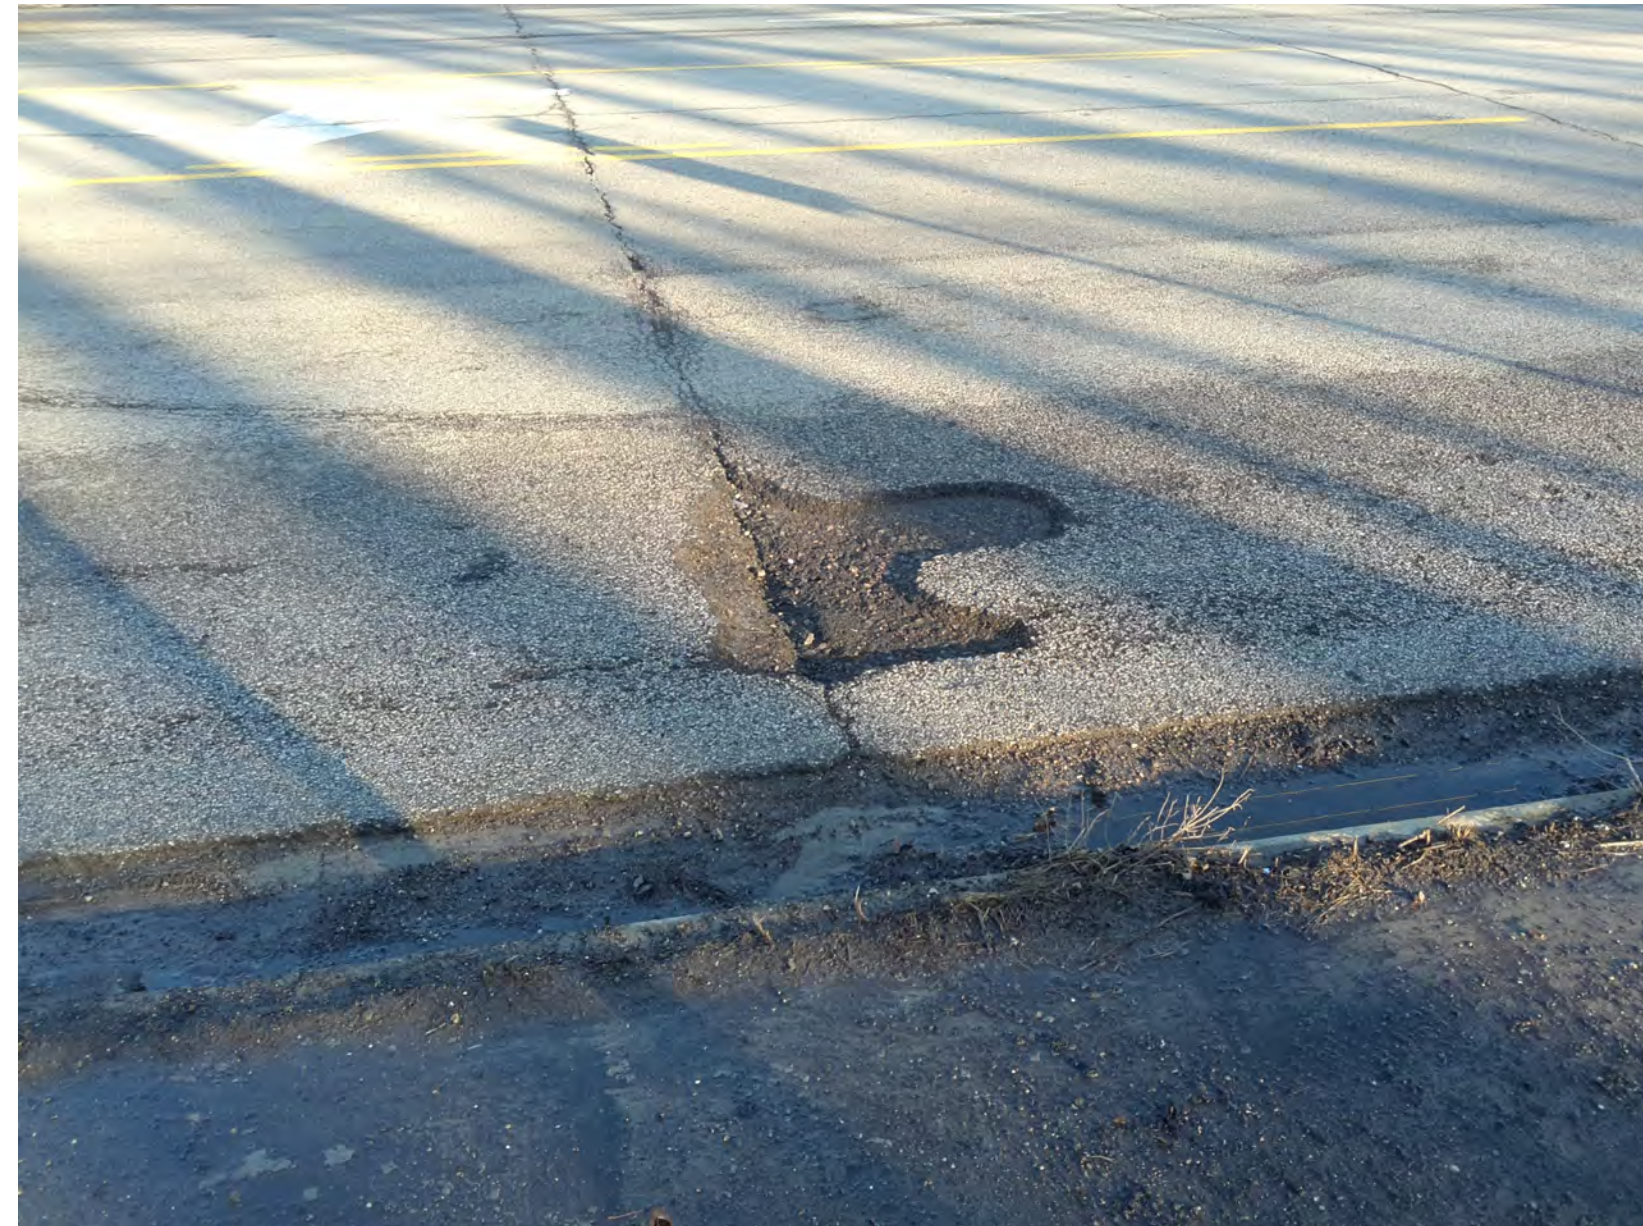
Asset ID: 1705952 _____

Deficiencies: 1 (Unacceptable), High Urgency _____

4'3'3" _____

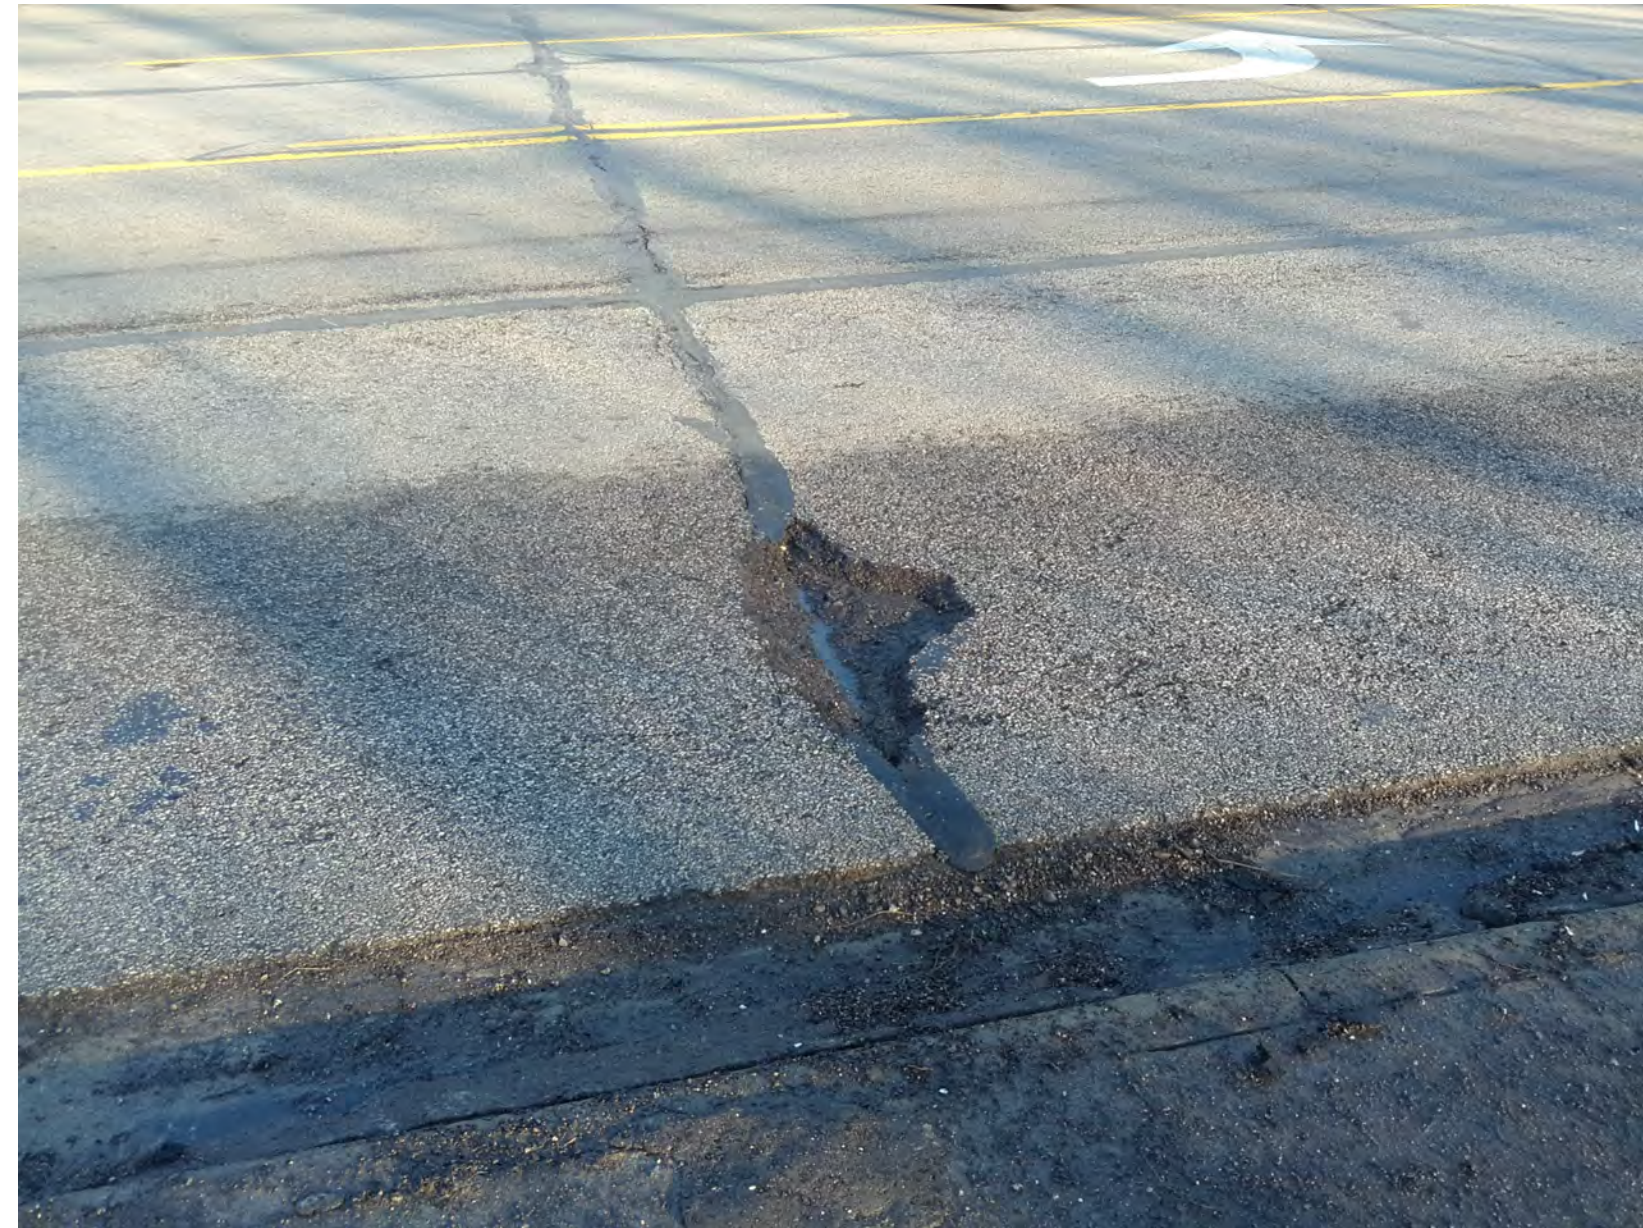
Asset ID: 1705953 _____

Deficiencies: 1 (Unacceptable), Medium Urgency _____

2'*.5'*2" _____

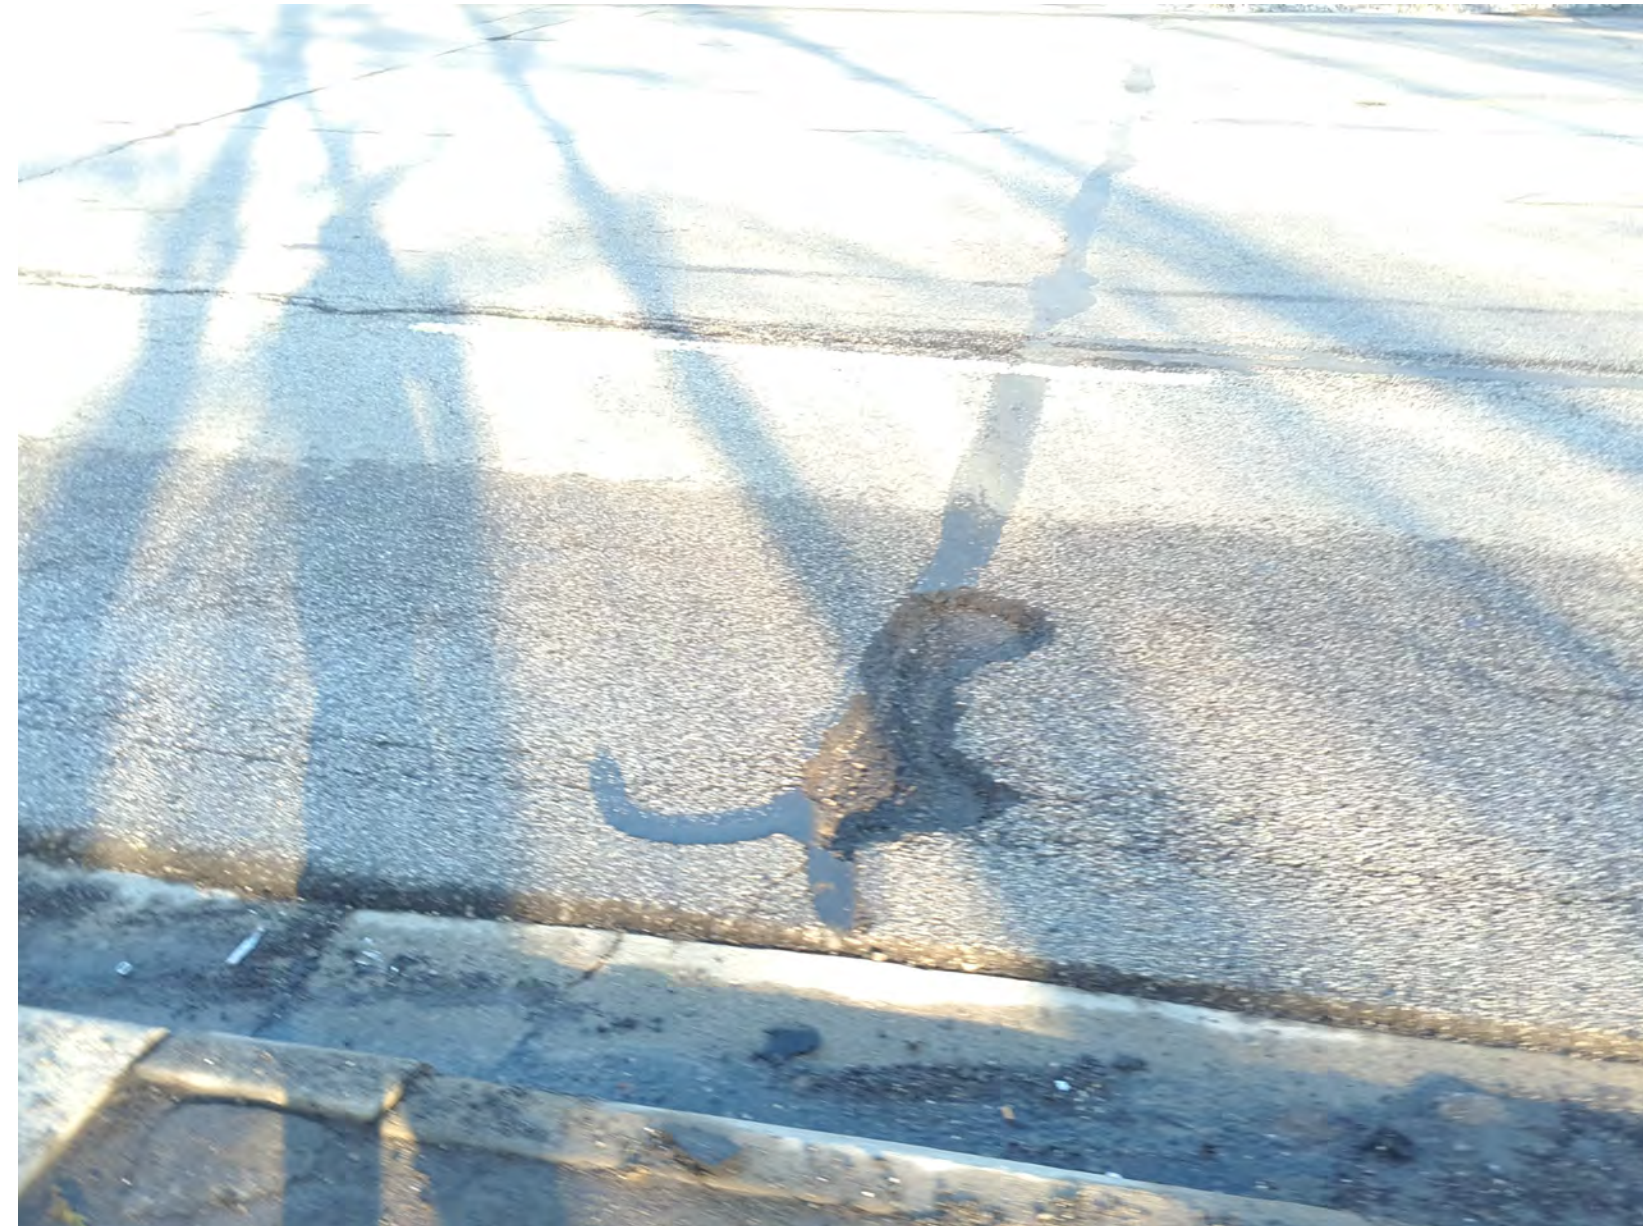
Asset ID: 1705954 _____

Deficiencies: 1 (Unacceptable), Medium Urgency _____

3'*2'*1" _____
