iiAssessment - Potholes

Project Name: Potholes _____

Date: 2/20/2014 _____

Field Inspector: Todd Rickenberg _____

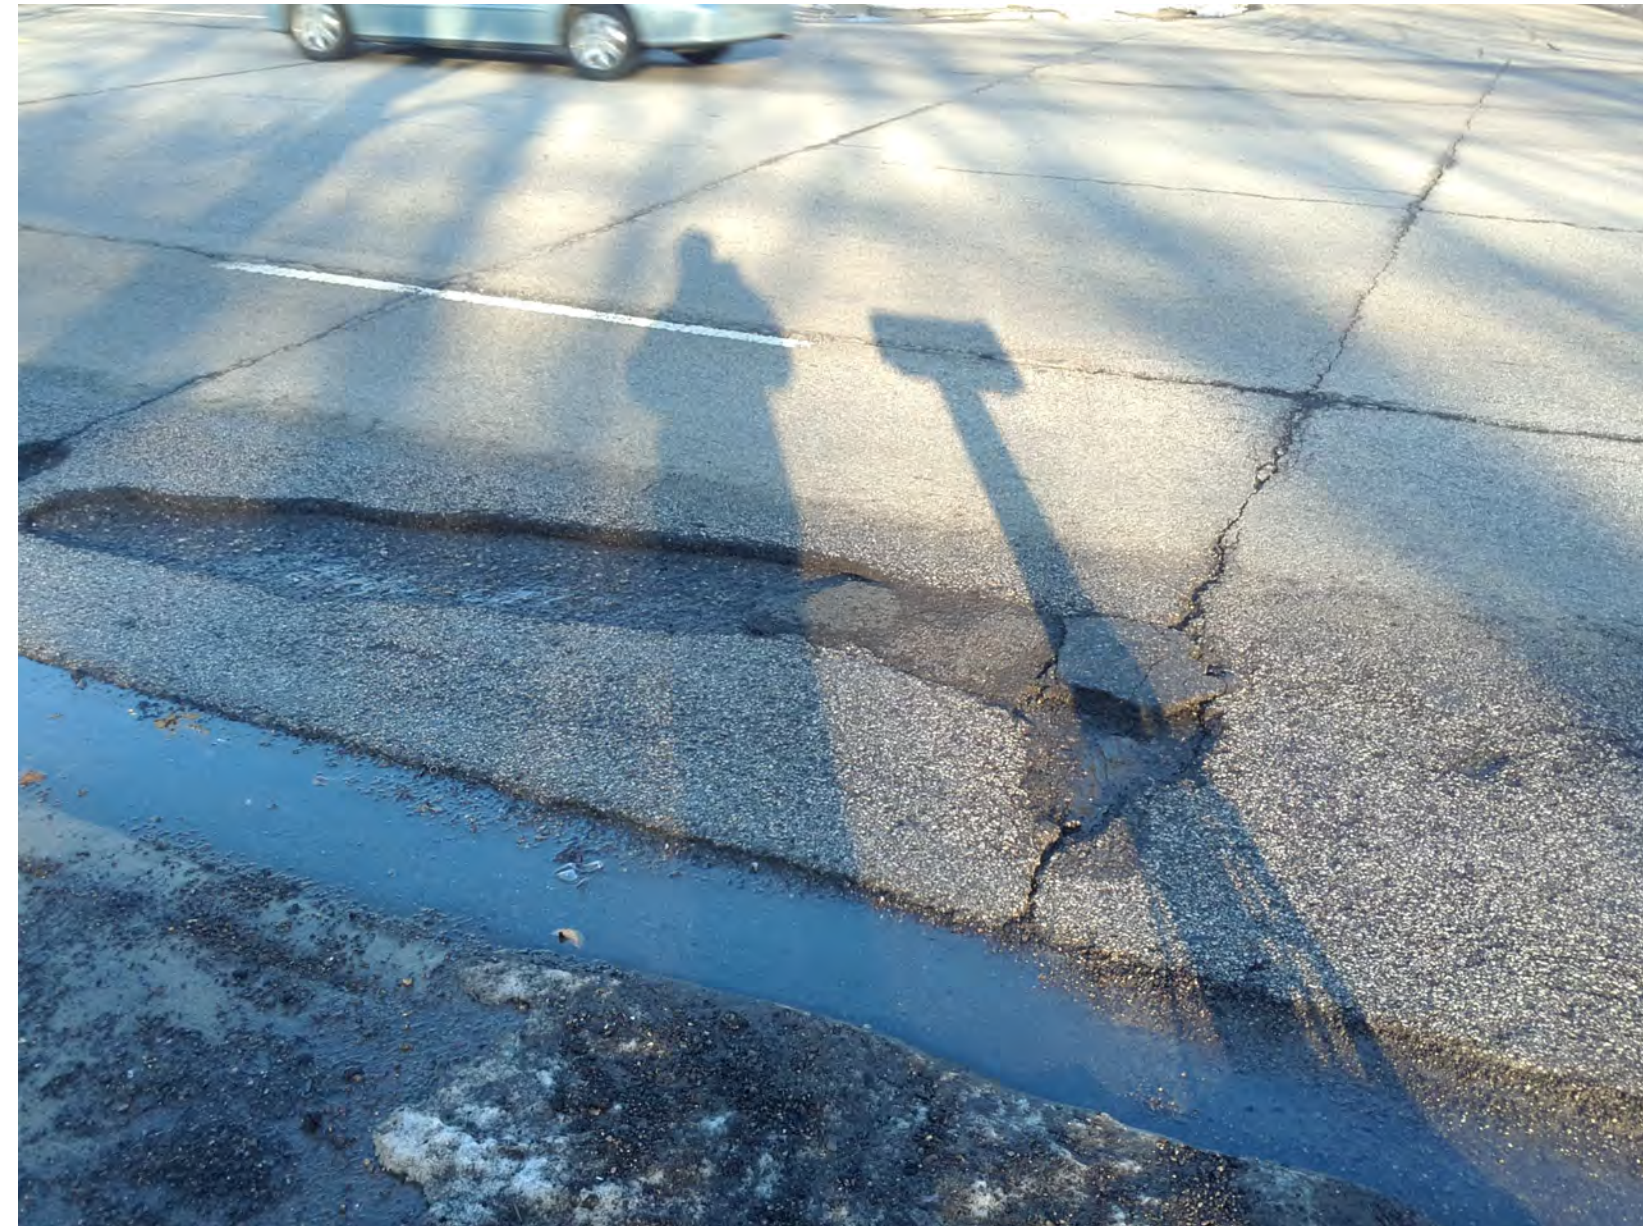
Asset ID: 1705956 _____
Address: 5085 Cleveland Avenue, _____
Columbus, OH 43231, USA _____
Longitude: -82.95192 _____
Latitude: 40.07459 _____
Direction: N/A _____

Length: N/A _____
Width: N/A _____
Height: N/A _____
Type: N/A _____
Material: N/A _____
Deficiencies: 1 (Unacceptable), High Urgency _____

2'x8'x3" _____

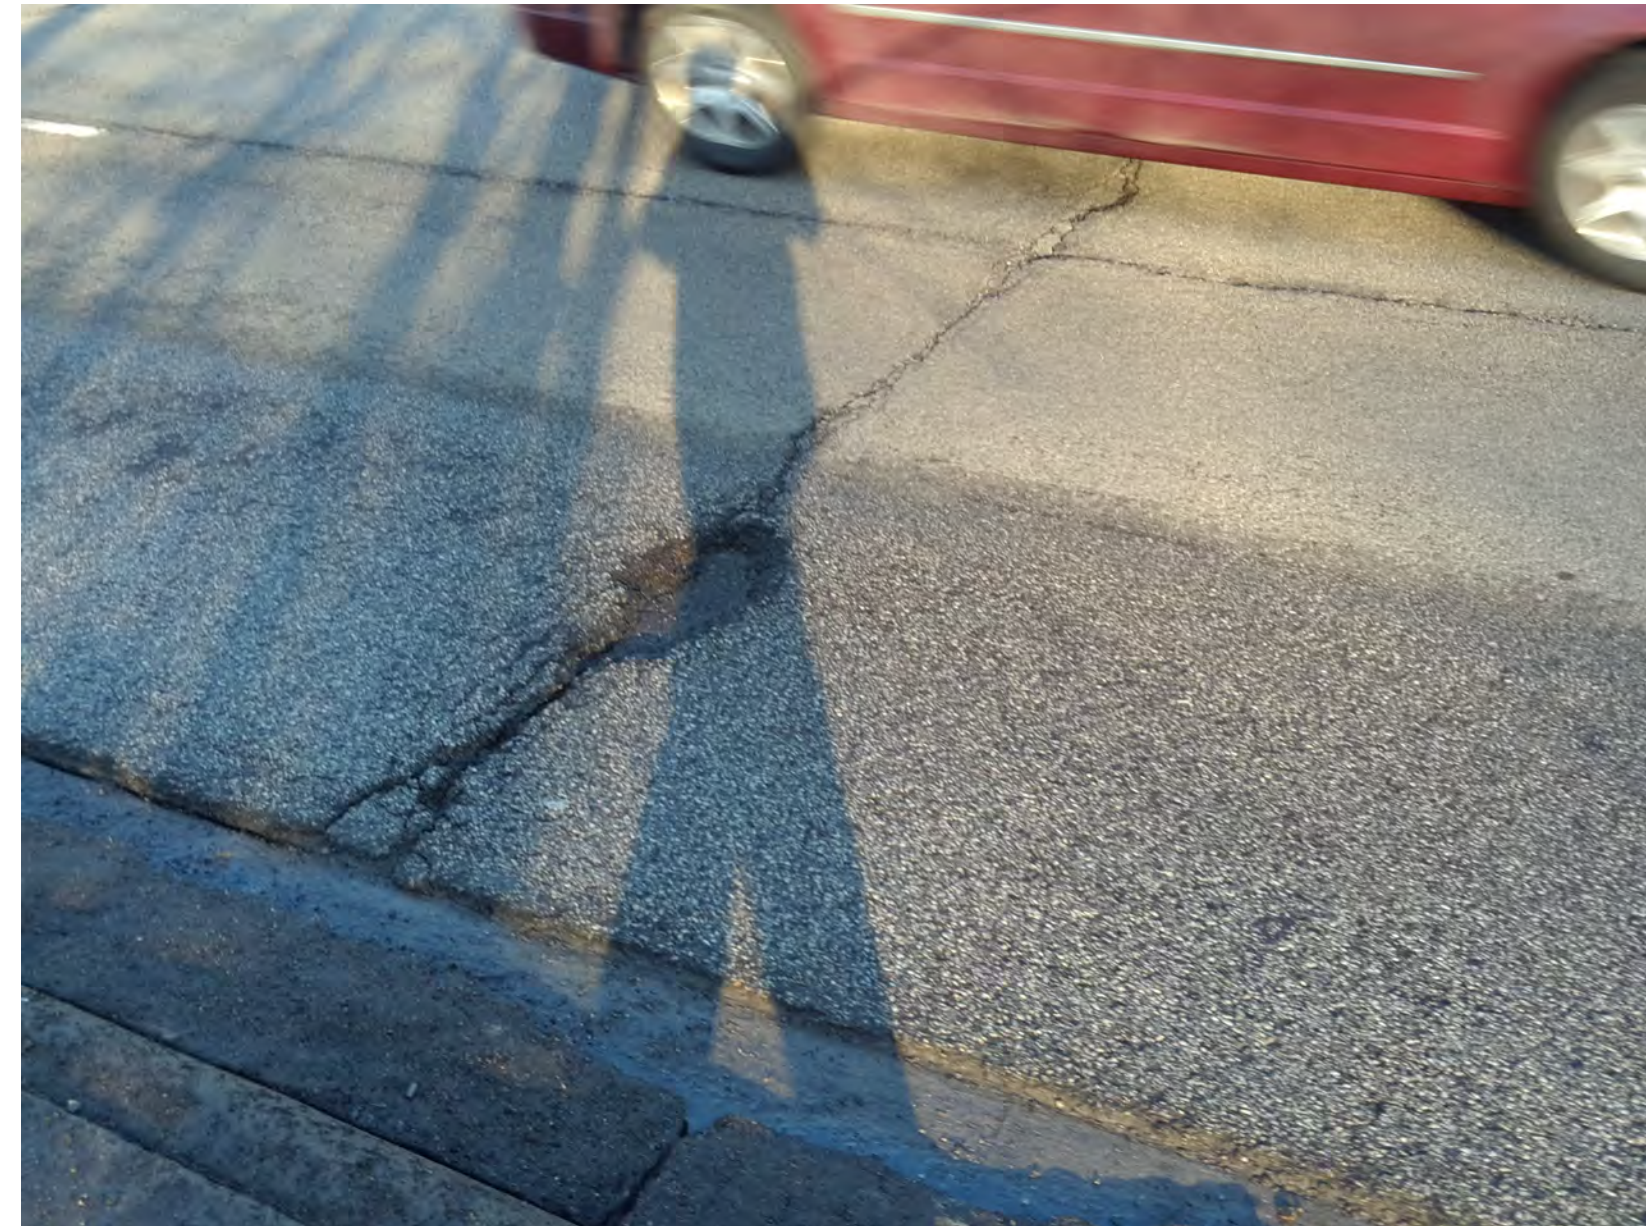
Asset ID: 1705957 _____

Deficiencies: 1 (Unacceptable), Medium Urgency _____

1'*1'*2" _____

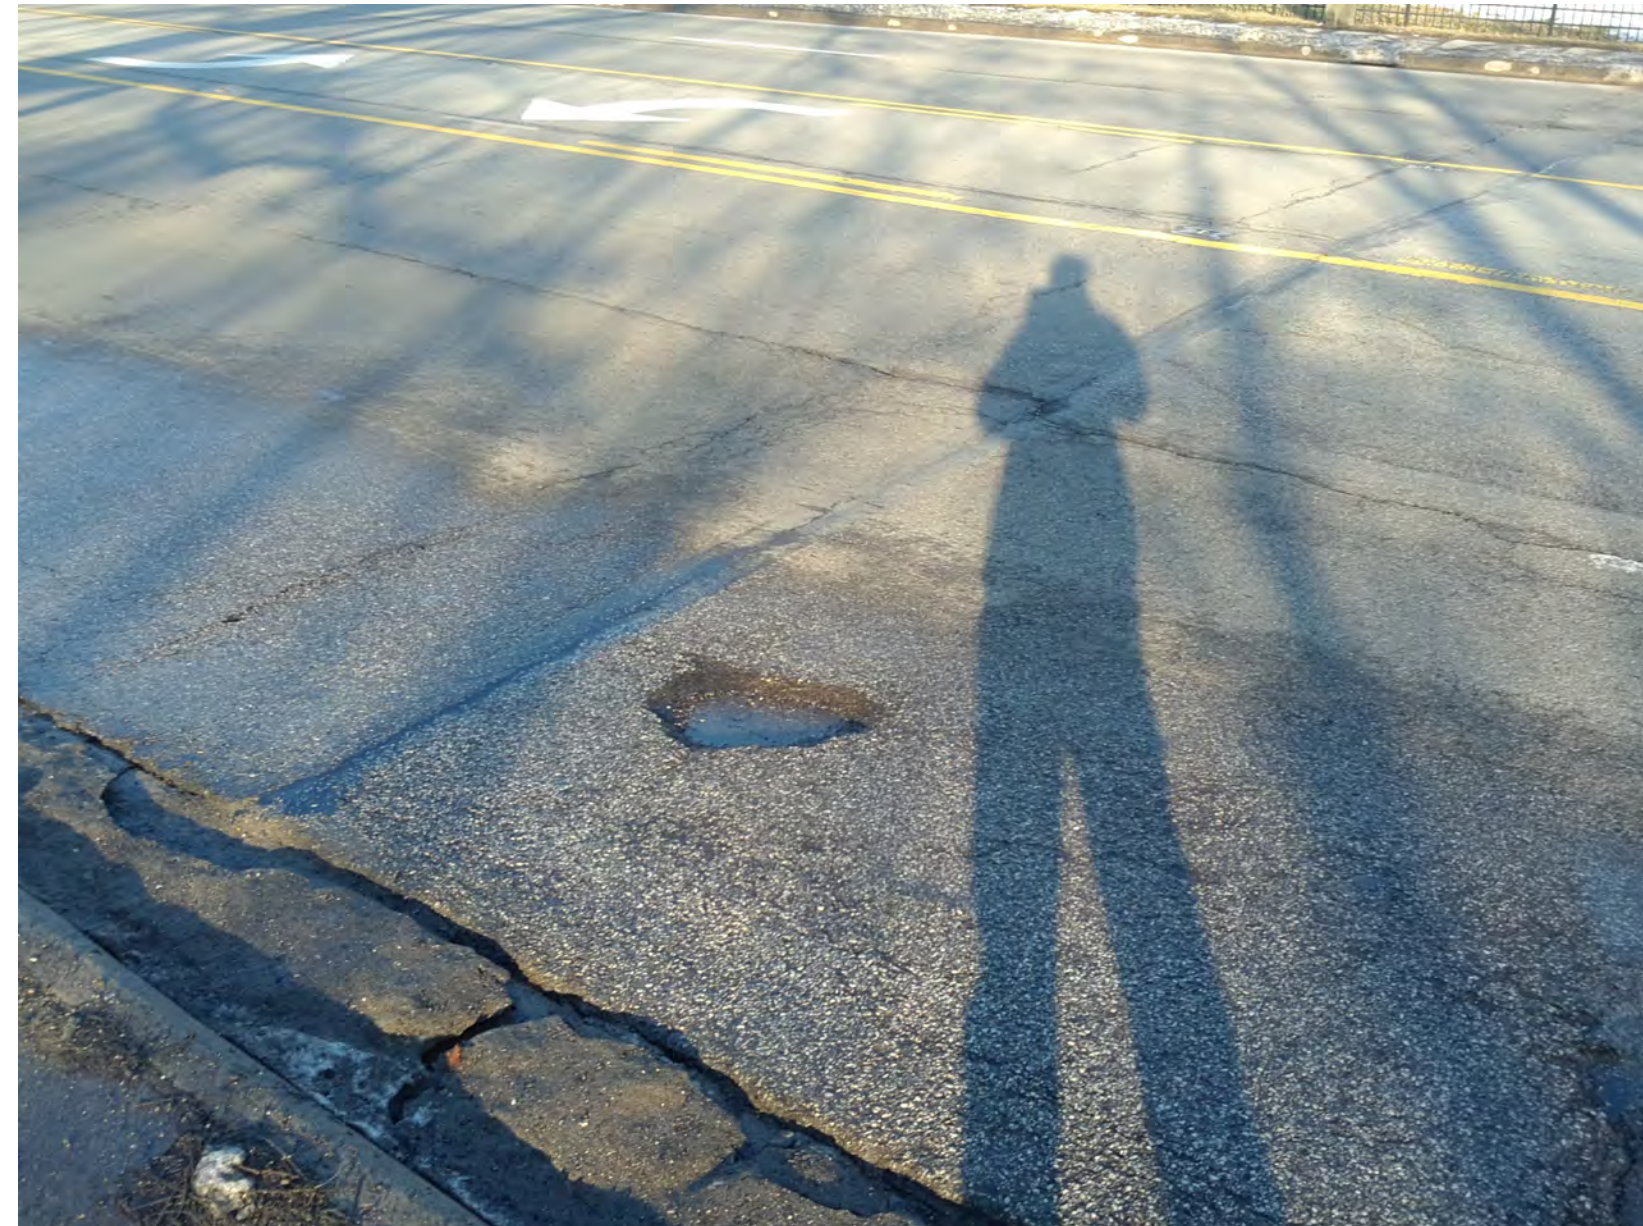
Asset ID: 1705958 _____

Deficiencies: 1 (Unacceptable), High Urgency _____

2'*2'*3" _____
