Demonstration of the AquaBlok® Sediment Capping Technology

Innovative Technology Evaluation Report

Final

National Risk Management Research Laboratory
Office of Research and Development
U.S. Environmental Protection Agency
Cincinnati, Ohio 45268

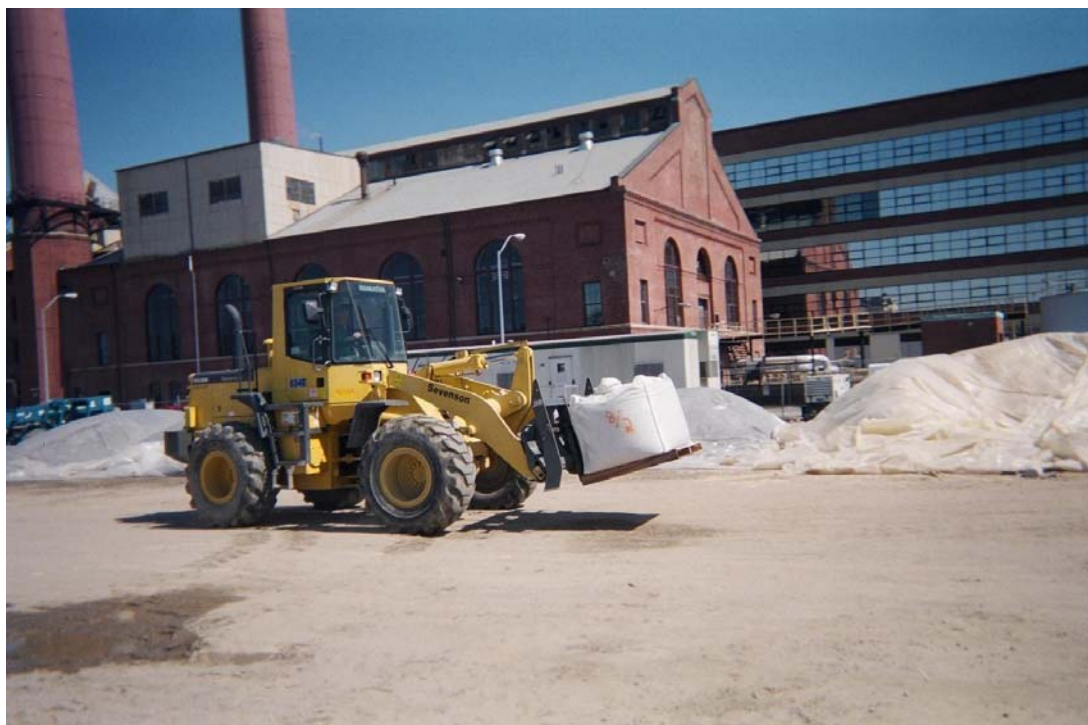
Figure 3-5. AquaBlok® in 2-Ton SuperSack at Staging Area

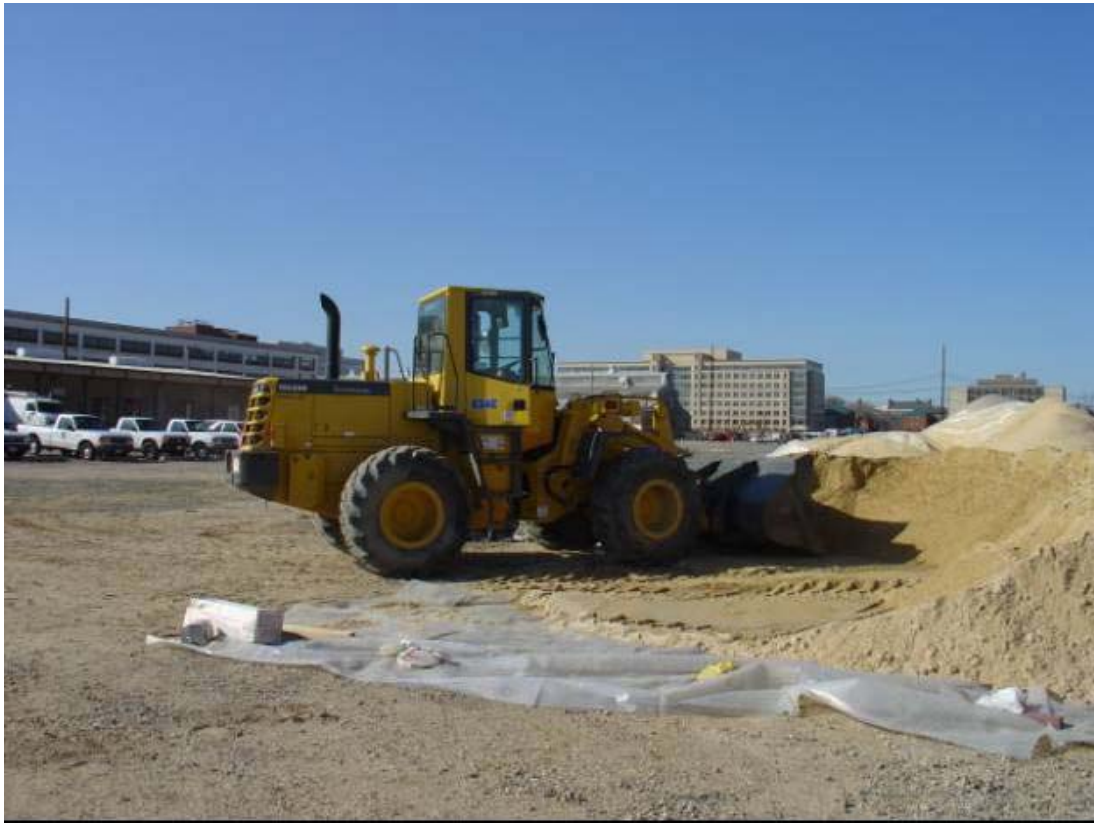
Figure 3-6. Sand Cap Material Stored in Bulk at Staging Area

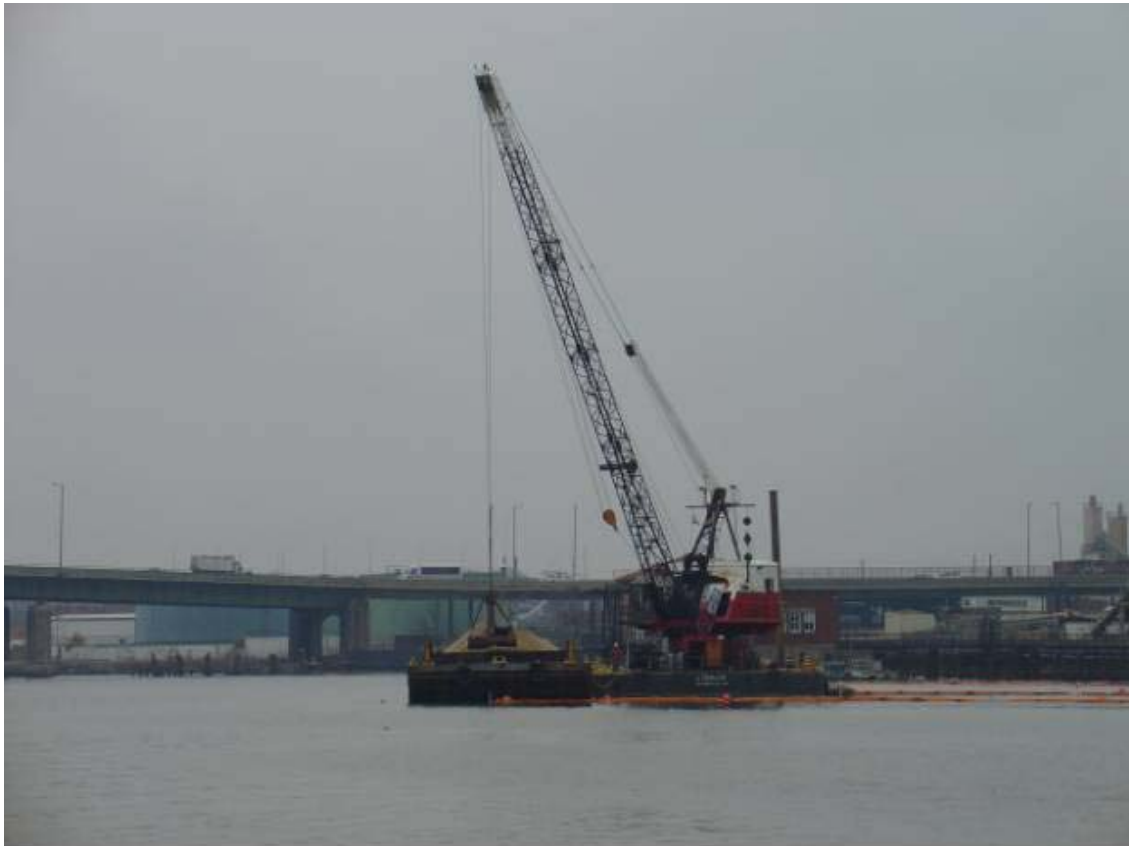
Figure 3-8. Crane Barge Used to Place Caps in Demonstration Area

nearshore loading area. A belt conveyor system was then used to transfer the materials from the nearshore material stockpile area to a material barge secured along the shoreline (see Figure 3-7). After loading, a tugboat was used to move the material barge beside a crane barge that was used to actually construct the caps (see Figure 3-8).

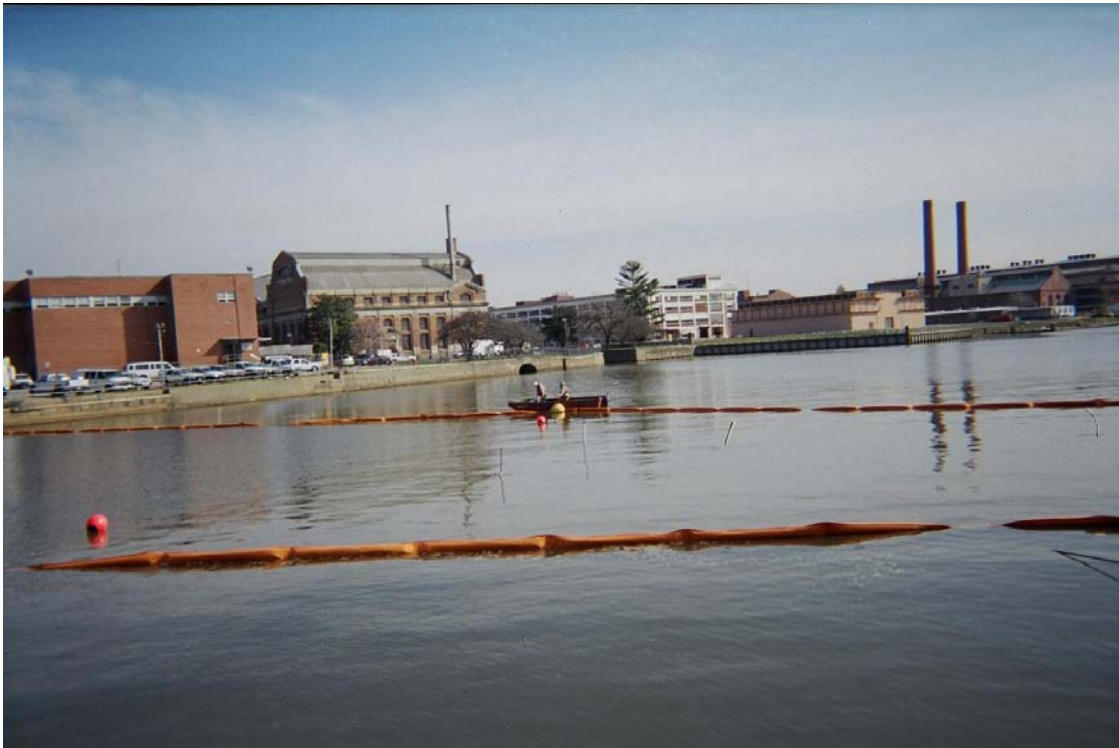
Figure 3-9. Silt Curtains Deployed Around Demonstration Area Capping Cells

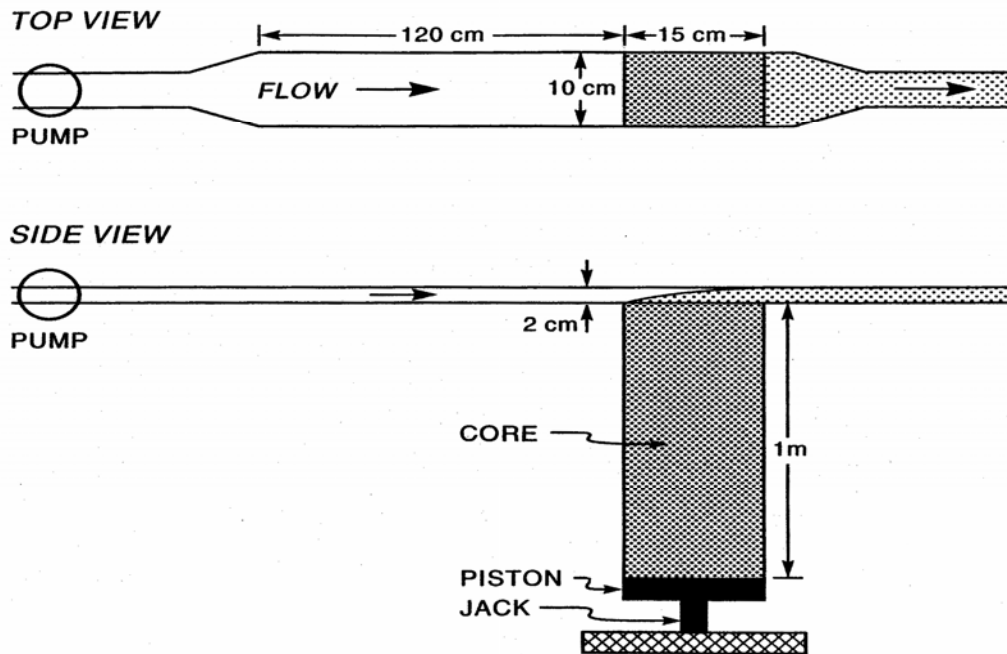
section coring sleeve containing sediment is inserted. The main components of the flume are the coring sleeve, a test section where the coring sleeve is advanced, a water storage tank, a pump to force water through the system, an inlet for the introduction of uniform, fully-developed, turbulent flow, and a flow exit section. The Sedflume system, as with the coring sleeve, is generally constructed of a transparent material so that sediment-water interactions can be directly observed. Water is pumped from the water storage tank, through a pipe, and then through a flow converter into the rectangular duct shown on Figure 3-10.

Figure 3-10. Sedflume Schematic (from McNeil and Lick, 1996)

Water is forced through the duct and the test section and over the surface of the test sediments. The shear produced by this flow causes the sediments to erode. As the sediments extruded from the core sleeve erode, the core is continually moved upward by the operator so that the sediment-water interface remains level with the bottom of the test and inlet sections (a few millimeters of the core does protrude above the section floor). The erosion rate is recorded as the degree of upward movement of the sediments in the coring tube over time.

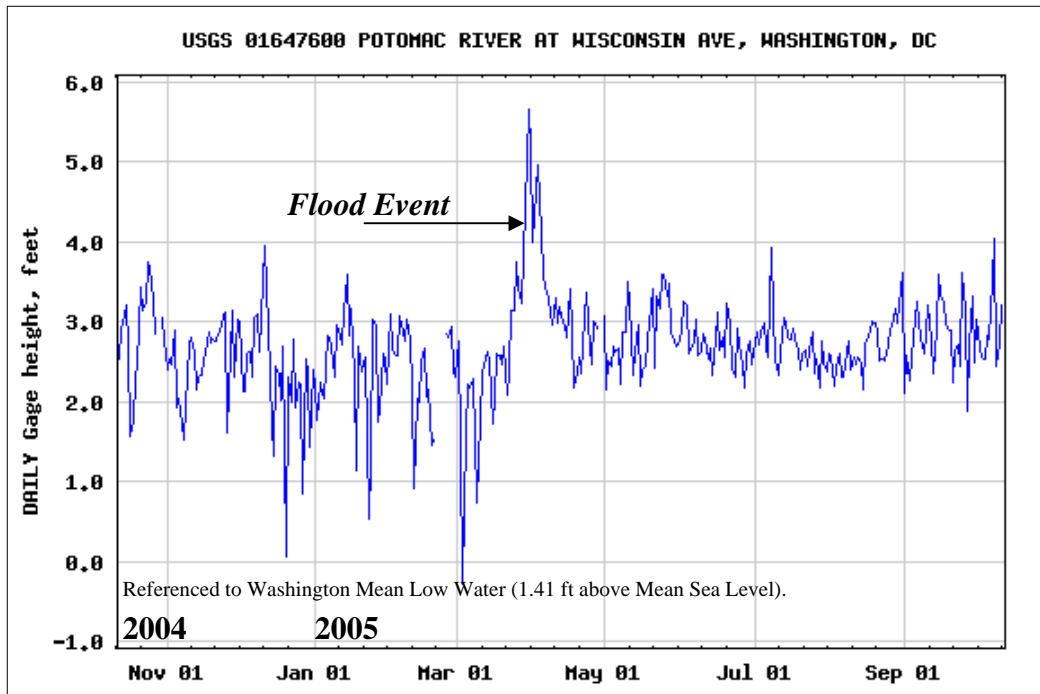
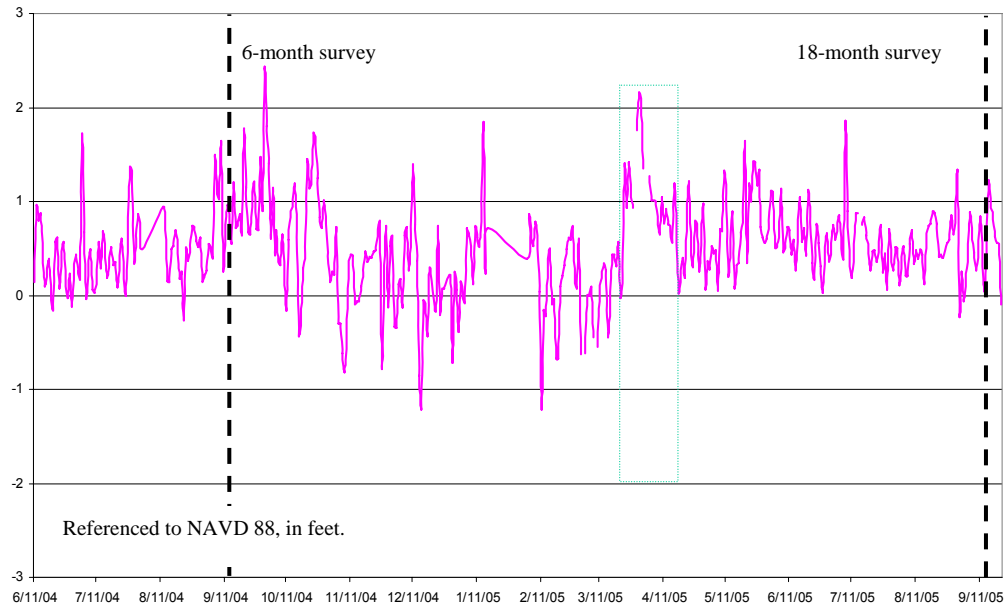
Figure 3-21. Potomac River (top) and Anacostia River (bottom) River Flows During Demonstration (flood event in top panel is highlighted in green in lower panel; from United States Geologic Survey [USGS], 2006)

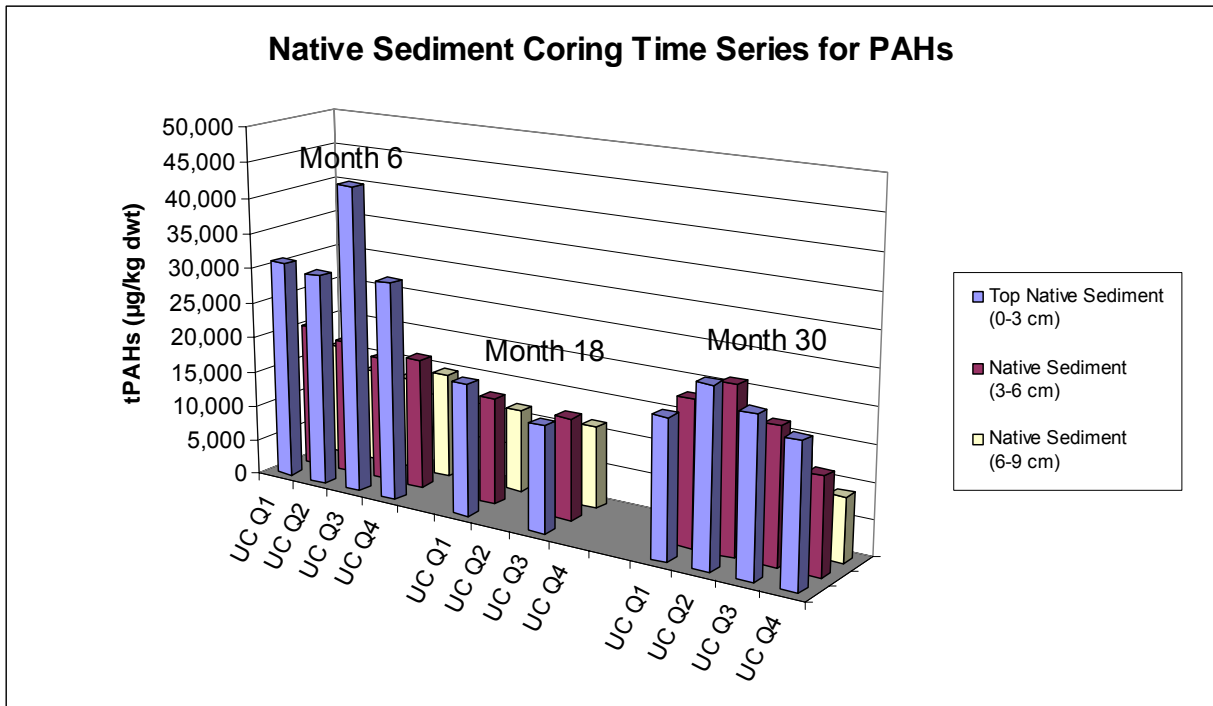
As demonstrated on Figure 3-23, total PAH concentrations in the surficial native sediments in the control cell during the six-month and 30-month post-capping coring events were generally between 20,000 and 40,000 µg/kg and declined to some extent with depth. Total surficial PAH concentrations during the 18-month post-capping coring effort were comparatively lower, which may have been an artifact of increased deposition of relatively disproportionately inorganic new sediment during this timeframe (see Sections 3.3.1.1.3 and 3.3.1.2.3). Alternatively, the variability in surficial total PAH concentrations could be related to simple laboratory analytical variability and/or the varying

Figure 3-23. Total PAHs in Control Cell Cores

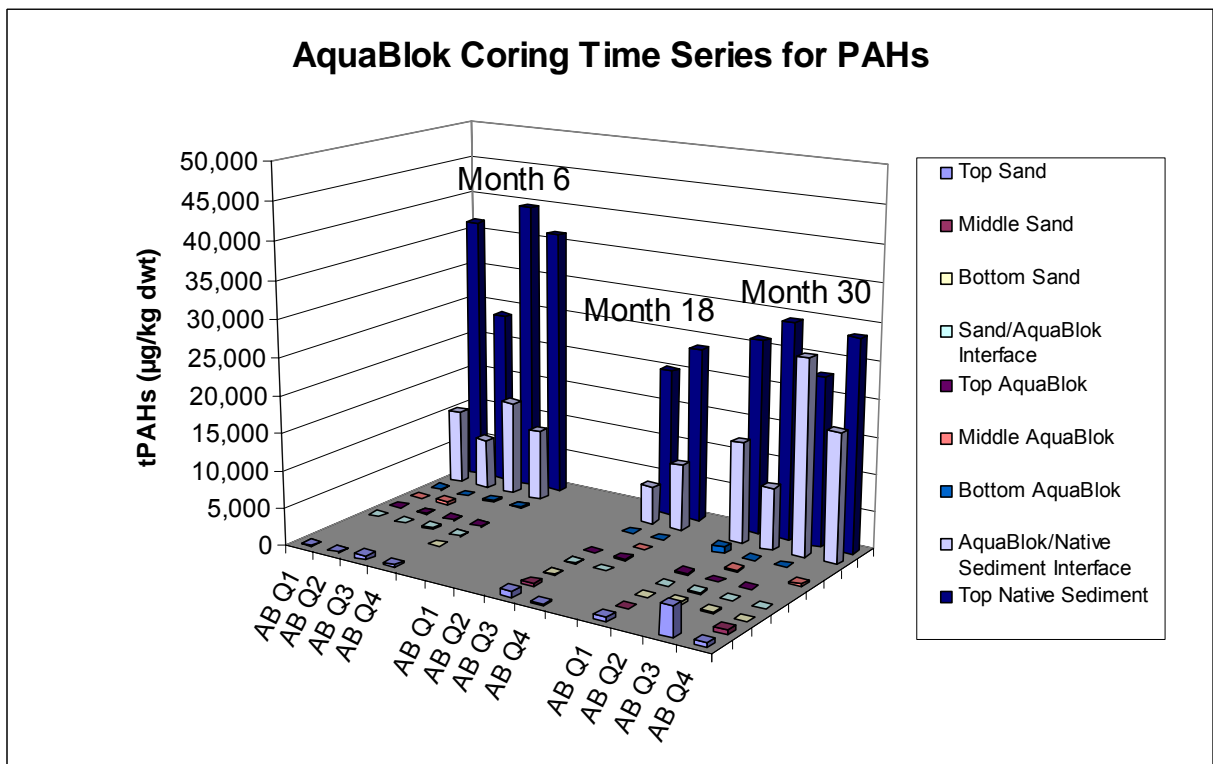
Figure 3-24. Total PAHs in AquaBlok® Cell Cores

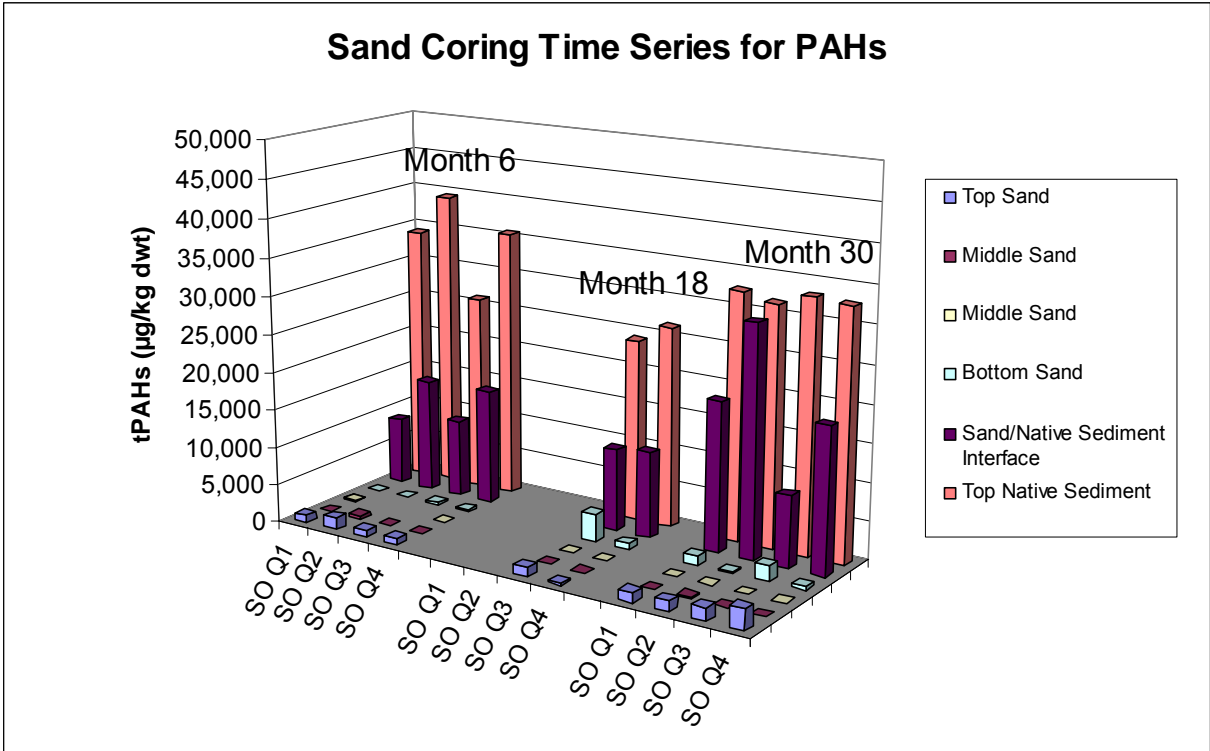
Figure 3-25. Total PAHs in Sand Cell Cores

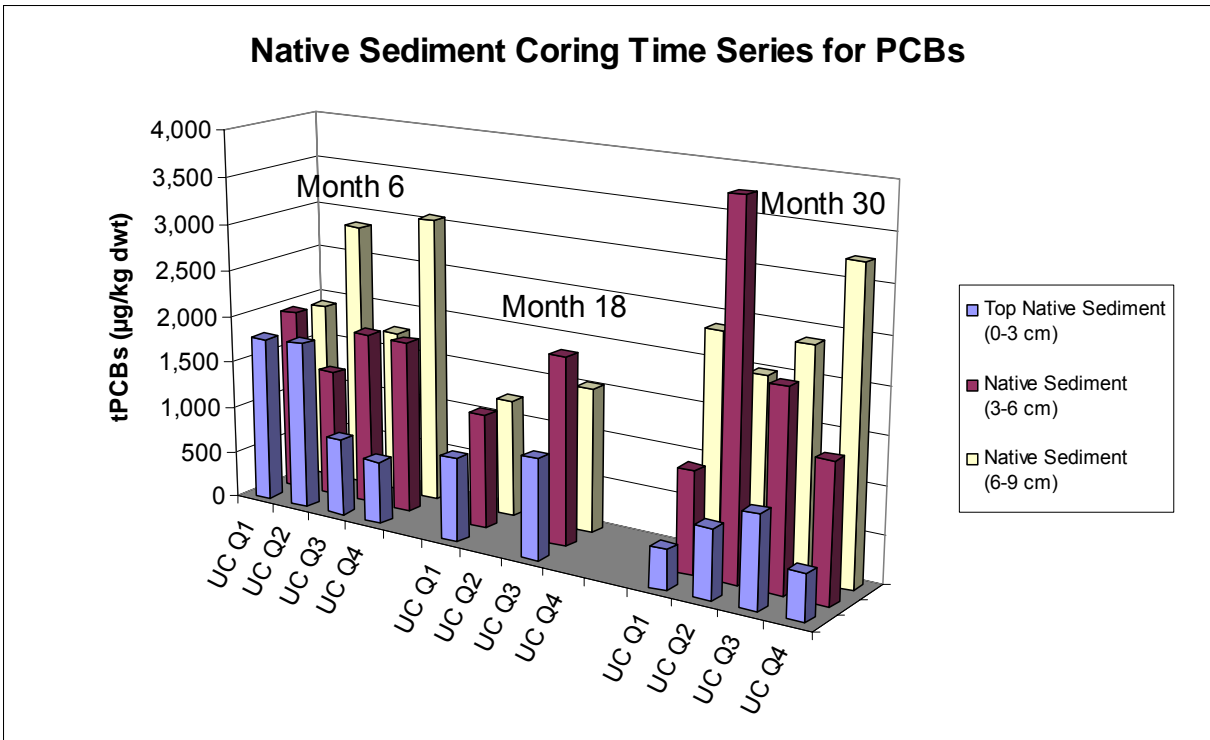
Figure 3-26. Total PCBs in Control Cell Cores
