Electrical Survey - South Side

Task	Survey South Side Electrical Room
-------------	-----------------------------------

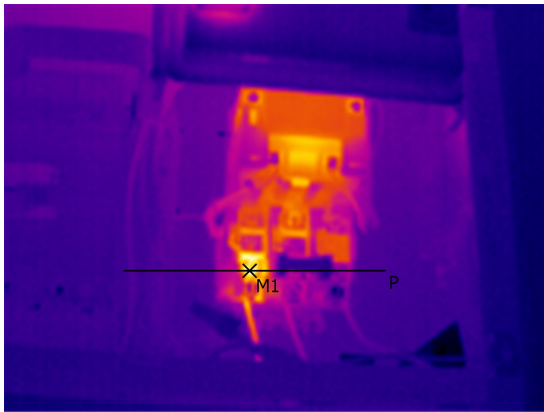
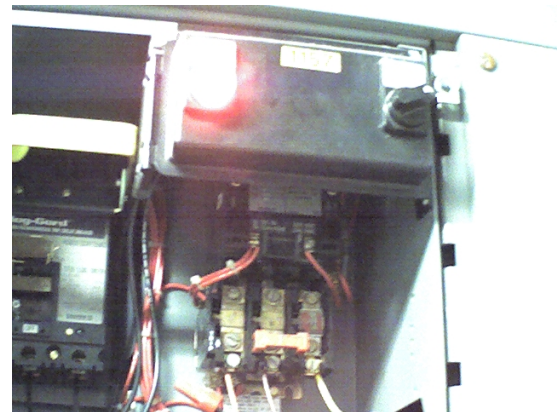
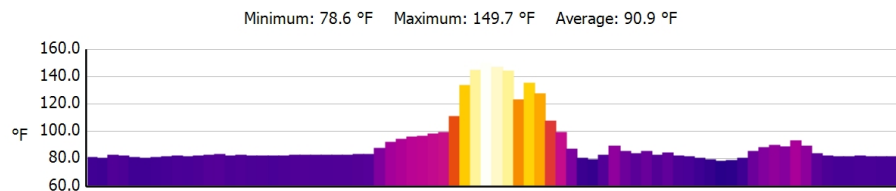
File:
Breaker #35.bmt

Measurement Objects	Temp. [°F]	Emiss.	Refl. temp. [°F]	Remarks
Measure point 1	149.7	0.95	64.9	Hot phase connection - Loose?

Highlighted problem areas need to be checked at next maintenance turnaround

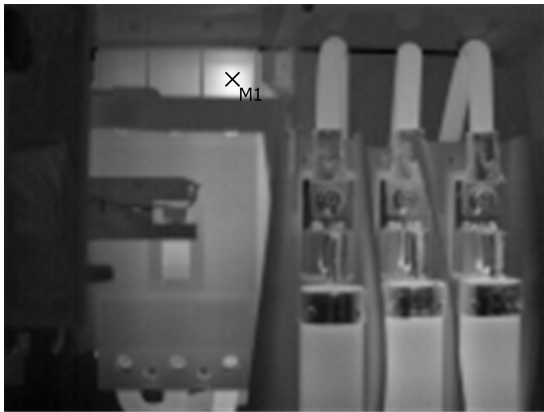
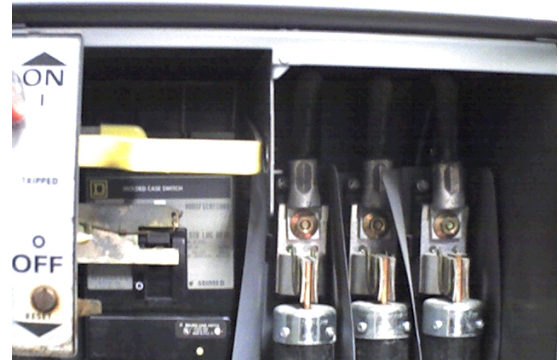
File:
Hot Connection.bmt

Measurement Objects	Temp. [°F]	Emiss.	Refl. temp. [°F]	Remarks
Measure point 1	134.1	0.95	64.9	Single phase hot -Fuse Box #38
