Nano-Technology

Reconditioning and durable wear protection for metal surfaces in tribologic systems

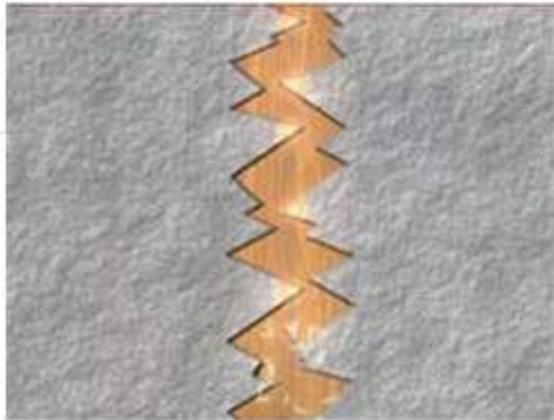
Friction and pressure in engines and gearboxes generates high temperatures on metal surfaces that trigger the chemical bonding process

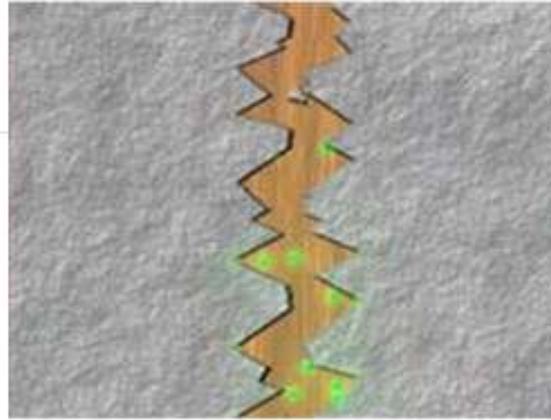
The soft Nanoparticles remove dirt from the rubbing metal surfaces and react with the metal atoms to form a smooth and protective layer on the surface.

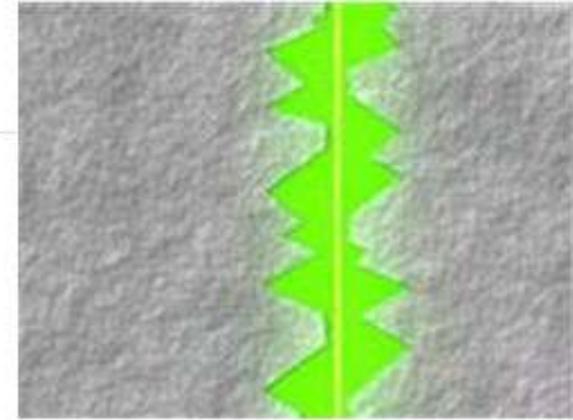
The final result is a new and very smooth metal surface structure. These properties, in turn, give the machine more power, higher efficiency and longer life.

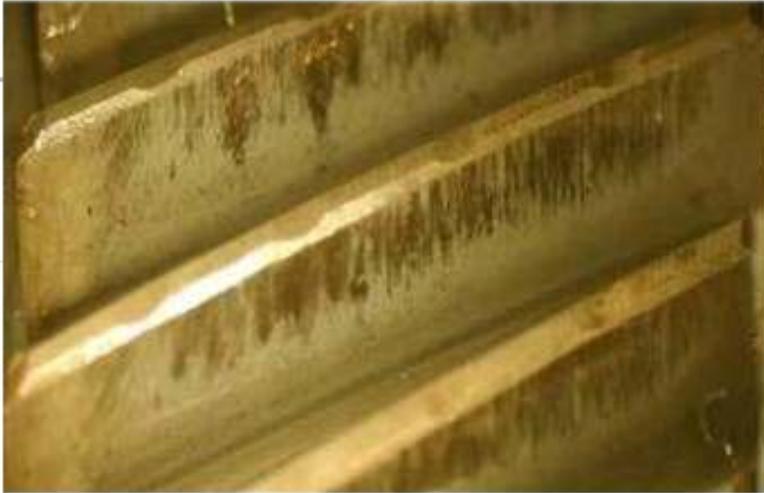
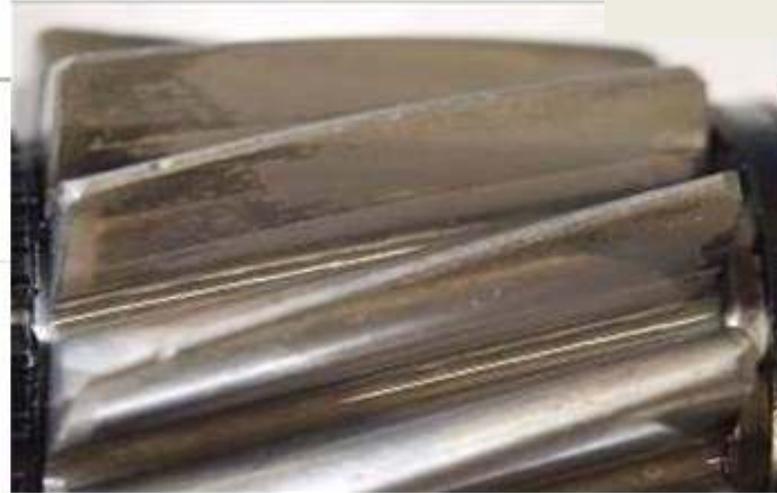
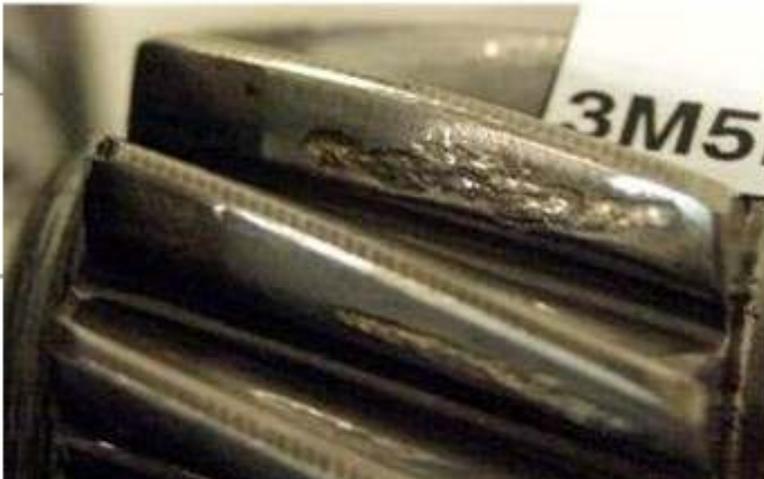
Damages at gears

Gear before and after Treatment

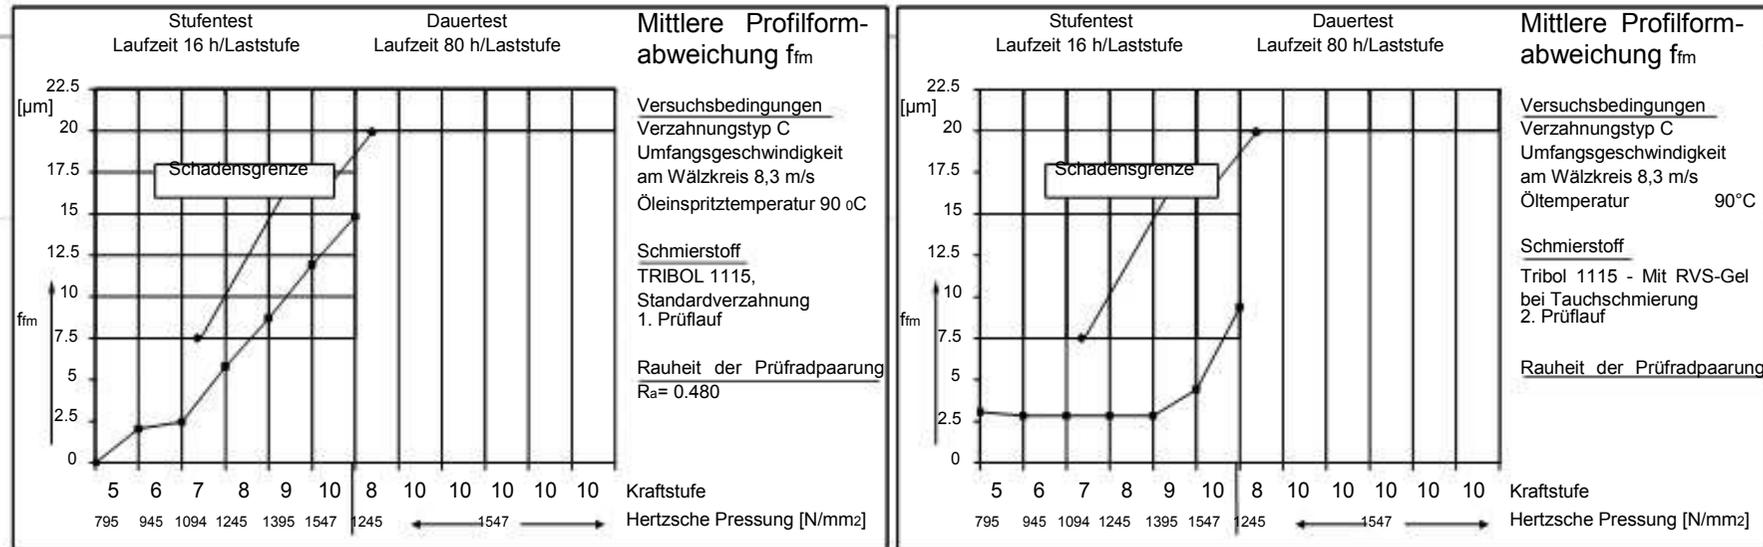
FVA Micropitting Test

Results: Increase of 2 load steps, reduction of roughness by 17%, reduction of changing profile by 37%, reduction of pitting area by 8% and reduction of weight loss by 30%!

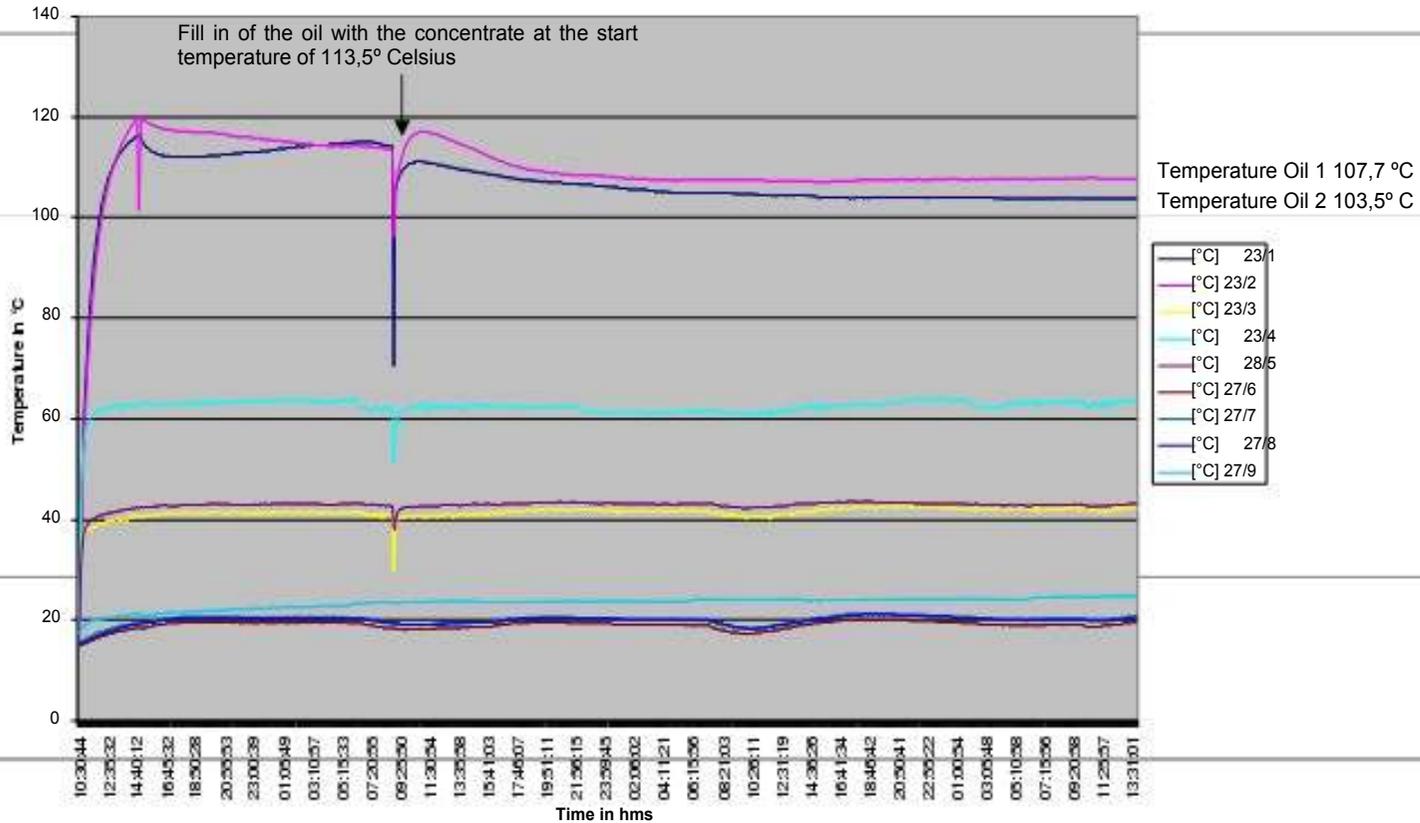
Temperature trend of the 2 Tandler gears with 2 different oils with and without NLG Coating
- Temperature reduction of 6 - 10 °Celsius

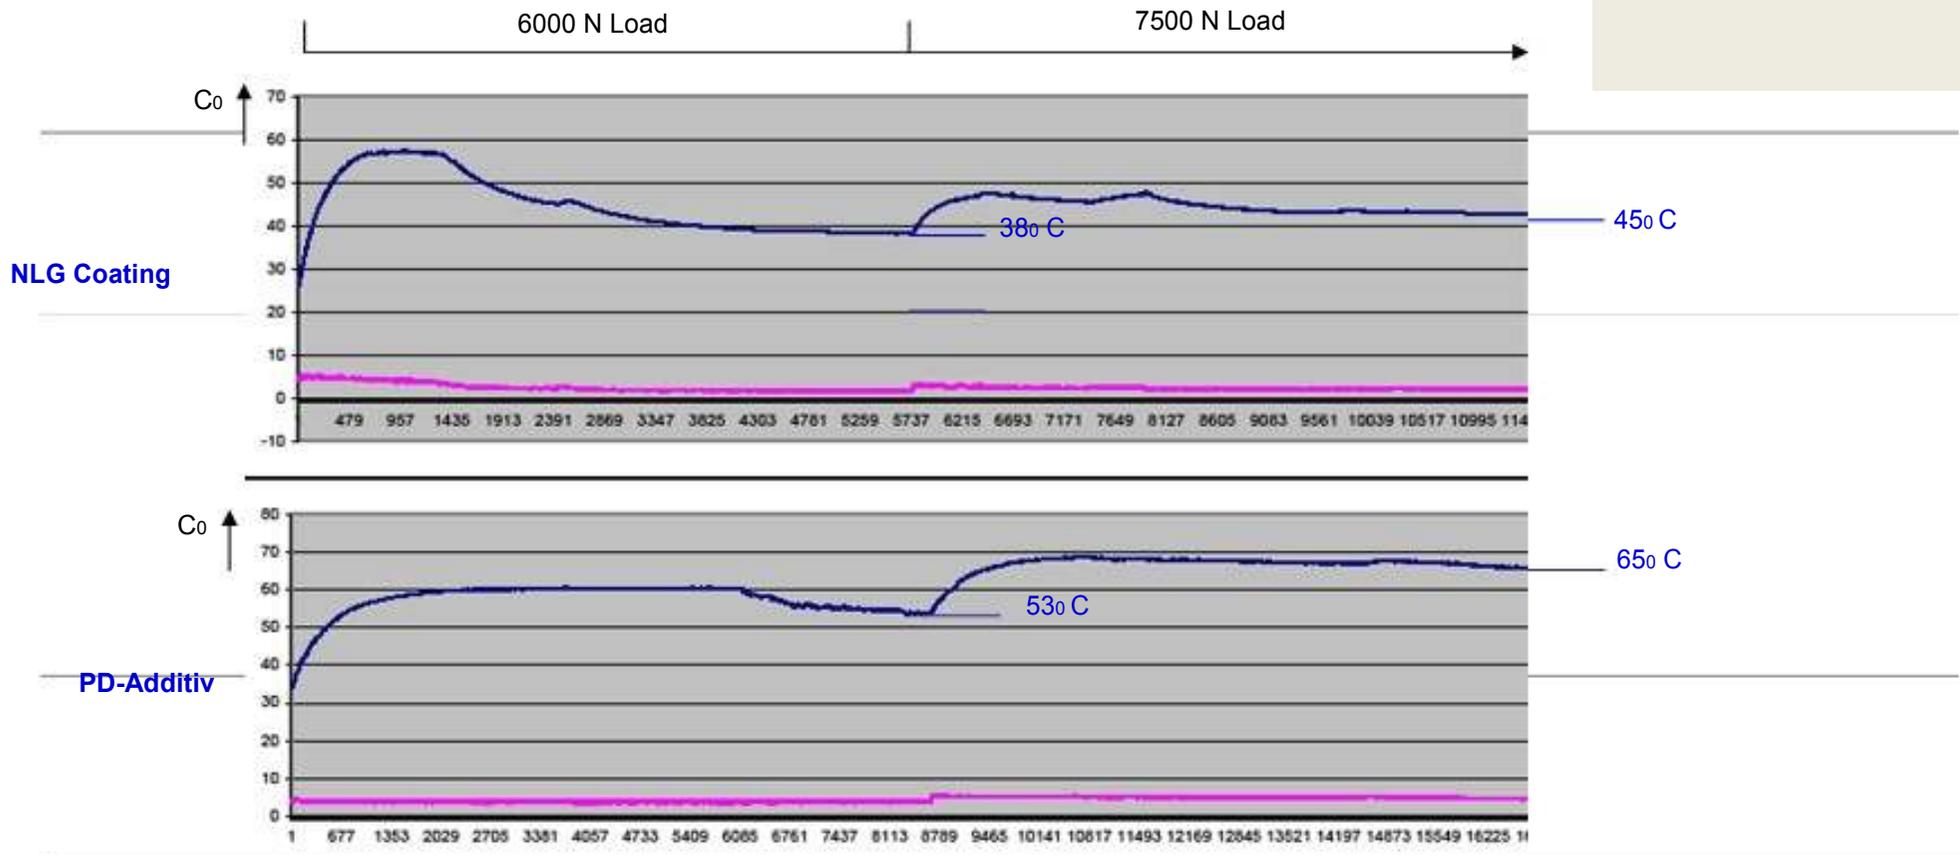
Temperature regime at 2 roller bearings 3205: NLG Nano-coating versus PD-Additiv with different load
Result: Temperature reduction of 15 -20° Celsius, due to less friction in the bearing!

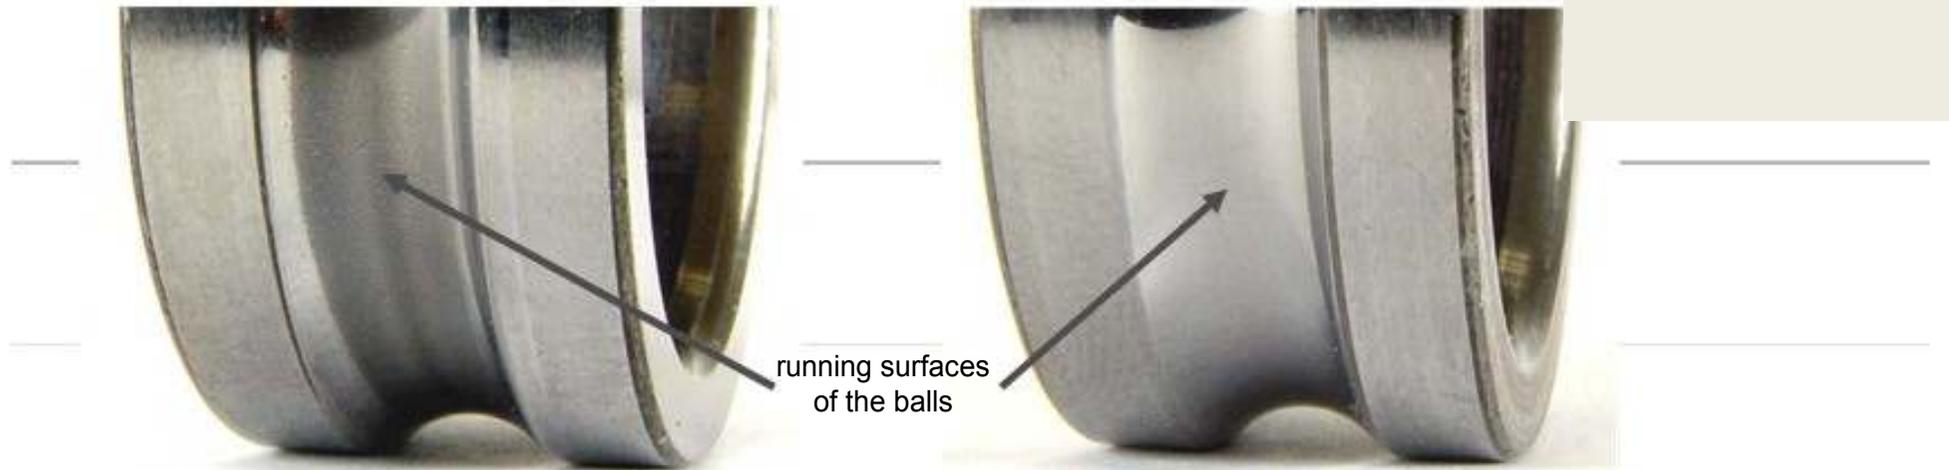
Photos of the inner races of two ball bearings after 50 hours of operation in a range of fatigue

This ball bearing shows damage due to wear and tear. The running surface of the balls clearly shows pitting

This ball bearing does not show any wear. The running surface of the balls clearly shows a wear resistant coating.

Bearing type: No. 6205 (d=25mm D=52mm)
Lubricant: Special bearing grease
Operating time: 50 hours
Rotational speed: 500 min⁻¹
Nominal load: 5000 N radial (range of fatigue)

Bearing type: No. 6205 (d=25mm D=52mm)
Lubricant: Special bearing grease **treated with NLG Coating**
Operating time: 50 hours
Rotational speed: 500 min⁻¹
Nominal load: 5000 N radial (range of fatigue)

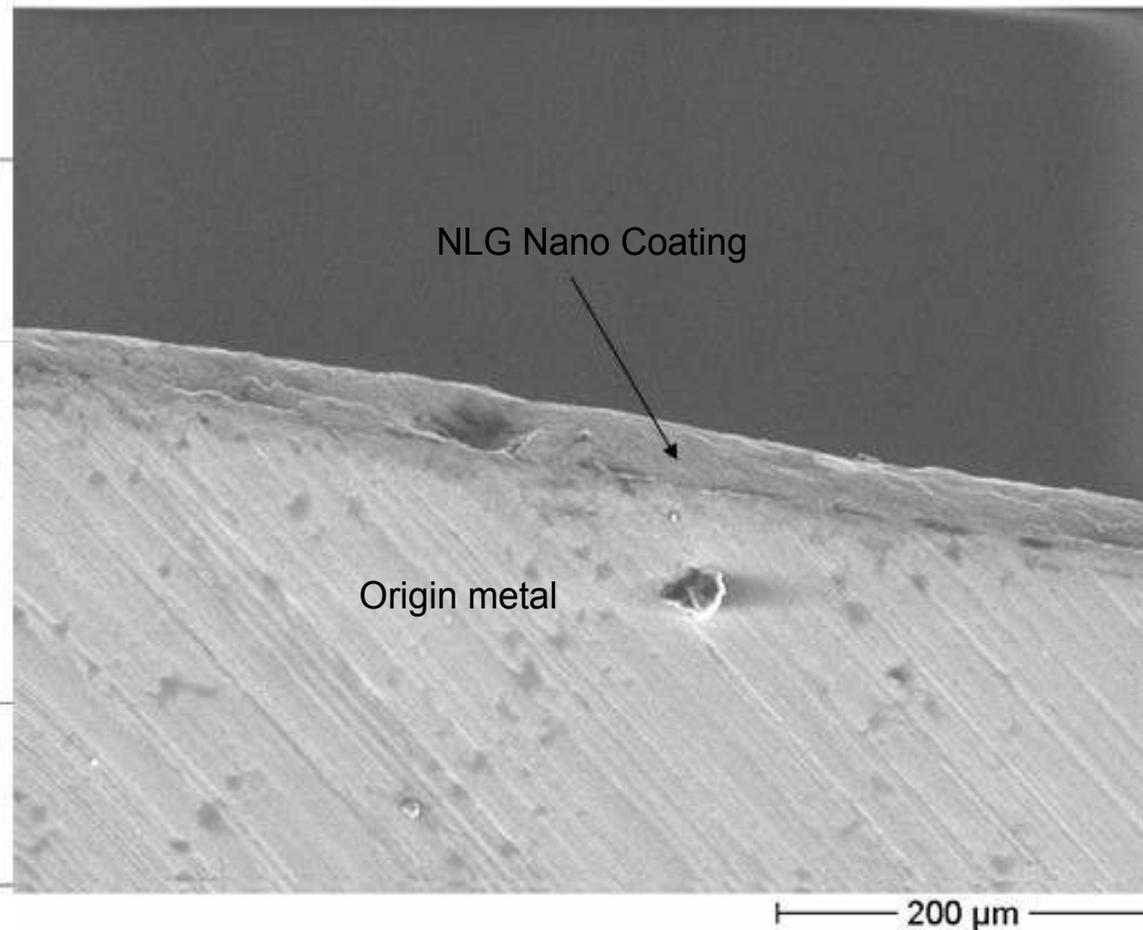
Microsection of a ball bearing surface

The microsection shows the running surface of a ball bearing of a planet gear box after 250 hours of operation in an area of fatigue. The NLG Nano Coating up to 30μm could be obviously recognized.

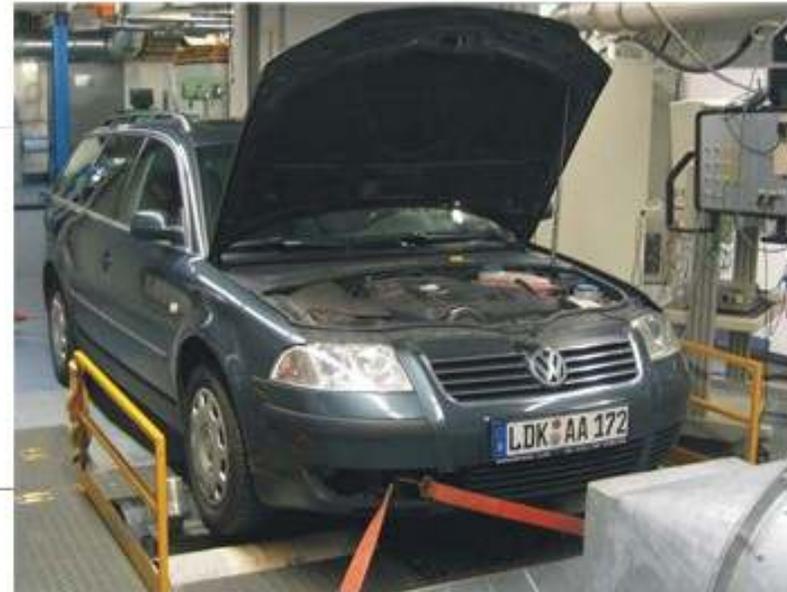
VW Passat 1,9 TDI:

Die University of Applied Science in Frankfurt examined on a VW Passat 1,9 TDI the effects of a engine treatment M2 and a gear treatment G5 in relation to fuel consumption and emissions.

Hersteller	Volkswagen	Typ	Passat TDI
Km-Stand	147.700 (19.12.2006)	Hubraum	1900 ccm
Leistung	96 kW / 4000 Umin ⁻¹	Erstzulassung	25.07.2002
Motor	Diesel – Euro 3

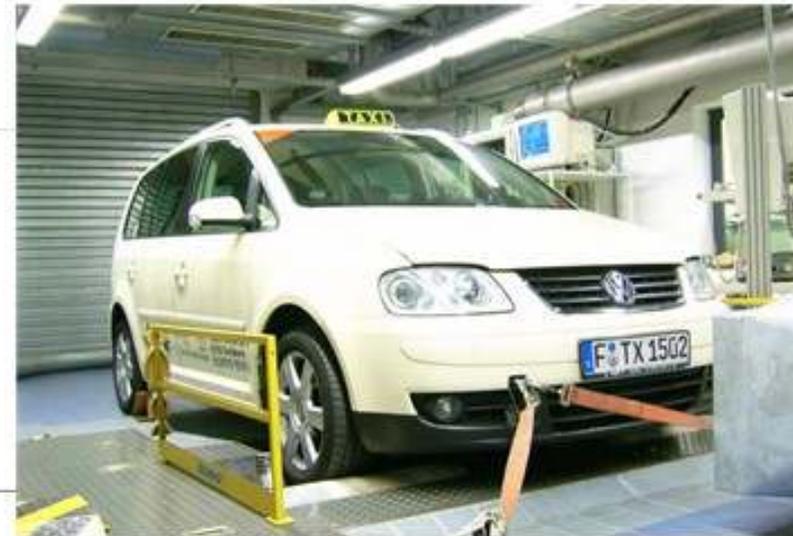
VW Touran:

Together with a taxi company in Frankfurt/ Germany the University of Applied Science investigated the influence of M2 to the fuel consumption and emissions on a VW Touran.

Hersteller	Volkswagen	Typ	Touran
Km-Stand	160.218 (30.05.2007)	Amtl. Kennz.	F – TX 1502
Hubraum	1968 ccm	Getriebe	Automatik, 6 Stufen
Leistung	103 kW / 4000 Umin ⁻¹	Erstzulassung	21.02.2005
Motor	Diesel – Euro 4

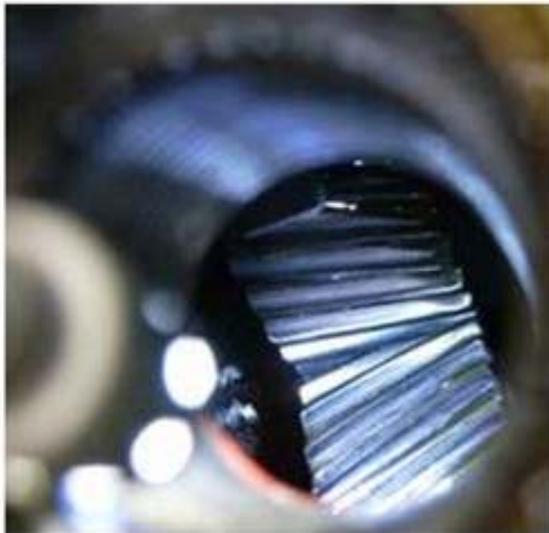
Treatment of 2 drill head gears at Volkswagen engines production line in Salzgitter

Short lifetime, extreme high costs in case of idleness and breakdown (>25.000,-€), higher oil temperature (51°C). Emergency run problems due to oil leakage.

Oil and oil filter are clean with nearly no metal particles. After NLG Nano-coating oil temperature was reduced by about 6°C to max. 45°C. Due to a system leakage drilling emulsion went into the gearbox. The NLG Nanocoating prevented the system against damages.

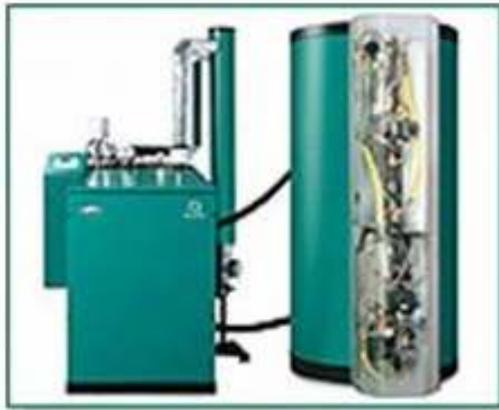
Treatment of a thermal power station from Sachs

Extreme high oil consumption, loud noise and high costs of repair

Decrease of oil consumption during 2.700 rhs from 7 litres to 1 litre. Obvious reduction of noise. Cost savings due to the NLG Coating treatment of about 1.600,00 €!

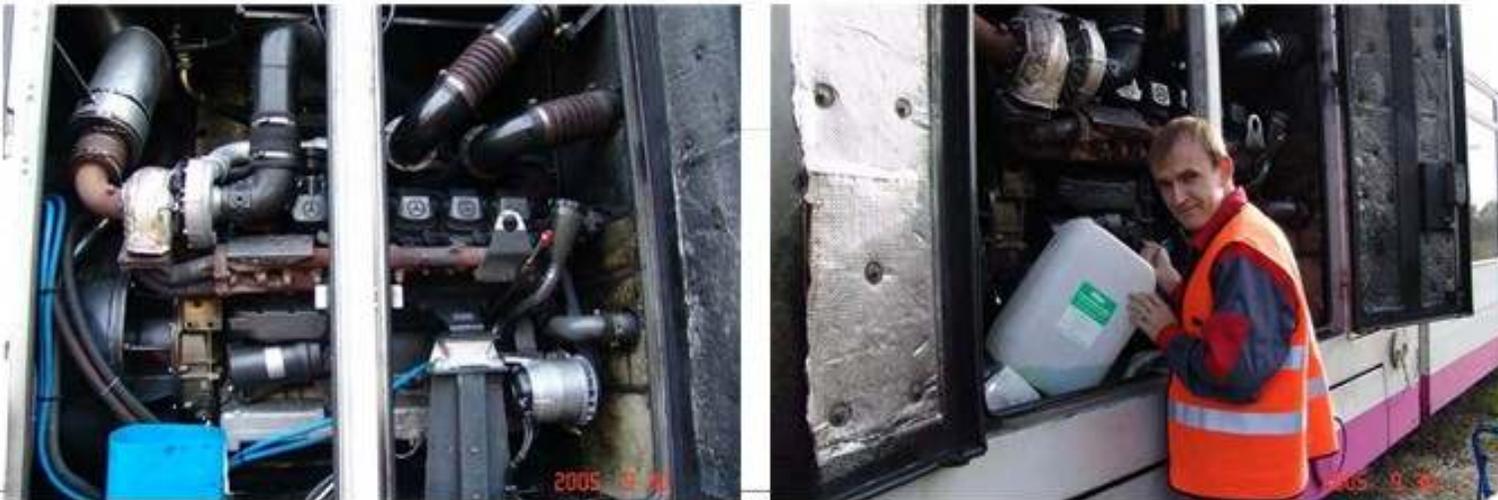
Treatment of a diesel locomotive of SBB

NLG Nano-coating treatment of diesel engine (1.320,- EUR) in competition and relation to a normal revision W6 according to MTU/Mercedes specifications (30.000,- EUR).

Better engine power and reduced noise with NLG Nano-coating treatment. Full availability and a lot of cost saving.

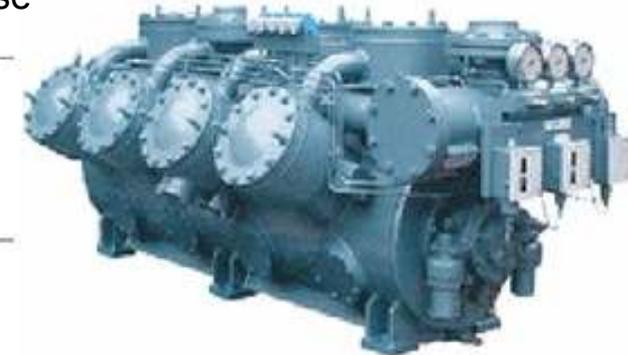
Treatment of a cooling compressor

- Compressor was running with high wear noise on the valve plates
- No spare parts available, machine ought to be scrapped
- Investion of 300.000,- EUR was necessary!

After the first NLG Nano-coating treatment and 20 minutes running time the compressors noise was obvious reduced. After the second treatment and about 10 running hours the wear noise disappeared completely!

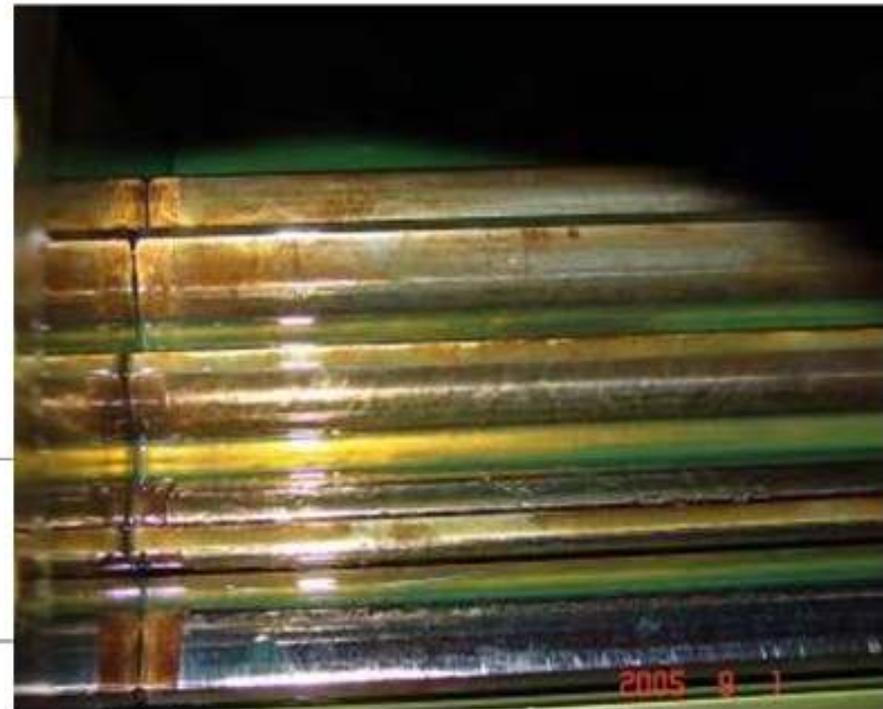
before treatment:

Worn out and corroded gear teeth,
cracked and welded bearings

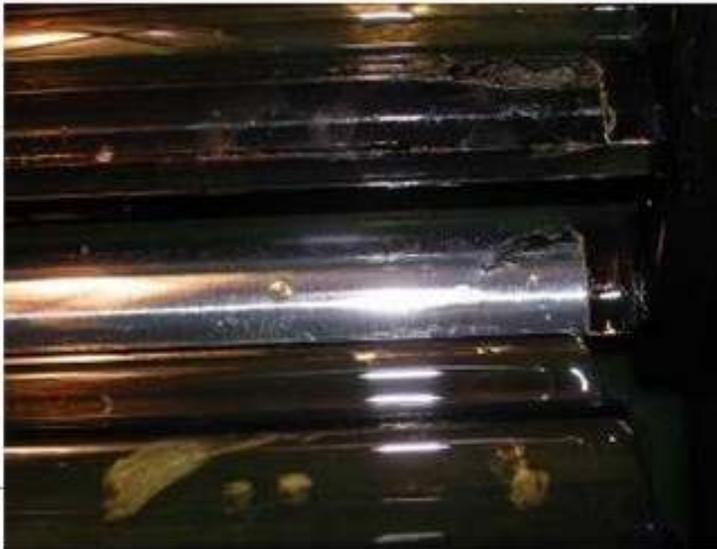
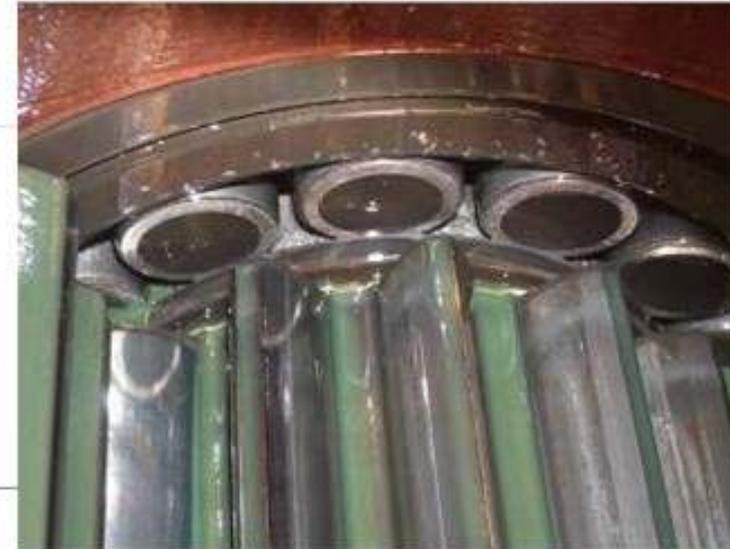
After treatment:

Shiny and coated teeth surfaces. The cracked and welded roller bearing was running for 1 year as a slide bearing. The exchange gearbox was standing beside during this time for emergency cases.

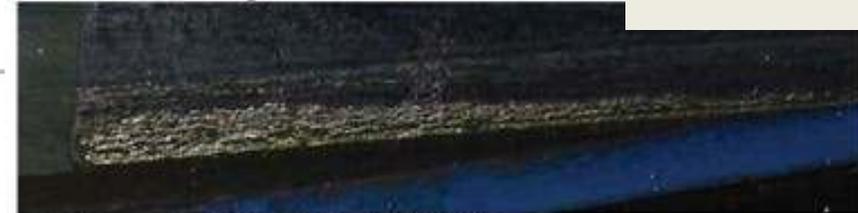
vor der Behandlung 29.06.2005

Gear wheels were exchanged every 7
-9 months for 70.000,- EUR.

After the single treatments we recognized
the closing of the surface pittings and the
enlargement of the load carrying area. The
gearbox is still in use.

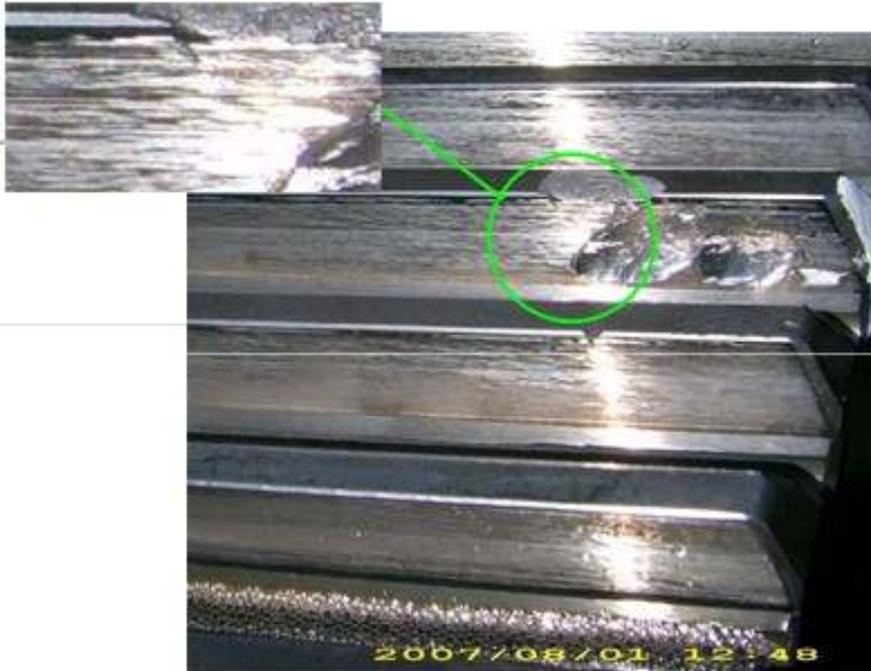
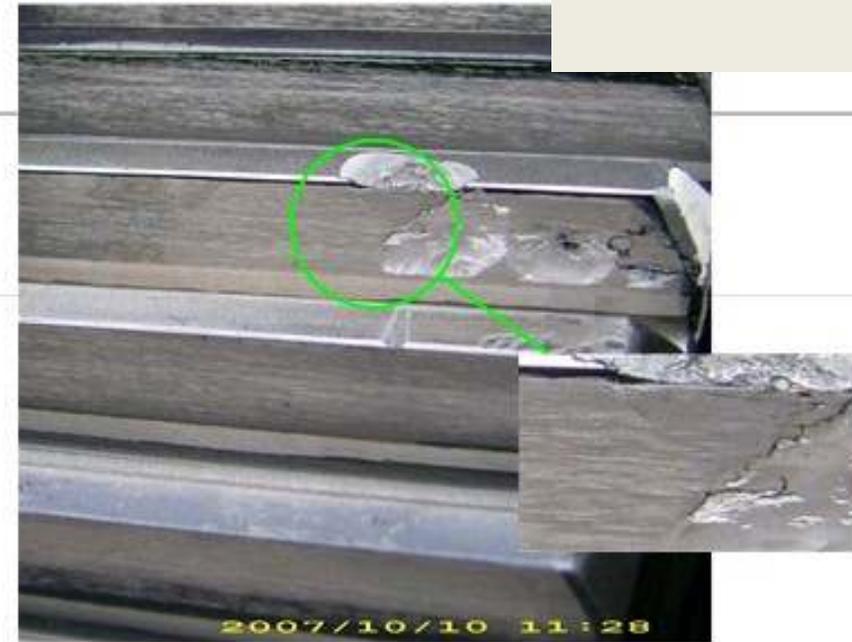
Coating of a wind power station gearbox TW250

- The teeth surfaces are much smoother and more shiny (replicas before and after)
- The damages are without sharp edges
- The coated teeth surfaces had a higher electrical resistance of about 50 Ω

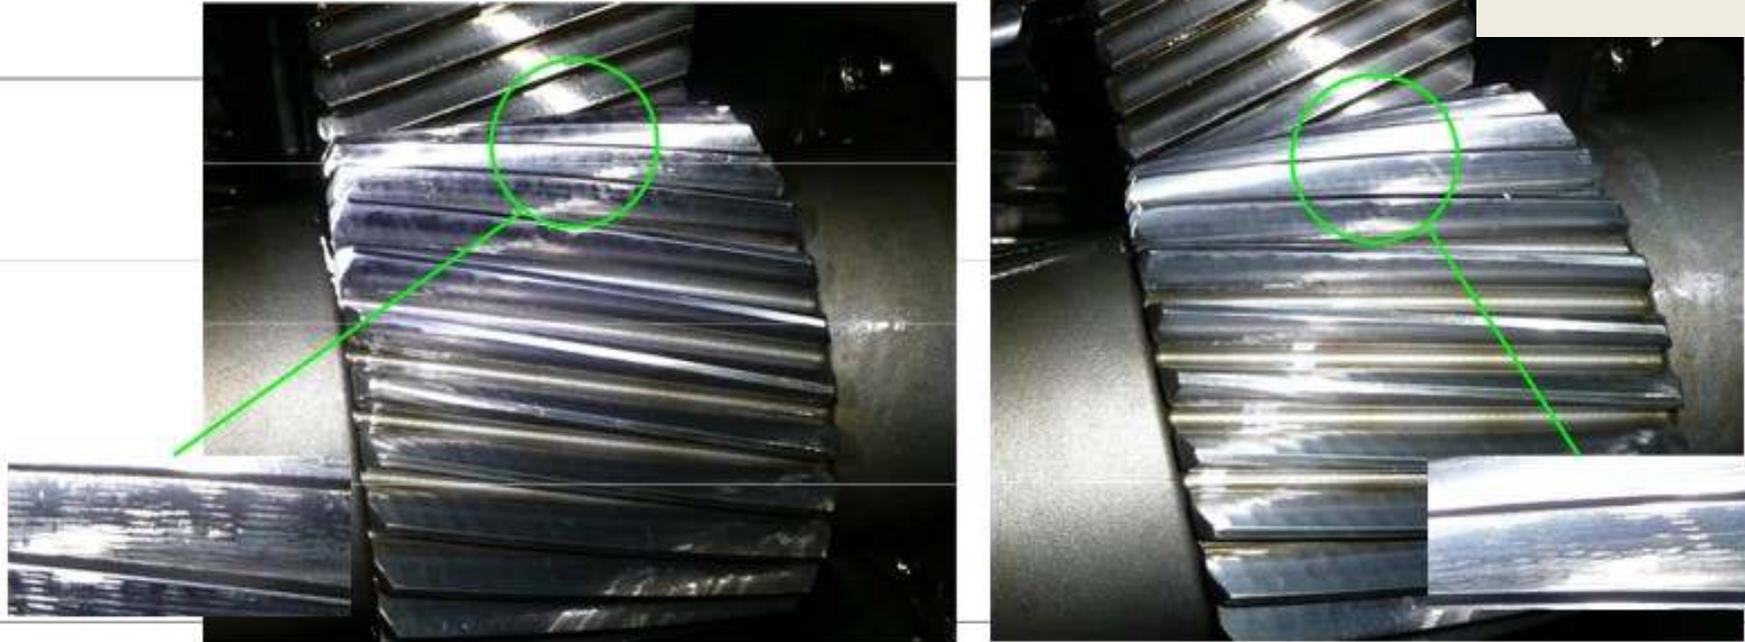
Coating of a wind power station gearbox TW600

- The teeth surfaces are much smoother and more shiny (replicas before and after)
- The damages are without sharp edges
- The coated teeth surfaces had a higher electrical resistance of about 100 Ω

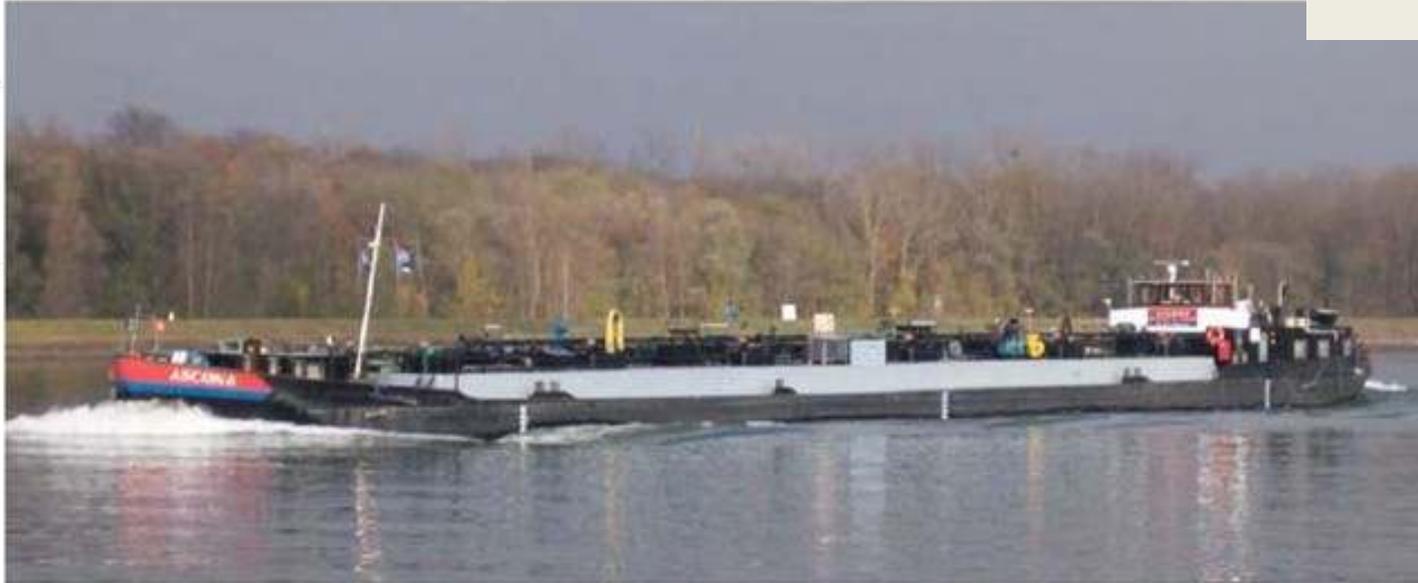
Treatment of a inland going vessel

High oil consumption, engine and gearbox in bad condition

NLG Nano-coating Treatment of engine, power supply and gearbox. ZF reverse gear unit was running more silent and soft. Oil consumption of the engine was reduced from 4,0 litre to 2,5 litre during 24 hours (90 % load). Oil consumption of the power supply was reduced from 0,6 litre to 0,3 litre during 24 hours.

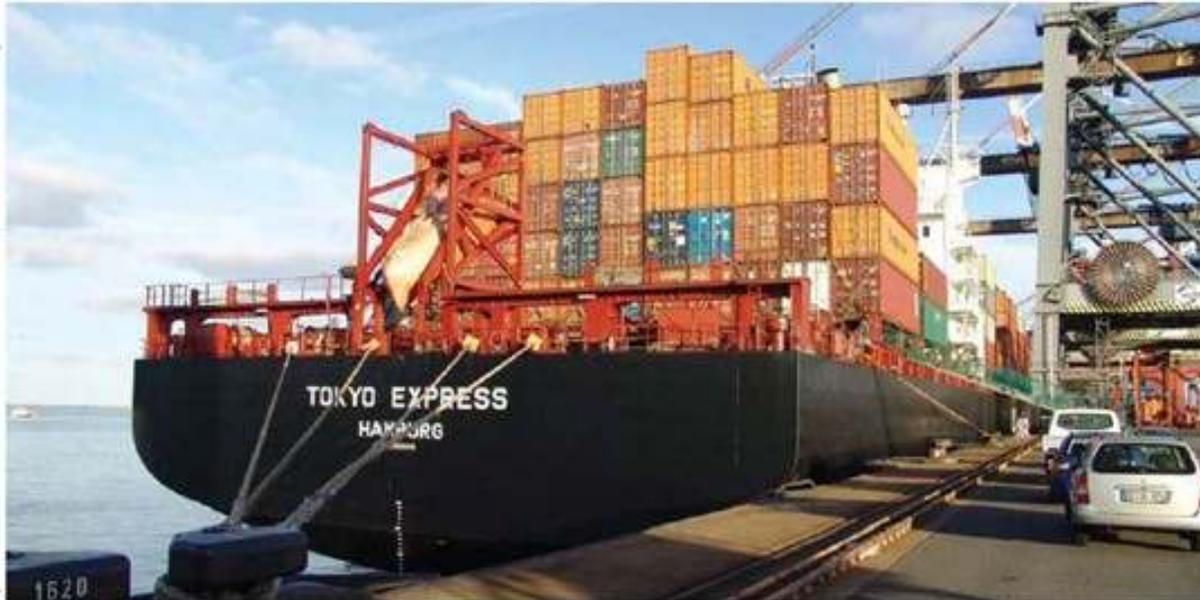
Treatment of compressors and separators of Hapag Lloyds „Tokyo Express“

Carbonization of the valves due to water in the oil caused by different air humidity. High oil temperatures, damages of valves, piston and rings.

NLG -Nanocoating reduced the internal friction and oil temperature. Carbonization and wear was reduced. Lifetime of valves, piston and rings were doubled.

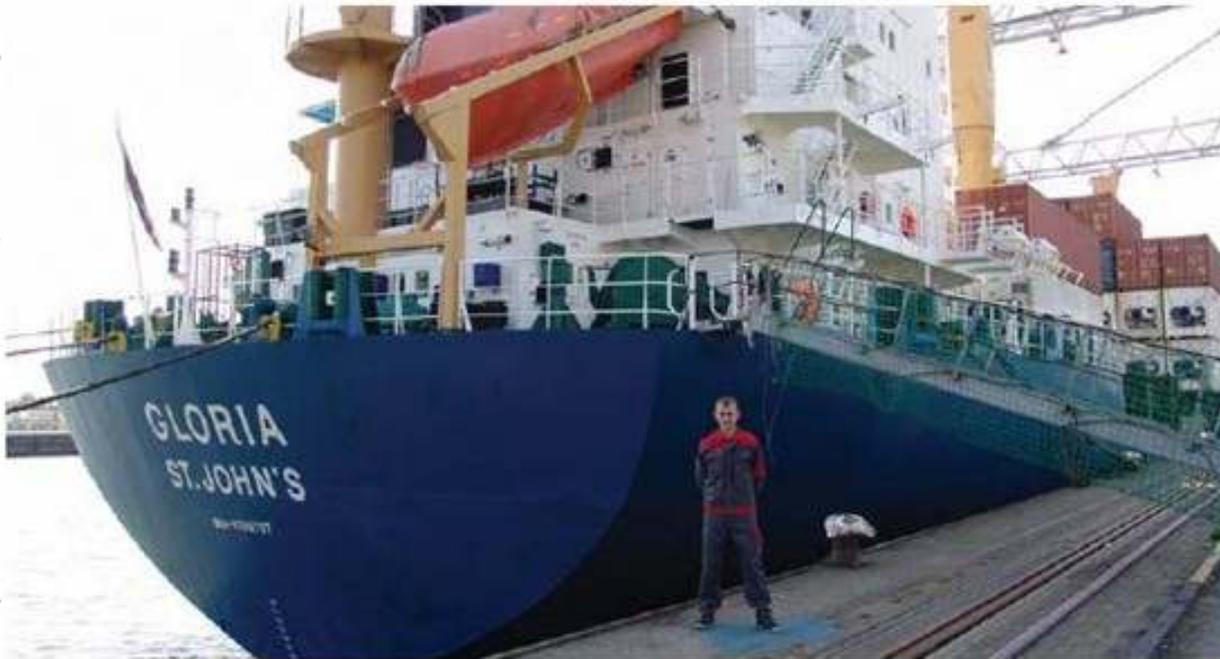
Treatment of Sulzer 2-stroke engine 6 RTA 62U of “MV Gloria”

Problem: Strong cylinder liner and piston ring wear after 18.000rhs, due to bad fuel and material problems. Piston ring wear was recorded via a monitoring system.

Solution: Cylinder liner and piston ring life time was extremely improved to >30.000rhs. The monitoring system recorded a coating on liner and rings.

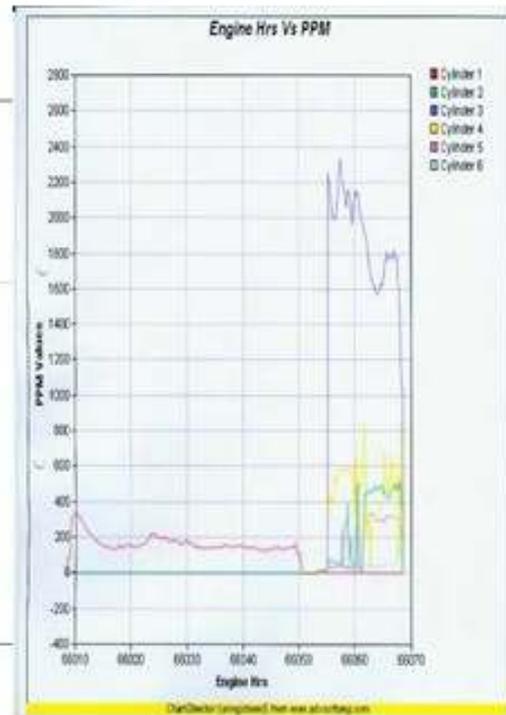
Treatment of one cylinder of a Sulzer 2-stroke engine 6 RTA 62U

Problem: Strong cylinder liner and piston ring wear after 18.000rhs, due to bad fuel and material problems. Liner wear was recorded via a condition monitoring system.

Solution: Cylinder liner wear and piston ring life time was extremely improved. After 2.5 years CMS detects nearly no wear in the scrape down oil in cylinder 6.

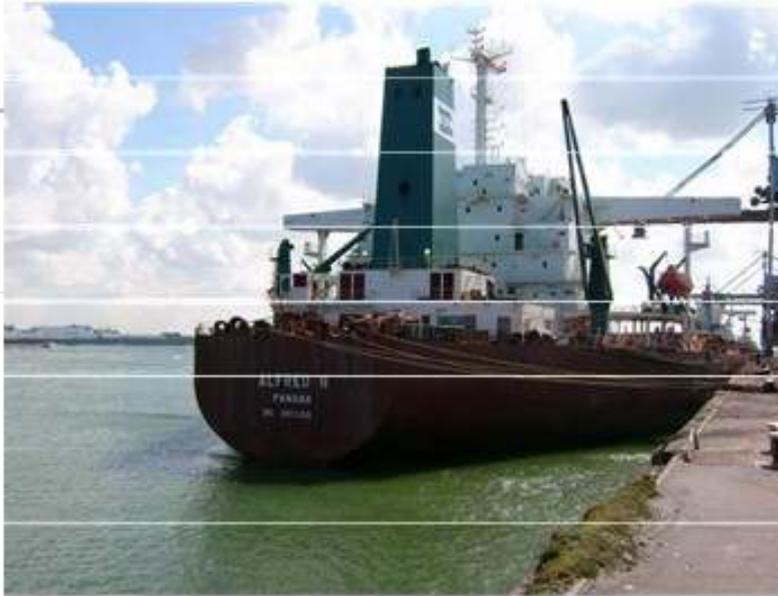
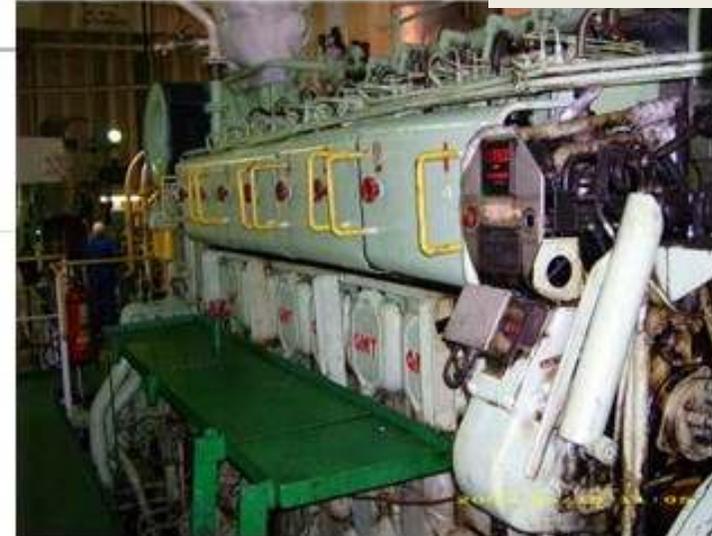
Treatment of 2 GMT auxiliary engines of the “Alfred N”

Extreme high lube oil consumption of the 2 auxiliary engines GMT 230.P8BL, 99,7 ltr. cylinder capacity
