Pediatric Case Study  
June 19, 2014

## **StethGuard™ Barrier Technology Prevents Transference of Potentially Harmful Microorganisms During A Routine Examination with a Stethoscope in a Pediatric Office**

Julio C. Guerra, MD, FAAP  
Kimberley A. Davies, Ph.D.

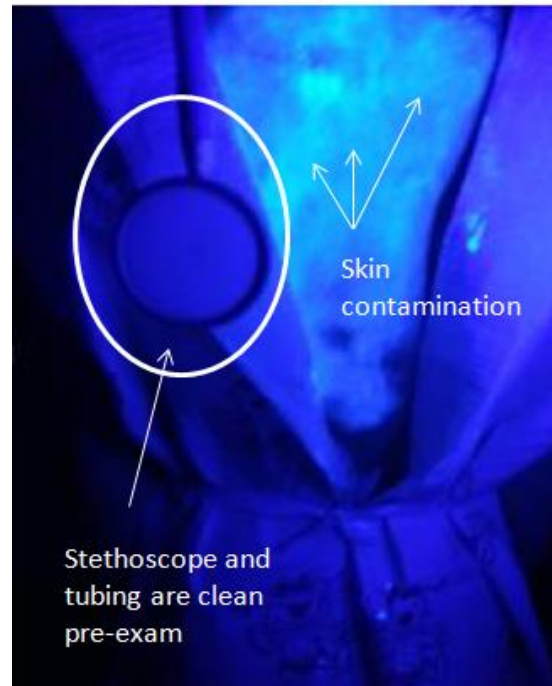
### 1. Contaminated Patient's Back with Adjacent Clean Stethoscope

A light brush of *Glo-Germ Powder™* was placed on the patient's back to simulate contamination with bacteria.

When examined under a "Woods Lamp", the fluoresced area simulates an area of contamination with pathogenic microbes.

A clean stethoscope was placed next to the patient to demonstrate that there is no "glow" or contamination noted on the diaphragm or distal tube of the stethoscope.

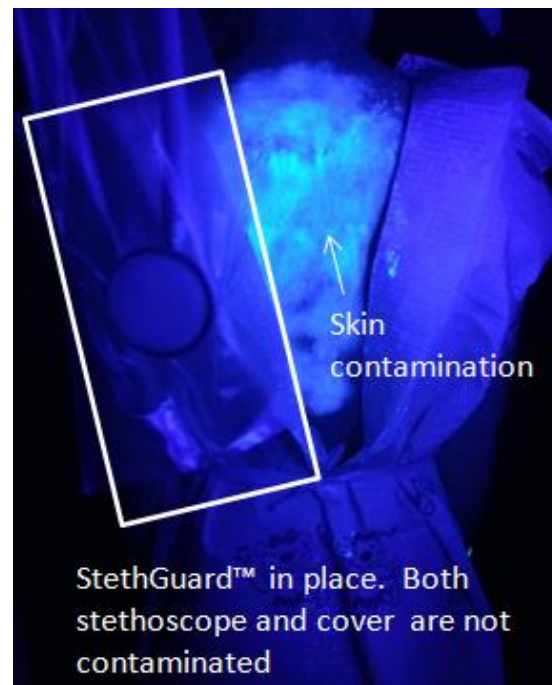
### 2. Clean Stethoscope with StethGuard™ Cover in Place Prior to Patient Exam

An "easy to use" and "disposable" StethGuard™ cover was placed over a clean stethoscope.

Note that there is no contamination observed on either the stethoscope diaphragm and distal tubing nor the StethGuard™ cover prior to examining the patient as compared to the patient's contaminated back.

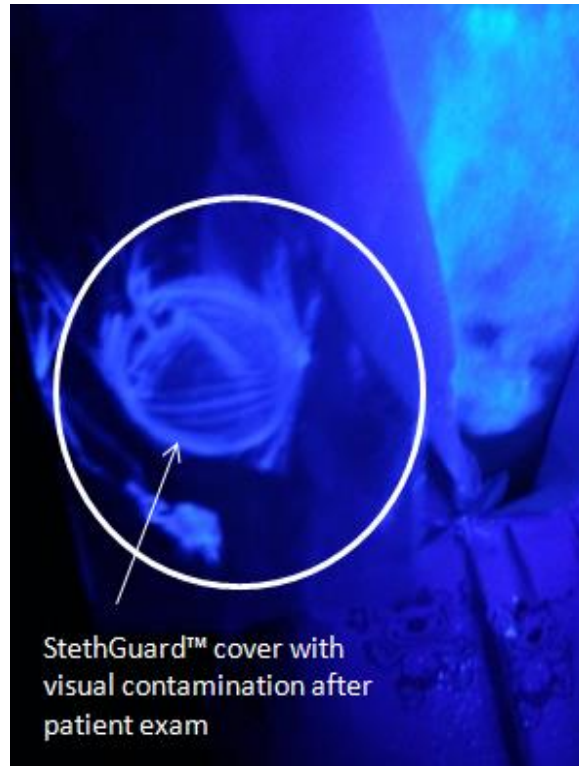
### 3. Post Patient Lung Exam - The StethGuard™ Cover is Pulled Off the Stethoscope.

After a routine lung exam with the clean StethGuard™ covered stethoscope, the StethGuard™ cover was pulled off the stethoscope and was examined under a Woods Lamp.

A positive transference of the Glo-Germ™ powder from the contaminated patient's back and on to the StethGuard™ cover was noted.

It is clearly visible on the used StethGuard™ cover, the "glowing" outline of stethoscope design that actually came in contact with the contaminated patient.

This fluoresced outline represents potential harmful bacteria that can be transferred to the next patient if proper stethoscope hygiene measures are not implemented.

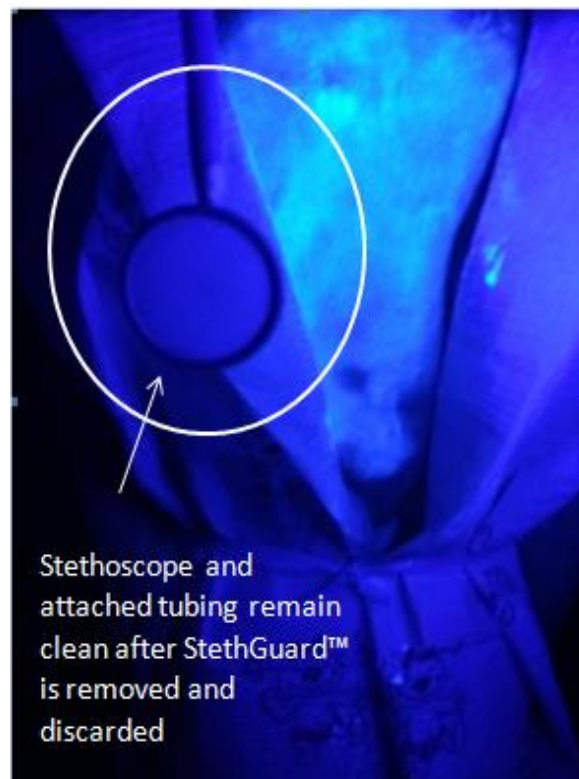
### 4. Discard the StethGuard™ Cover - Stethoscope and Distal Tubing Remains Clean.

After the StethGuard™ cover was properly removed and discarded, the stethoscope was placed under a Wood's Lamp for examination and was noted to be free of any visual signs of contamination.

The StethGuard™ design covers not only the diaphragm and bell of the stethoscope, but also the distal tubing which are the critical areas that are commonly contaminated with harmful bacteria.
