# **Development, Testing, and Data Collection of a Pathway Measurement Tool (PathMeT)**

**July 2014**

**University of Pittsburgh**

**Human Engineering Research Laboratories**

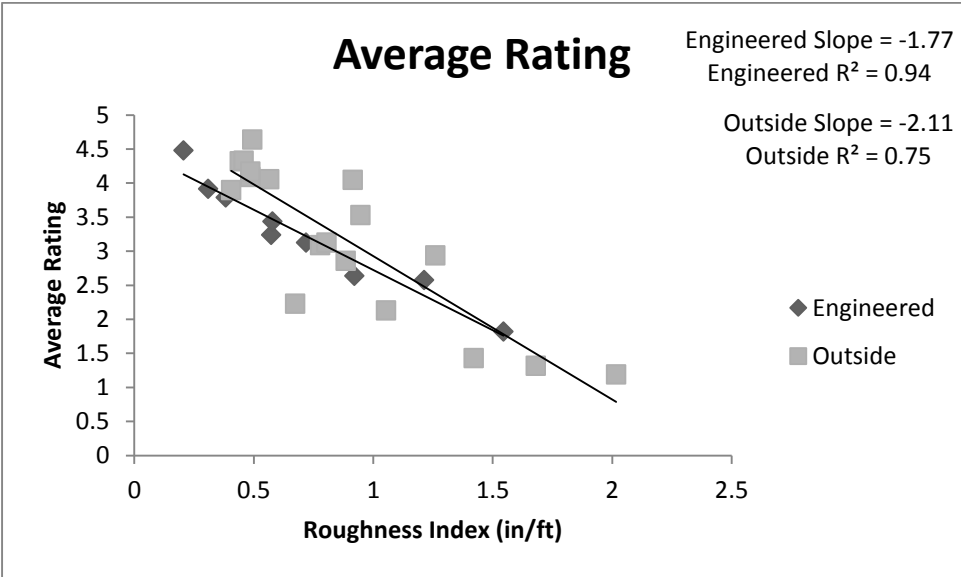
**Figure 2: Indoor-Outdoor Average Rating Versus Roughness**

The results from the study show that wide cracks in surfaces cause wheelchair users to be exposed to dangerous WBVs. In addition, regardless of the level of WBVs, wide cracks can cause discomfort as reported by wheelchair users. **Error! Reference source not found.** shows that as the roughness of surfaces increases, root mean square (RMS) acceleration increases. Figure 2 shows that as surface roughness increases the average rating (which is related to comfort) decreases. [13]

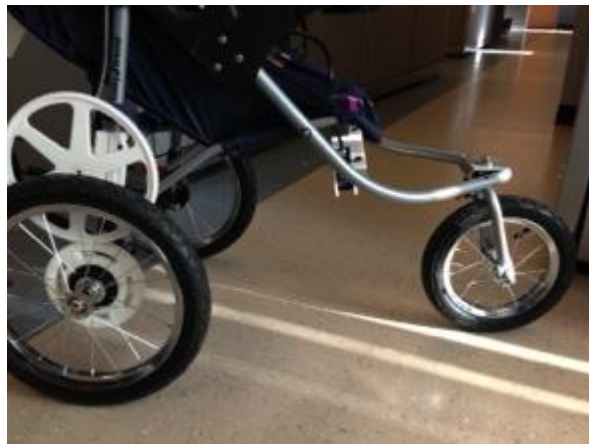
**Figure 5: P2 made from a jogging stroller**

The chassis of P2 (Figure 5), the second prototype, was taken from a jogging baby stroller since jogging strollers are designed to be pushed over sidewalks at a fast pace while eliminating vibrations. The frame was adapted to include enclosures for the laser and encoder. It is a manually propelled device with the wheels inflated to 60 psi in order to reduce the deformation of the tires while travelling over cracks and imperfections. Two different data collection methods were utilized: driving directly over surfaces and driving over plywood tracks, similar to the method for P1. Users refrained from pushing down on the stroller handle to prevent any bias that could occur from the front wheel lifting off the ground.

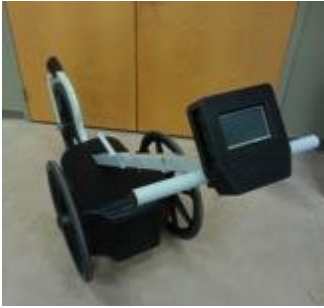
<b>Method</b>	<b>Pros</b>	<b>Cons</b>
<b>Wheeled</b>

<ul style="list-style-type: none"> <li>- Quick data collection</li> <li>- Inexpensive</li> </ul>	<ul style="list-style-type: none"> <li>- Some error due to a smaller area that makes contact with surface</li> </ul>
<b>Tracked</b>

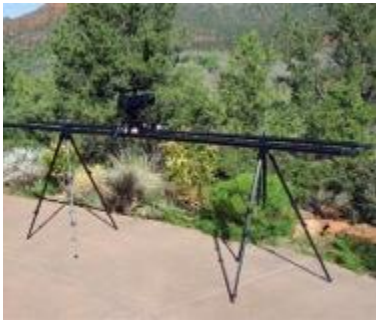
<ul style="list-style-type: none"> <li>- Autonomous robot</li> <li>- Tracks reduce error due to a larger area that makes contact with surface</li> </ul>	<ul style="list-style-type: none"> <li>- Expensive</li> </ul>
<b>Railed</b>

<ul style="list-style-type: none"> <li>- Eliminates error due to contact with surface</li> </ul>	<ul style="list-style-type: none"> <li>- Time consuming compared with Wheeled and Tracked methods</li> </ul>

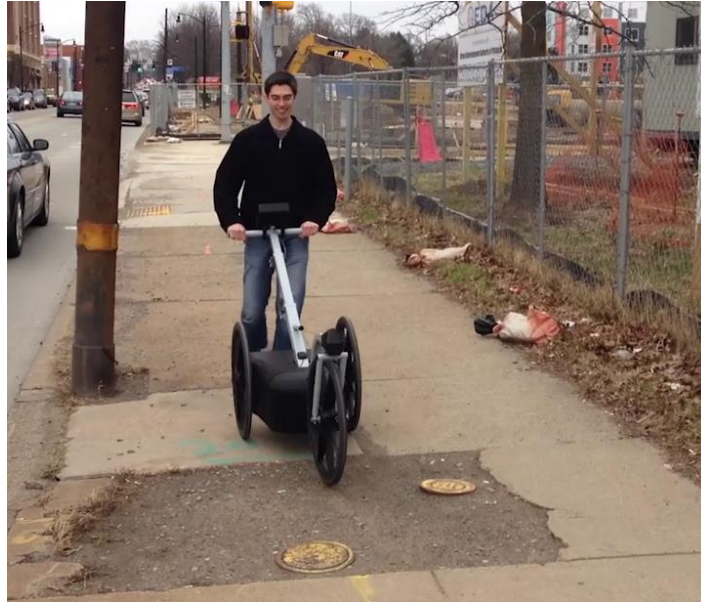
**Figure 14: Data collection during Rolling Mode**

This three-wheeled rolling design was selected in order to ensure that the device was easy to propel over an uneven surface. A second design concept considered was a tracked system. This system would be beneficial because it would eliminate errors experienced by traversing rough terrain with wheels. However, this treaded tracked system would need to be a robotic system since it would be difficult to propel with tracks, which would increase costs. The advantage of the long railway track would be its ability to completely eliminate errors caused by wheels since the track would be stationary on the ground. In addition, data would be collected in one long pass over the surface. Table 5 shows a comparison of the pros and cons of the three methods. However, the time and effort needed to set up this design does not make it user-friendly. Therefore, a user-friendly rolling device was designed to improve speed, while maintaining accuracy and keeping costs low. This method of data collection is referred to as Rolling Mode (Figure 14).

Rolling Mode allows the user to push PathMeT continuously at a speed of  $1.0 \text{ m/s} \pm 10\%$ . This speed has been chosen in order to ensure 1mm resolution and to be consistent with typical walking and wheelchair speeds. This mode allows for a large amount of data to be collected in a relatively short period of time. While data is continuously collected in Rolling Mode, the user is alerted of pathway segments that either are not in compliance with the roughness criteria or that result in data errors. Data from these segments is then recollected using the Inchworm Mode outlined below. When PathMeT is stopped, each rough segment is displayed in a queue. The queue displays the distance the user must backtrack in order to recollect the data for each segment. The user can either decide to recollect the data or ignore the error.

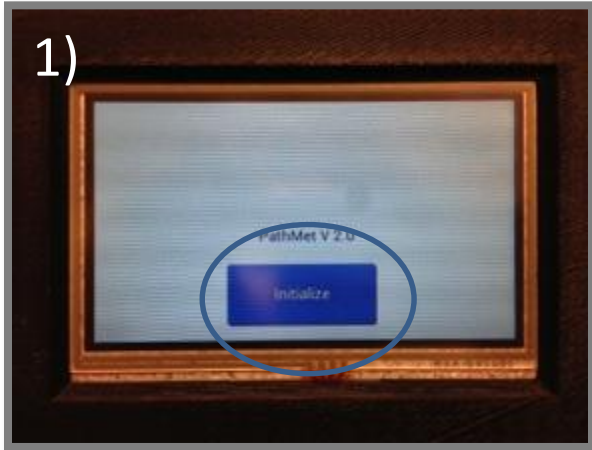
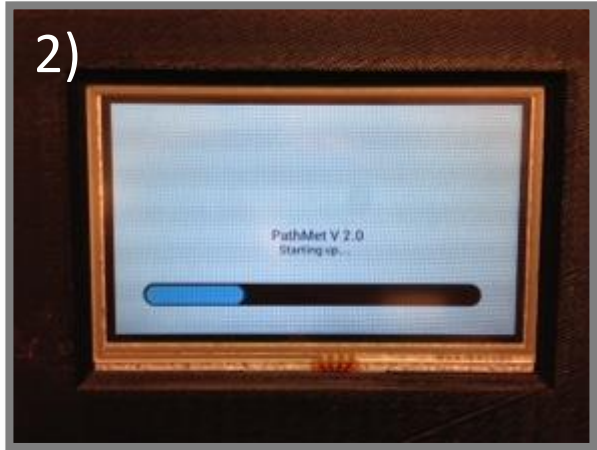
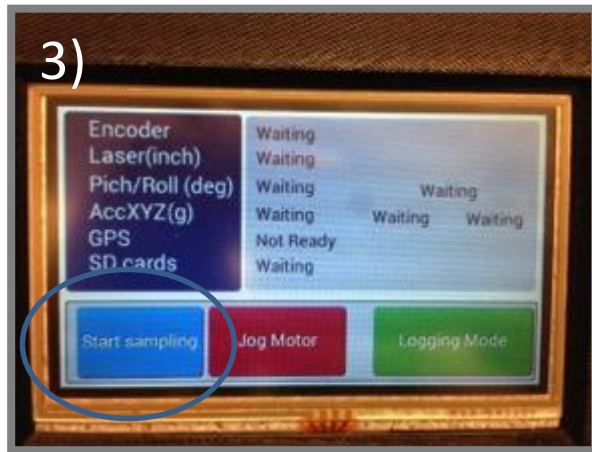
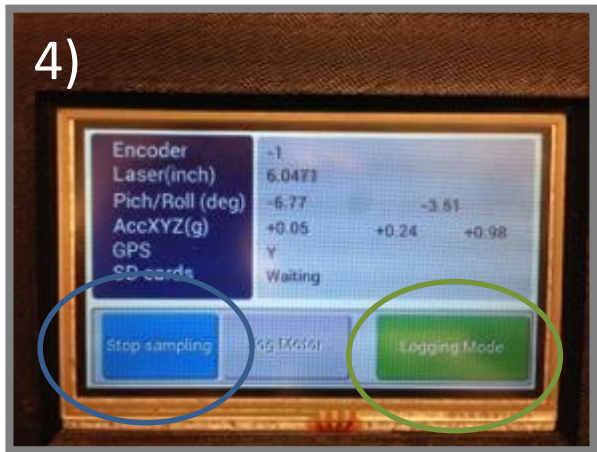
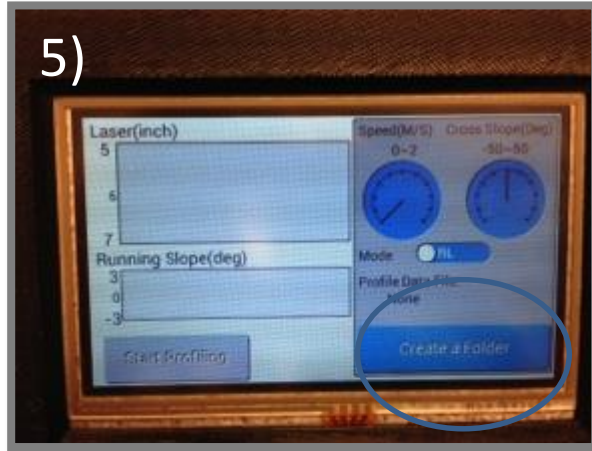
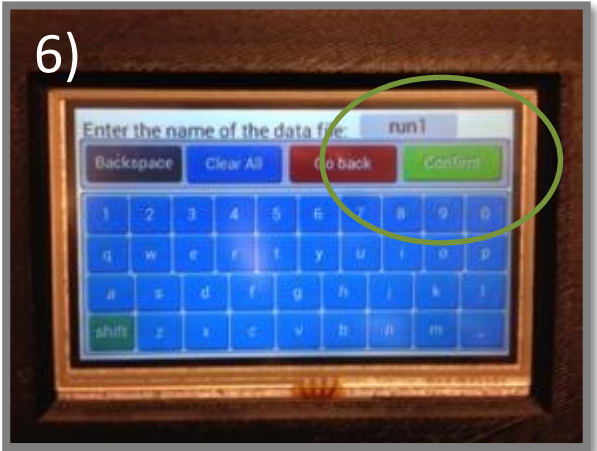
Figure 17: PathMeT interface

Figure 17 shows the user interface for PathMeT and the step-by-step process for data collection. Step 1 shows the display upon powering the device. When ready, the user presses the “Initialize” button to initialize the system. Step 2 shows the loading bar after Step 1. This loading screen takes twenty seconds, allowing the laser to warm up and initialize. Step 3 shows that the system is waiting for a command. When ready, the user presses “Start sampling” to ensure that all the sensors are sampling properly. Step 4 shows PathMeT in “sampling mode”. In order to progress, the user first selects “Stop sampling,” then “Logging Mode.” Before data can be collected, the user creates a folder in which to save data for that specific data collection run. The user does this by selecting “Create a Folder” (Step 5), entering a file name up to six characters and pressing “Confirm.” Data collection begins in Step 7 when the user selects either Rolling Mode (RL) (shown in the picture) or Inchworm Mode (IW), presses “Start Profiling” and begins propelling the device, if in Rolling Mode. Step 8 shows the four instantaneous outputs that are displayed: A) Running Slope, B) Profile of the surface, C) Speed, D) Cross Slope. When

the user is propelling PathMeT at an appropriate speed, the speedometer is green; otherwise, the speedometer is red. When data collection is complete, the user presses the “Stop Profiling” button. Step 9 shows that the camera must finish transferring data before proceeding to the next run. Finally, Step 10 shows a summary of the run, including time elapsed, distance travelled, file name, last instantaneous speed, and average speed. The user can then select “new profile” to begin a new run, “About” to learn about the previous run, or “Help” for help in proceeding. These are the steps required for data collection.

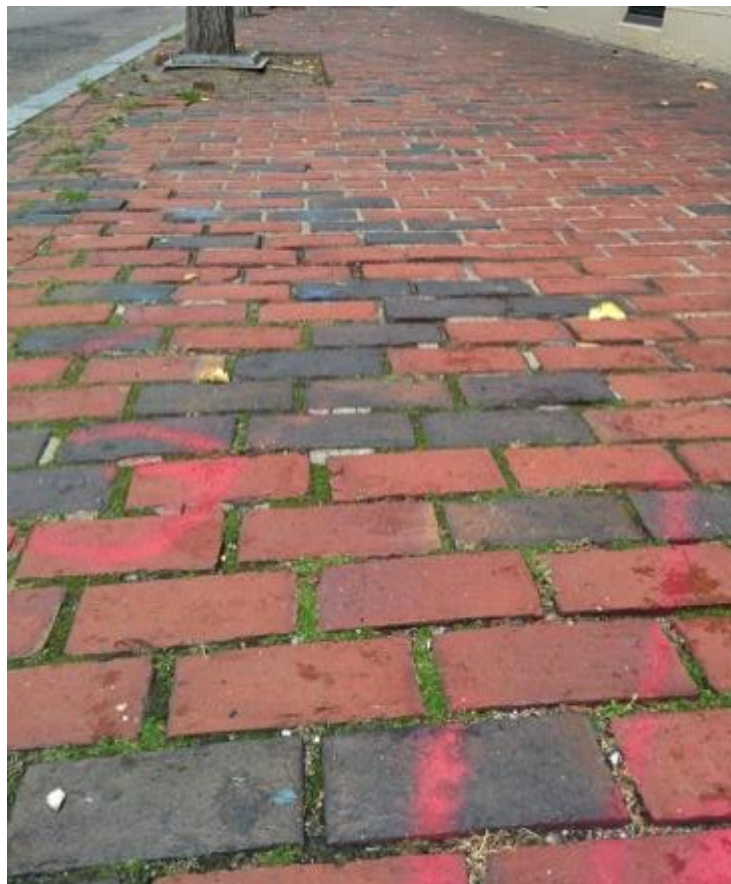
**Figure 22: Close-up of Surface 8**

Detailed analysis of Surface 8 reveals large gaps between pavers. A profile of the surface is presented in Figure 23a, and an enlarged section of the profile in Figure 23b. Upon further enlargement, Figure 23c shows that the width of one of the gaps is 1 inch. It appears as if a major contributor to the roughness of this surface is the large gap size.
