Understanding Agricultural Drain Tile Repair

Broken agricultural drain tile repairs are necessary to prevent future problems for both landowners and pipeline operators. Problems can appear years after pipeline construction has been completed, and these problems have expensive consequences for all parties.

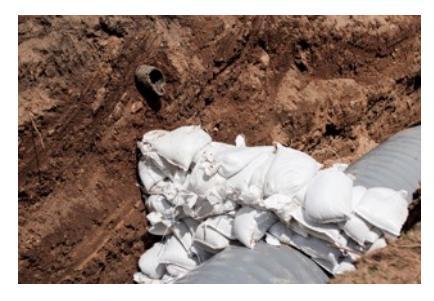
1.1: TYPICAL SANDBAG REPAIR

In order to maintain the appropriate grade on a permanent basis, bridges or stanchions were designed to provide support to the drain tile and to ensure separation between the drain tile and the pipeline. The most common form of bridge was a sand bag bridge. On large pipelines, 30" and larger, 100 or more sandbags are stacked from the bottom of the trench up to the required level to make drain tile repair. **ISEE PICTURE 1.1**]

Unfortunately, these types of bridges require a significant amount of labor & materials and are not stable during backfilling operations. If the sandbag bridge collapses during backfill, the trench needs to be re-excavated again.

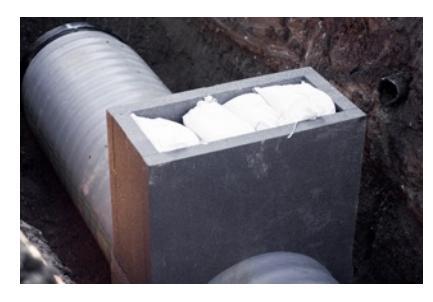
1.2: MAD DOG FOAM BRIDGE

In an effort to reduce labor costs and to speed up installation, various types of aggregate containment units have been designed. These units are designed to be quickly installed with a minimum number of sandbags, typically less than 15. These units can be installed by 2 laborers in less than 1 hour under normal conditions. [SEE PICTURE 1.2] The cost savings from using these bridges over sandbags can be significant when large numbers of broken drain tiles need to be repaired. Below is a chart that compares the cost of building sand bag bridges versus the cost of using Mad Dog Foam Bridges on 42" gas pipeline.

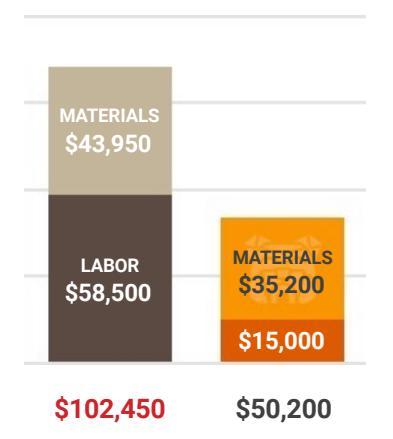
This graph of a pipeline installation shows the cost difference when repairing 50 water drain tile breaks with 200 sandbags vs. a Mad Dog Foam Bridge. A typical project can have up to 18 tile repairs per mile.
