GALVANIZED REBAR: IT WORKS.

Corrosion Resistant + Durable + Economic + Sustainable

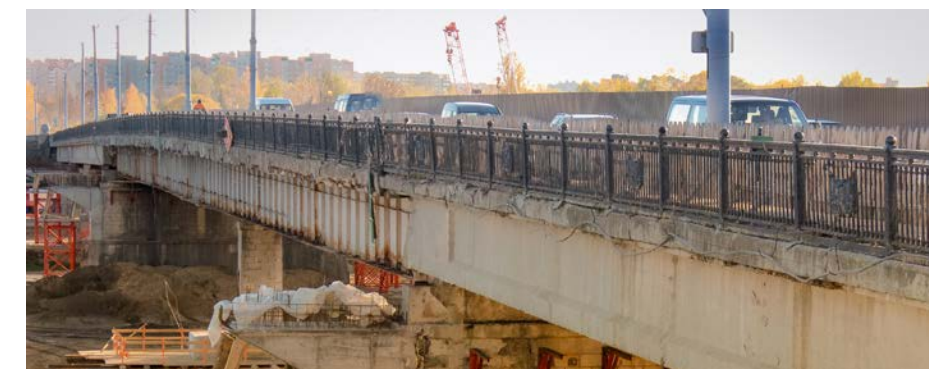
Bare (or black) steel reinforcement bars rely entirely on protection provided by the surrounding concrete. However, concrete permits the passage of chlorides from deicing salts, sea salts or other corrosive substances to the rebar because of its natural permeability, and also through cracks and expansion joints. Even carbon dioxide from the air will eventually result in rebar corrosion.

Despite precautionary measures and best practice, concrete structures remain vulnerable to reinforcement corrosion.

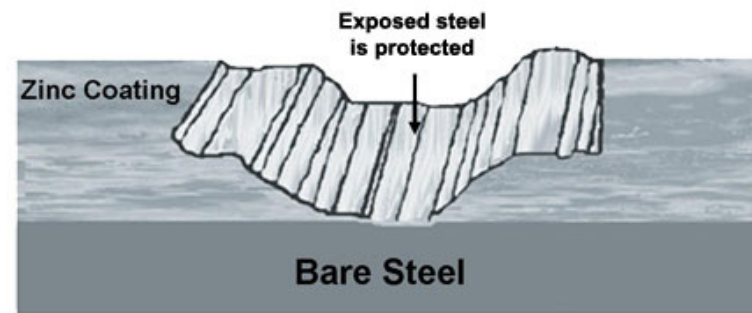
The excellent corrosion protection offered by zinc coatings or galvanizing derives from both the low natural corrosion rate of zinc coupled with its ability to extend protection to adjacent exposed steel areas, an effect known as cathodic protection. The coating also exhibits strong adhesion to the underlying steel surface due to its unique metallurgical bond that, together with the inherent toughness of a metallic coating, provides superior resistance to mechanical damage. The combination of these features results in a very durable coating, enabling concrete structures to be more tolerant of variability in concrete quality and reinforcement placement.

- It offers excellent resistance to chloride salt attack and is unaffected by concrete carbonation.
- Zinc's cathodic protection inhibits corrosion at any minor coating discontinuity and also prevents 'undercutting' of the coating, confining any corrosion risk to the local area of exposed steel.
- Zinc corrosion results in little accompanying volume change. Unlike with steel corrosion, there is no adverse impact on the surrounding concrete. Research shows that any corrosion products simply diffuse into the adjacent concrete, helping to fill micro porosity that further inhibits corrosion.

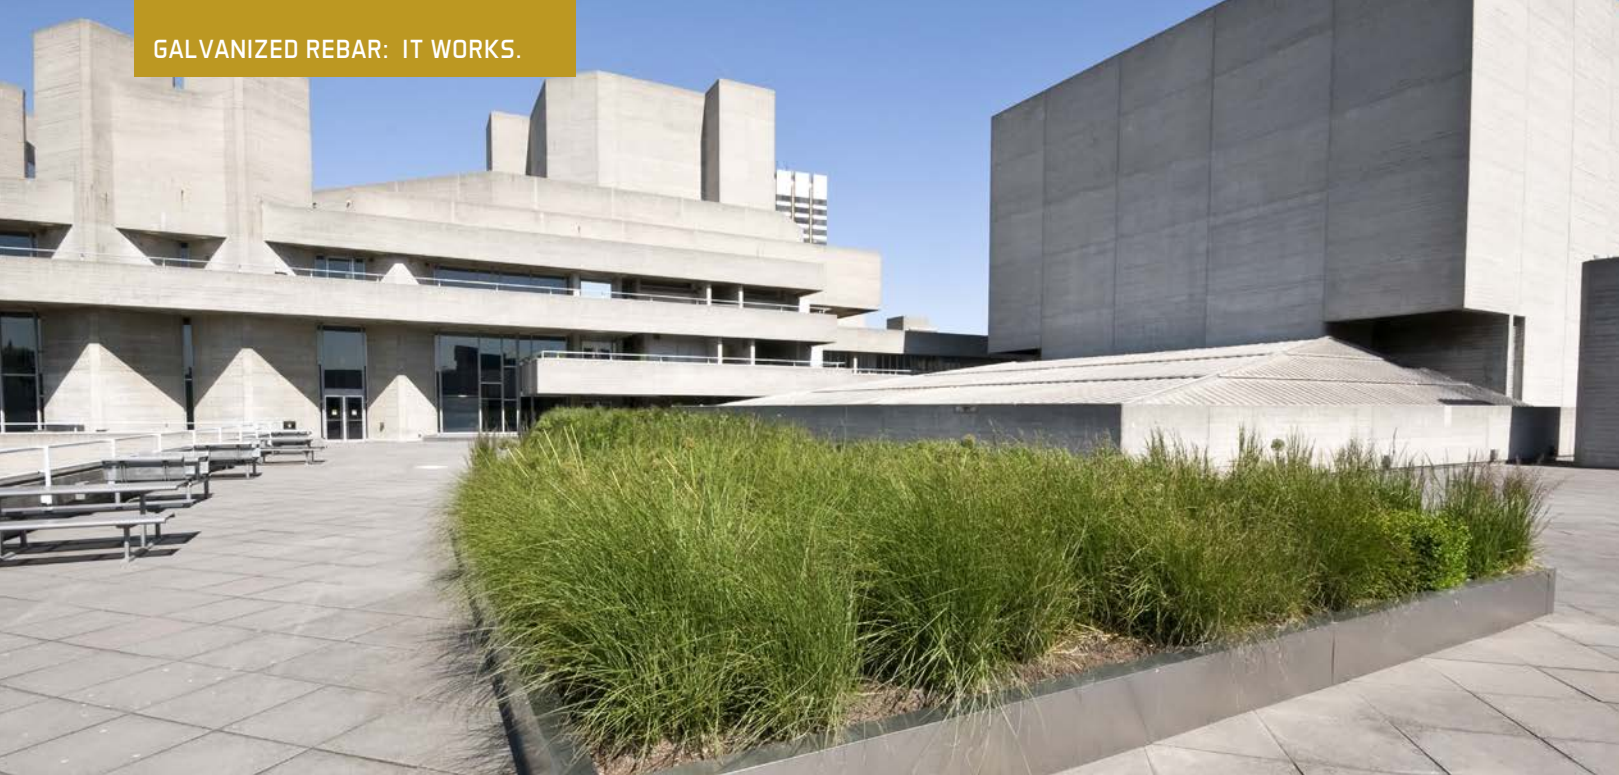
A strong metallurgical bond between the steel rebar and zinc coating is created during the galvanizing process. Galvanizing is metallurgically bonded to the steel up to 3,600 psi, meaning when rebar is dropped, kicked, stepped on, or rubbed against existing concrete or other rebar pieces on the job-site, the protective coating will remain tightly adhered. This durable zinc coating will withstand the effects of UV light, temperature extremes, and exposure to rain or snow, thus protecting the rebar both as it waits to be used and while in use. From installation through the use phase, galvanized rebar is abrasion resistant and durable.

Photo Credit: New York State Thruway Authority
