DETECTING INTEGRITY BREACHES
IN A RANGE OF PHARMACEUTICAL
BLISTER PACKAGE TYPES USING
SEPHA VISIONSCAN.

WHITE PAPER OVERVIEW

Dr. D. Dixon, University of Ulster, Shore Rd, Newtownabbey, N.Ireland, BT37 7QB
d.dixon@ulster.ac.uk

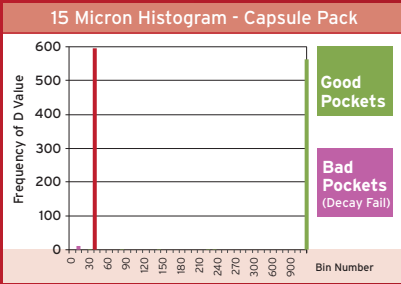
Figure 5a

Figure 5b
Distribution of G values (Fig. 5a) and D values (Fig. 5b) for good pockets and those containing 15µm holes for Pack 1.

From Fig. 5, one can see the distribution of G and D values for defect free packs and those containing a 15µm sized hole. The packs found to have incorrectly drilled defects have been removed from the data and the results of repeat testing are included. Those pockets with a laser drilled hole are coded as red in the histogram, while good pockets are shown in green. It can be seen from the figure that a marked difference is observed between the good packs and those with a defect. This allows a suitable threshold limit (shown as a red line) to be set enabling the reliable detection of faulty packs. Most of the pockets containing a defect were detected due to a difference in G value (deflection after the initial vacuum), while the remainder of the 15µm defects displayed failure via collapse during the period of reduced vacuum. Failures detected from the initial vacuum are referred to as gross holes, while the presence of smaller defects can be seen during the reduced vacuum phase. The ability to alter the vacuum and threshold levels allows the sensitivity of the system to be altered so that defects of a particular size are detected. The way in which the 15µm defect

was detected in pack 1 varied from the other pack types, with the pockets failing due to lack of initial deflection as opposed to collapse as seen with the other pack types. This could be down to the size of the pocket, resulting in a lower volume of air in the pocket and more rigid pocket lidding.

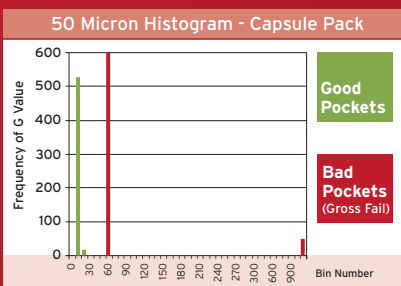
Figure 6
Distribution of G values for pockets containing either no defect or a 50µm hole (foil sealed capsule polymer pack).

Fig. 6 illustrates the distribution of G values from good packs and those with a 50µm hole. A marked difference is observed between the behaviour of the good pockets and those containing a laser drilled defect. In the case of the 50µm defects all the failures were detected due to differences in G value. All other packs tested during this study showed failure due to differences in G when looking for 50µm defects, aside from Pack type 2 which contained large round tablets. It was found that these pockets failed due to differences in D which could be down to the larger pocket volume.
