Plastic Surgeon Case Study:

## Persimmon Headquarters

**Client:** Persimmon  
**Sector:** Housebuilding  
**Repairs:** Stone portico

**Site:** Persimmon Corporate Headquarters  
York

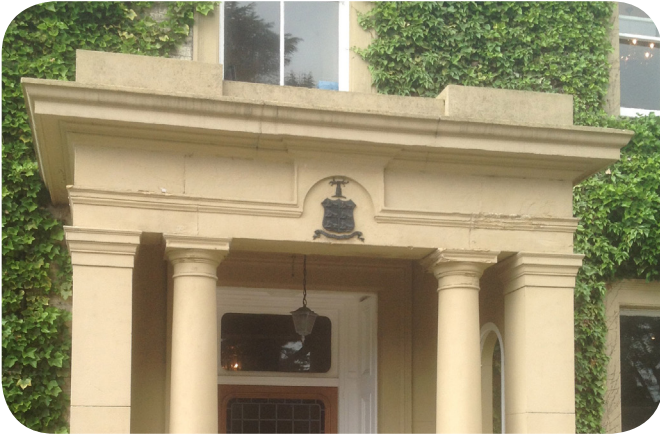
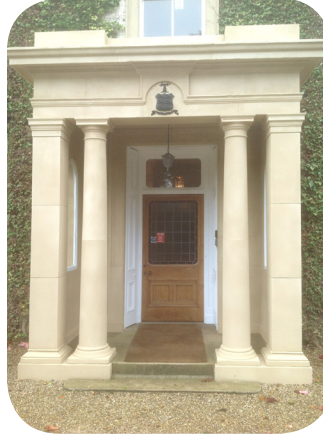
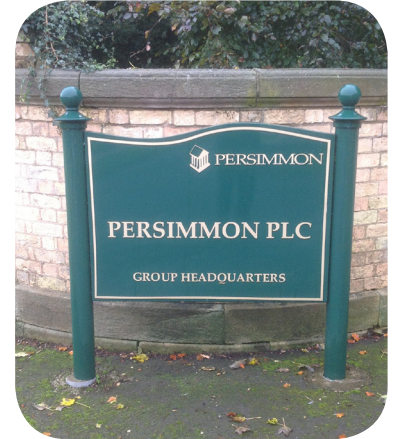
Mark Johnson takes up the account saying: "The stonework had suffered badly from exposure to the weather with areas that had either been eroded, or chunks had been spalled off by frost action. Numerous layers of masonry paint had also blistered or started to peel off and the water was causing further damage. Inside the entrance was in surprisingly bad condition.

"Our two Finishers therefore spent their first few days on the contract, brushing, scraping and sanding back the old paint, in order to get back to a solid substrate before any repairs could be made. We also had to bring in some tower scaffolding to reach the top sections beneath the flat roof."

The areas of stone which had been cut back were duly filled using Plastic Surgeon's premium stone repair product in its base colour; building back the deeper areas in layers to stabilize the work. Filled slightly proud of the original profile, the material was then sanded flush with the old sandstone masonry.

Then to complete the transformation, the Finishers selected the closest possible match of the company's Screedcoat product to colour the entire portico, using rollers and brushes for the detail areas. Finally an authentic texture was achieved by over-spraying the Screedcoat with specially graded silica, applied using guns and compressors.
